Profile/Photo Observation Report

Date:	04/16/2018	Weather:		Coding:	PACP 6.0
Pipe Length (ft):		Owner:	City of Hobart	Pre Clean:	No Pre-Cleaning
P.O.#:	64-1	Surveyor:	M. Pielacha	PSR:	M-605-066-M-605-057
Customer:	City of Hobart	Clean Date:		Shape:	C

Street:	Beverly Lane	Flow Control:	Not Controlled
City:	Hobart, IN	Year Renewed:	
Location:	Light Highway	Tape/Media #:	DEP 64
Purpose:	Routine Assessment	Dia/Height:	15"
Use:	Sanitary	Material:	CP
Drain Area:		Lining:	
Category:	NA		
Comment:			
Location Details:		Direction of Survey:	Downstream
US MH:	M-605-066	DS MH:	M-605-057
		Total Length Surveyed (ft):	295.7

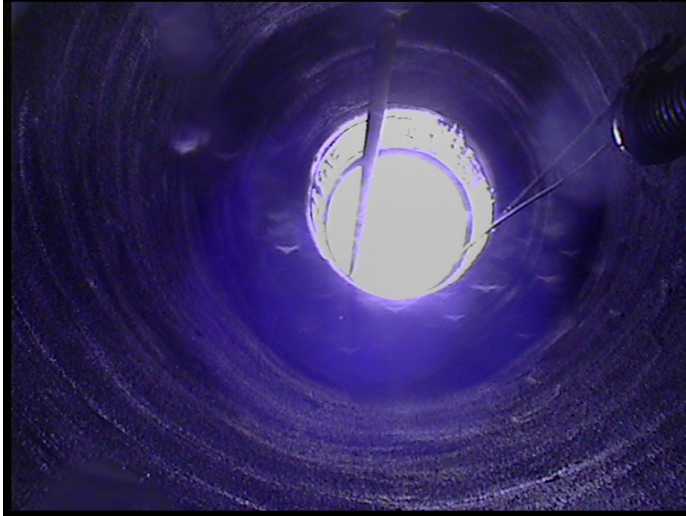
Code: **AMH**
Description: **Manhole**

Distance (ft): **.0**
Structural Grade: **0**
O&M Grade: **0**
Clock Start/From:
Clock To:
1st Value:
2nd Value:
Value Percent:
Continuous Index:
Within 8" of Joint: **NO**
Remarks: **M-605-066**

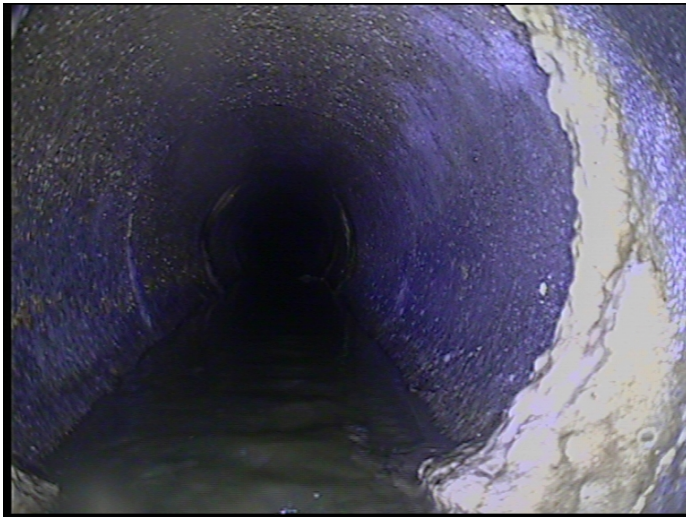
Code: **MWL**
Description: **Water Level**

Distance (ft): **.0**
Structural Grade: **0**
O&M Grade: **0**
Clock Start/From:
Clock To:
1st Value:
2nd Value:
Value Percent: **10.000**
Continuous Index:
Within 8" of Joint: **NO**
Remarks:

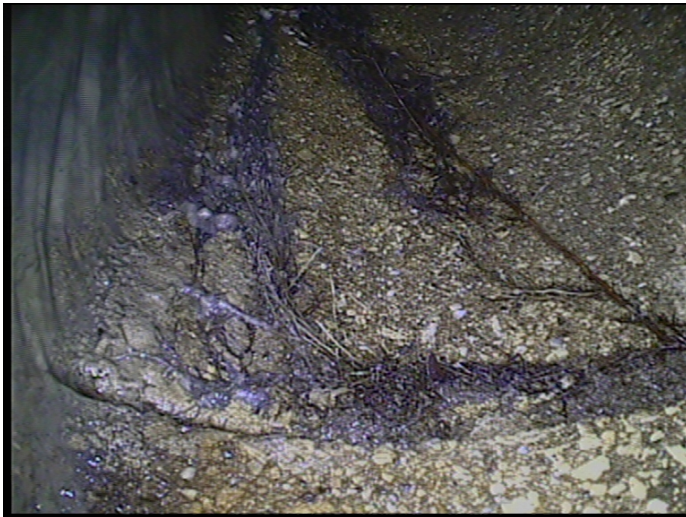
Code:	RFJ
Description:	Roots Fine Joint
Distance (ft):	173.2
Structural Grade:	0
O&M Grade:	1
Clock Start/From:	4
Clock To:	5
1st Value:	
2nd Value:	
Value Percent:	
Continuous Index:	
Within 8" of Joint:	YES
Remarks:

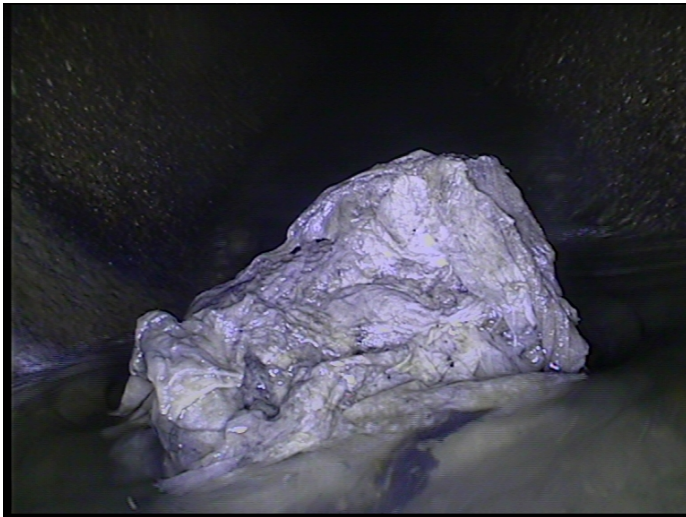
Code: **OBR**
Description: **Obstacle Rocks**

Distance (ft): **219.6**
Structural Grade: **0**
O&M Grade: **3**
Clock Start/From: **5**
Clock To: **7**
1st Value:
2nd Value:
Value Percent: **20.000**
Continuous Index:
Within 8" of Joint: **NO**
Remarks:

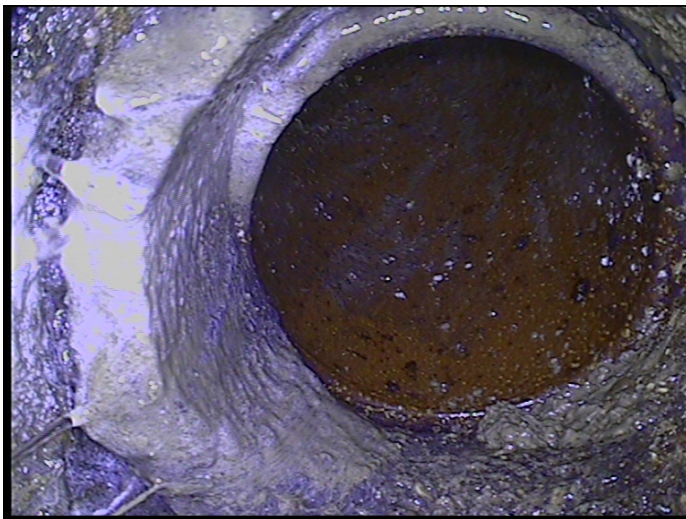
Code: **TBA**
Description: **Tap Break-in Active**

Distance (ft): **220.4**
Structural Grade: **0**
O&M Grade: **0**
Clock Start/From: **11**
Clock To:
1st Value: **4.000**
2nd Value:
Value Percent:
Continuous Index:
Within 8" of Joint: **NO**
Remarks:
