## Profile/Photo Observation Report

Date:	<b>04/16/2018</b>	Weather:		Coding:	<b>PACP 6.0</b>
Pipe Length (ft):		Owner:	<b>City of Hobart</b>	Pre Clean:	<b>No Pre-Cleaning</b>
P.O.#:	<b>64-1</b>	Surveyor:	<b>M. Pielacha</b>	PSR:	<b>M-605-066-M-605-057</b>
Customer:	<b>City of Hobart</b>	Clean Date:		Shape:	<b>C</b>

Street:	<b>Beverly Lane</b>	Flow Control:	<b>Not Controlled</b>
City:	<b>Hobart, IN</b>	Year Renewed:	
Location:	<b>Light Highway</b>	Tape/Media #:	<b>DEP 64</b>
Purpose:	<b>Routine Assessment</b>	Dia/Height:	<b>15"</b>
Use:	<b>Sanitary</b>	Material:	<b>CP</b>
Drain Area:		Lining:

US MH: **M-605-066** DS MH: **M-605-057** Total Length Surveyed (ft): **295.7**

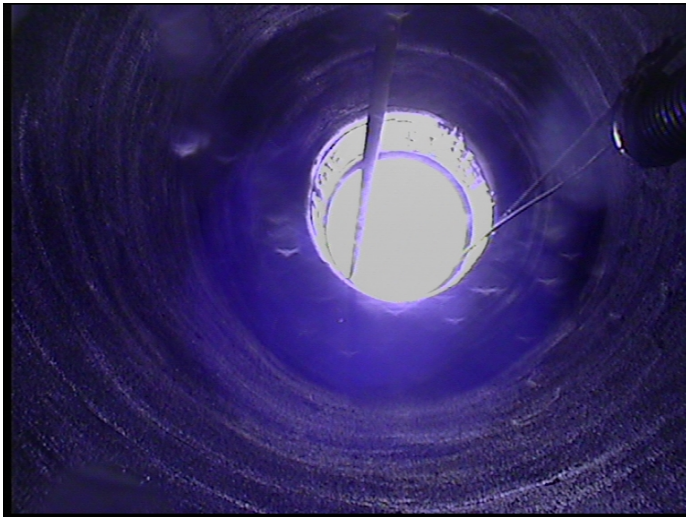
Code: **AMH**  
Description: **Manhole**

Distance (ft): **.0**  
Structural Grade: **0**  
O&M Grade: **0**  
Clock Start/From:  
Clock To:  
1st Value:  
2nd Value:  
Value Percent:  
Continuous Index:  
Within 8" of Joint: **NO**  
Remarks: **M-605-066**

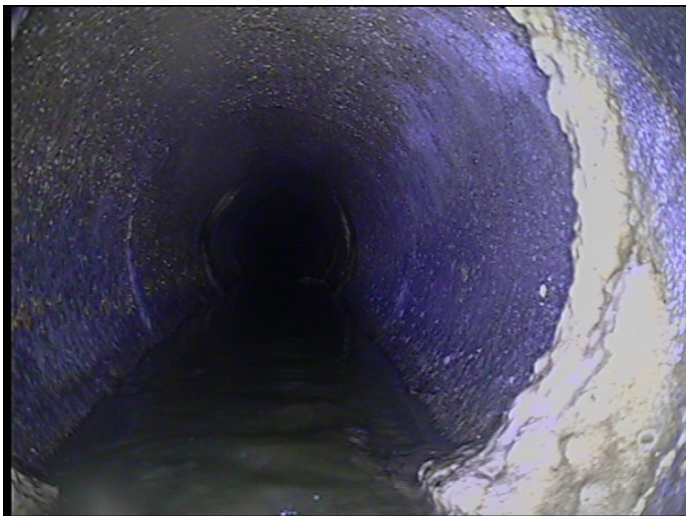
Code: **MWL**  
Description: **Water Level**

Distance (ft): **.0**  
Structural Grade: **0**  
O&M Grade: **0**  
Clock Start/From:  
Clock To:  
1st Value:  
2nd Value:  
Value Percent: **10.000**  
Continuous Index:  
Within 8" of Joint: **NO**  
Remarks:

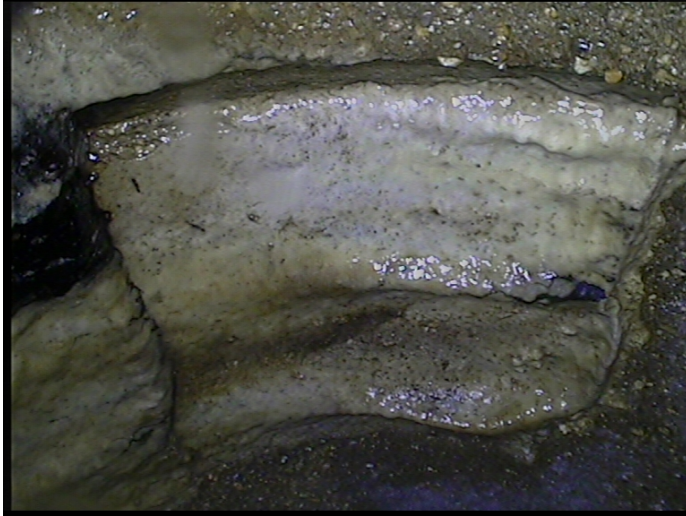
Code:	<b>CC</b>
Description:	<b>Crack Circumferential</b>
Distance (ft):	<b>6.8</b>
Structural Grade:	<b>1</b>
O&M Grade:	<b>0</b>
Clock Start/From:	<b>9</b>
Clock To:	<b>10</b>
1st Value:	
2nd Value:	
Value Percent:	
Continuous Index:	
Within 8" of Joint:	<b>YES</b>
Remarks:

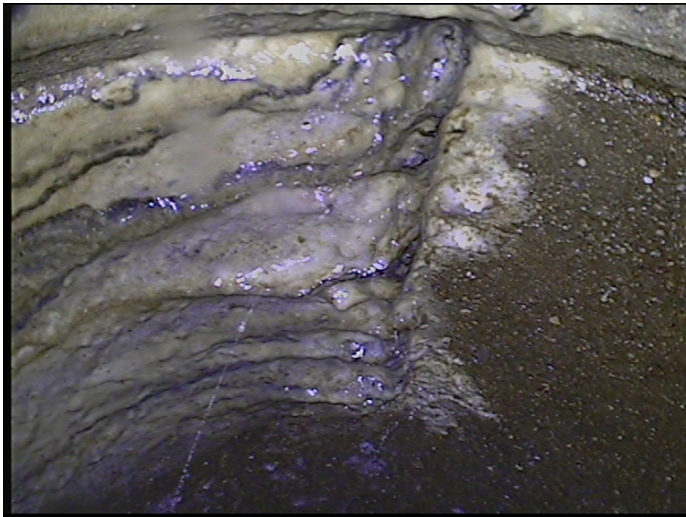
Code:	<b>CL</b>
Description:	<b>Crack Longitudinal</b>
Distance (ft):	<b>22.0</b>
Structural Grade:	<b>2</b>
O&M Grade:	<b>0</b>
Clock Start/From:	<b>11</b>
Clock To:	
1st Value:	
2nd Value:	
Value Percent:	
Continuous Index:	
Within 8" of Joint:	<b>YES</b>
Remarks:

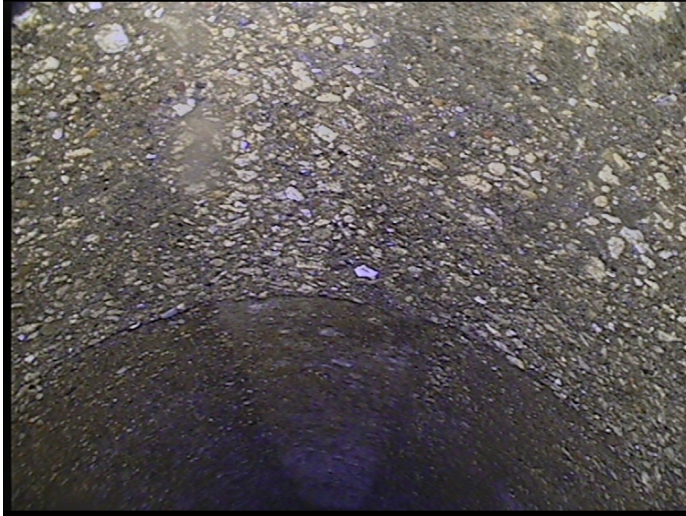
Code: **SAV**  
Description: **Surface Aggregate Visible**

Distance (ft): **33.6**  
Structural Grade: **3**  
O&M Grade: **0**  
Clock Start/From: **8**  
Clock To: **4**  
1st Value:  
2nd Value:  
Value Percent:  
Continuous Index: **S01**  
Within 8" of Joint: **YES**  
Remarks:

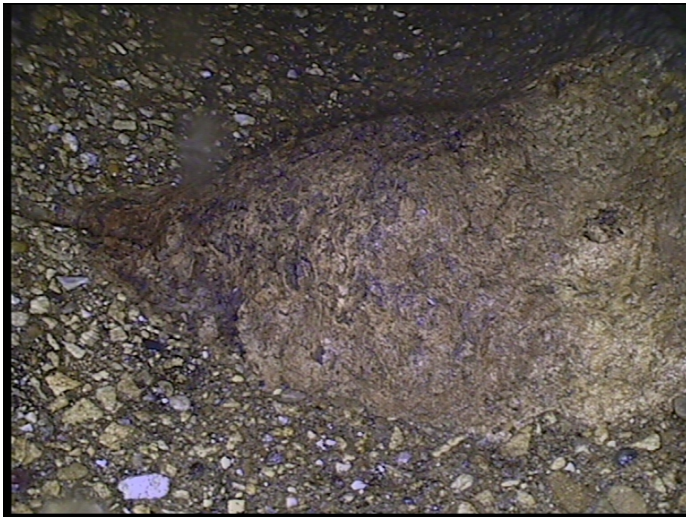
Code: **DAE**  
Description: **Deposits Attached Encrustation**

Distance (ft): **46.3**  
Structural Grade: **0**  
O&M Grade: **2**  
Clock Start/From: **7**  
Clock To: **9**  
1st Value:  
2nd Value:  
Value Percent: **5.000**  
Continuous Index:  
Within 8" of Joint: **YES**  
Remarks:

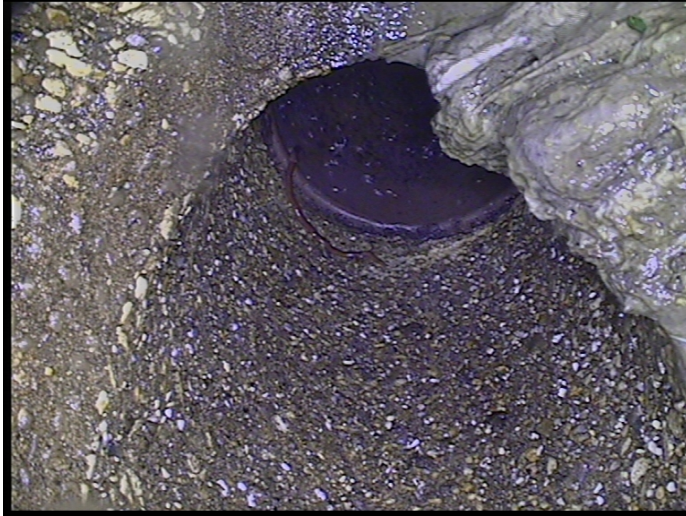
Code: **TFA**  
Description: **Tap Factory Active**

Distance (ft): **47.9**  
Structural Grade: **0**  
O&M Grade: **0**  
Clock Start/From: **2**  
Clock To:  
1st Value: **4.000**  
2nd Value:  
Value Percent:  
Continuous Index:  
Within 8" of Joint: **NO**  
Remarks:

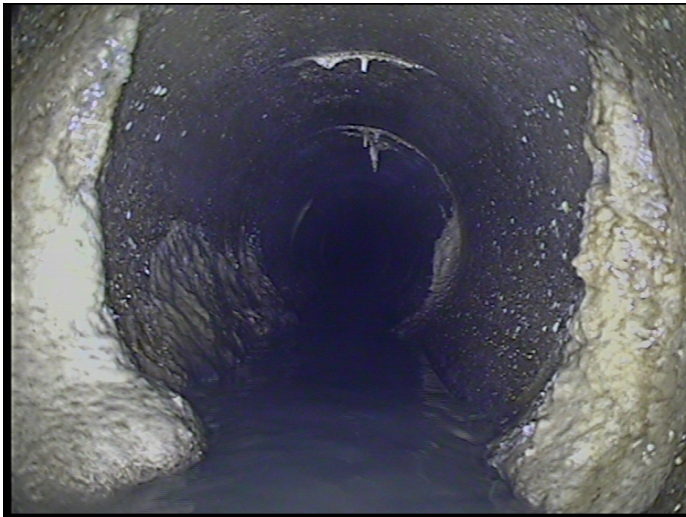
Code: **DAE**  
Description: **Deposits Attached Encrustation**

Distance (ft): **51.3**  
Structural Grade: **0**  
O&M Grade: **2**  
Clock Start/From: **7**  
Clock To: **5**  
1st Value:  
2nd Value:  
Value Percent: **5.000**  
Continuous Index: **S02**  
Within 8" of Joint: **YES**  
Remarks:

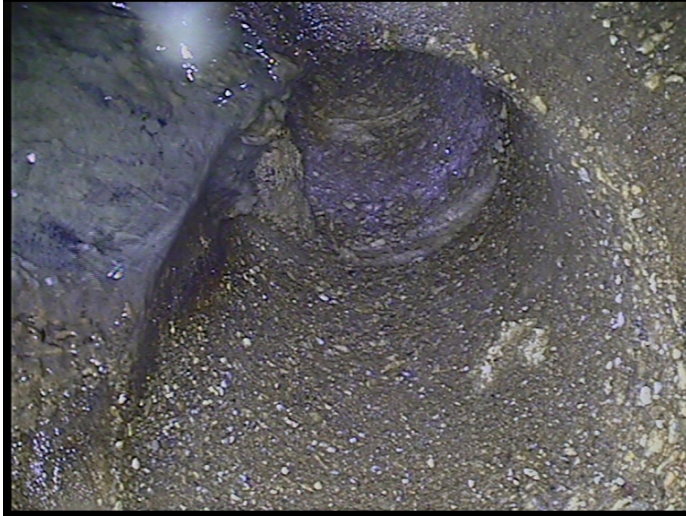
Code: **TFA**  
Description: **Tap Factory Active**

Distance (ft): **66.3**  
Structural Grade: **0**  
O&M Grade: **0**  
Clock Start/From: **10**  
Clock To:  
1st Value: **4.000**  
2nd Value:  
Value Percent:  
Continuous Index:  
Within 8" of Joint: **NO**  
Remarks:

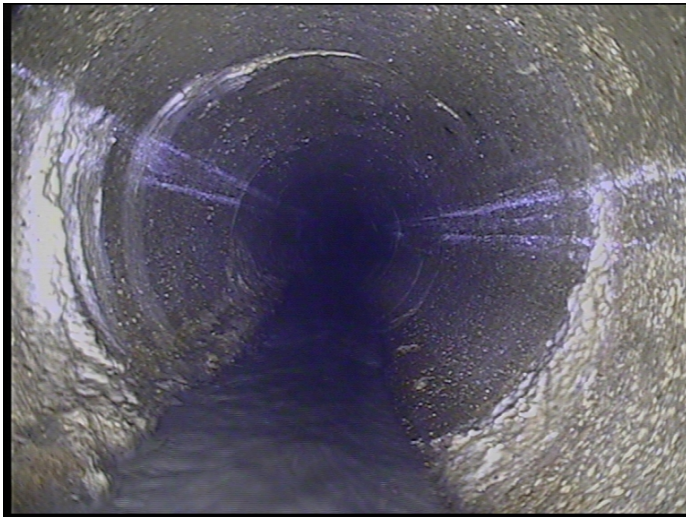
Code: **DAE**  
Description: **Deposits Attached Encrustation**

Distance (ft): **86.7**  
Structural Grade: **0**  
O&M Grade: **2**  
Clock Start/From: **7**  
Clock To: **5**  
1st Value:  
2nd Value:  
Value Percent: **5.000**  
Continuous Index: **F02**  
Within 8" of Joint: **NO**  
Remarks:

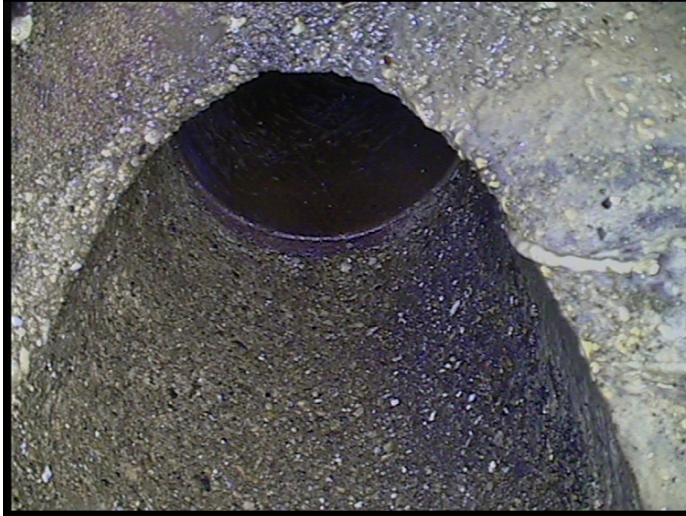
Code: **TF**  
Description: **Tap Factory**

Distance (ft): **114.1**  
Structural Grade: **0**  
O&M Grade: **0**  
Clock Start/From: **2**  
Clock To:  
1st Value: **4.000**  
2nd Value:  
Value Percent:  
Continuous Index:  
Within 8" of Joint: **NO**  
Remarks:

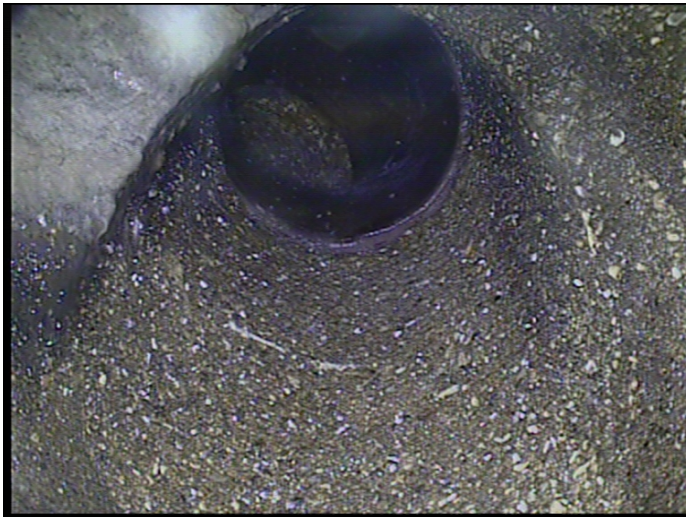
Code: **TF**  
Description: **Tap Factory**

Distance (ft): **138.8**  
Structural Grade: **0**  
O&M Grade: **0**  
Clock Start/From: **10**  
Clock To:  
1st Value: **4.000**  
2nd Value:  
Value Percent:  
Continuous Index:  
Within 8" of Joint: **NO**  
Remarks:

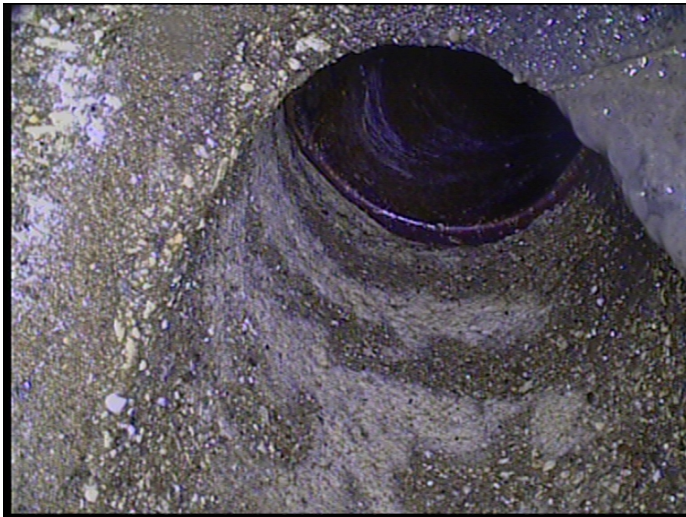
Code:	<b>TFA</b>
Description:	<b>Tap Factory Active</b>
Distance (ft):	<b>162.7</b>
Structural Grade:	<b>0</b>
O&M Grade:	<b>0</b>
Clock Start/From:	<b>2</b>
Clock To:	
1st Value:	<b>4.000</b>
2nd Value:	
Value Percent:	
Continuous Index:	
Within 8" of Joint:	<b>NO</b>
Remarks:

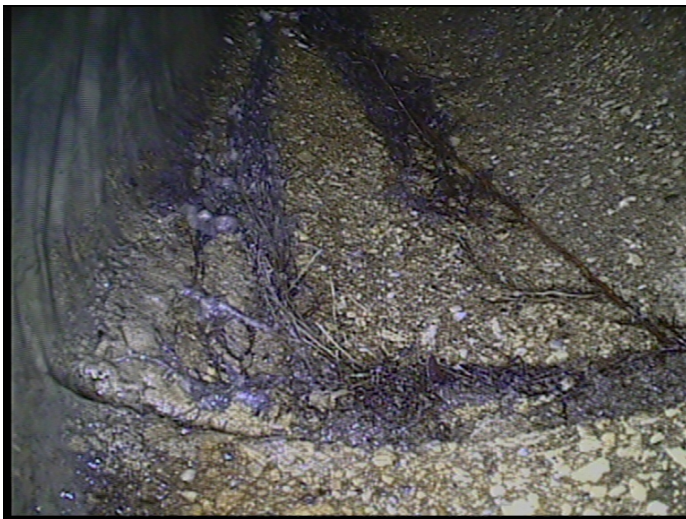
Code:	<b>RFJ</b>
Description:	<b>Roots Fine Joint</b>
Distance (ft):	<b>173.2</b>
Structural Grade:	<b>0</b>
O&M Grade:	<b>1</b>
Clock Start/From:	<b>4</b>
Clock To:	<b>5</b>
1st Value:	
2nd Value:	
Value Percent:	
Continuous Index:	
Within 8" of Joint:	<b>YES</b>
Remarks:

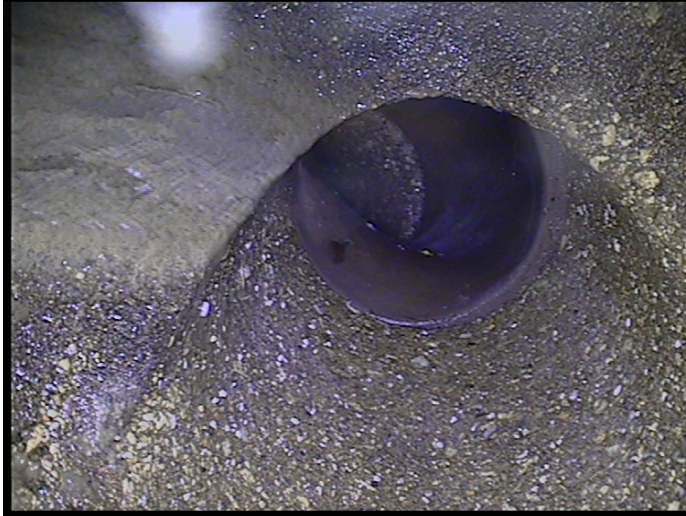
Code:	<b>TFA</b>
Description:	<b>Tap Factory Active</b>
Distance (ft):	<b>178.2</b>
Structural Grade:	<b>0</b>
O&M Grade:	<b>0</b>
Clock Start/From:	<b>10</b>
Clock To:	
1st Value:	<b>4.000</b>
2nd Value:	
Value Percent:	
Continuous Index:	
Within 8" of Joint:	<b>NO</b>
Remarks:

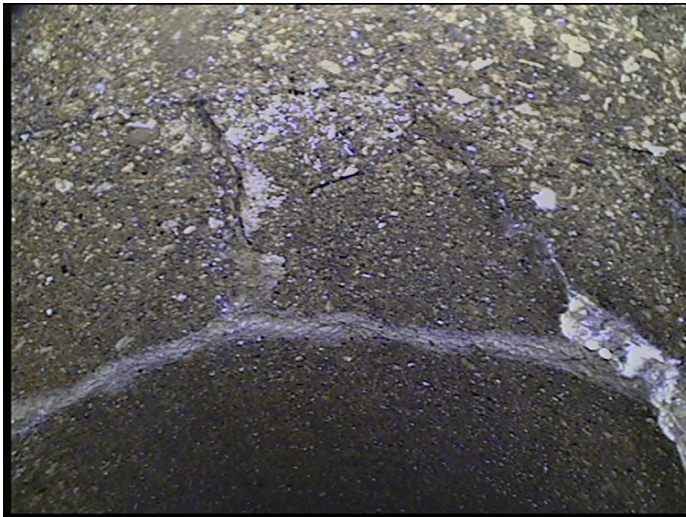
Code:	<b>CM</b>
Description:	<b>Crack Multiple</b>
Distance (ft):	<b>182.2</b>
Structural Grade:	<b>3</b>
O&M Grade:	<b>0</b>
Clock Start/From:	<b>10</b>
Clock To:	<b>2</b>
1st Value:	
2nd Value:	
Value Percent:	
Continuous Index:	
Within 8" of Joint:	<b>YES</b>
Remarks:

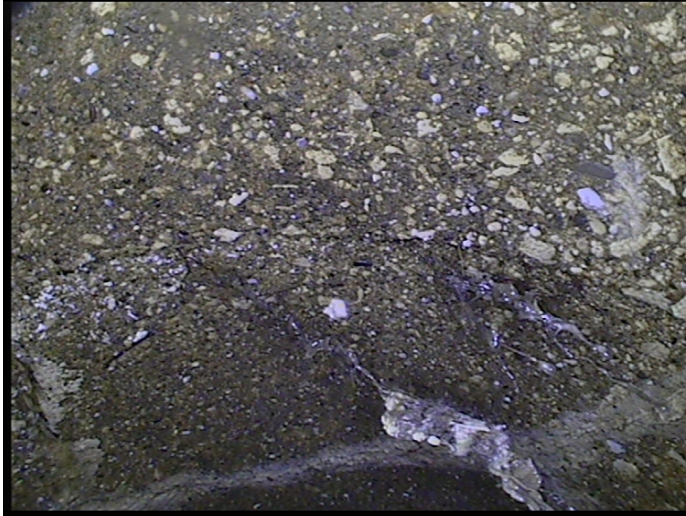
Code: **RFJ**  
Description: **Roots Fine Joint**

Distance (ft): **182.2**  
Structural Grade: **0**  
O&M Grade: **1**  
Clock Start/From: **1**  
Clock To:  
1st Value:  
2nd Value:  
Value Percent:  
Continuous Index:  
Within 8" of Joint: **YES**  
Remarks:

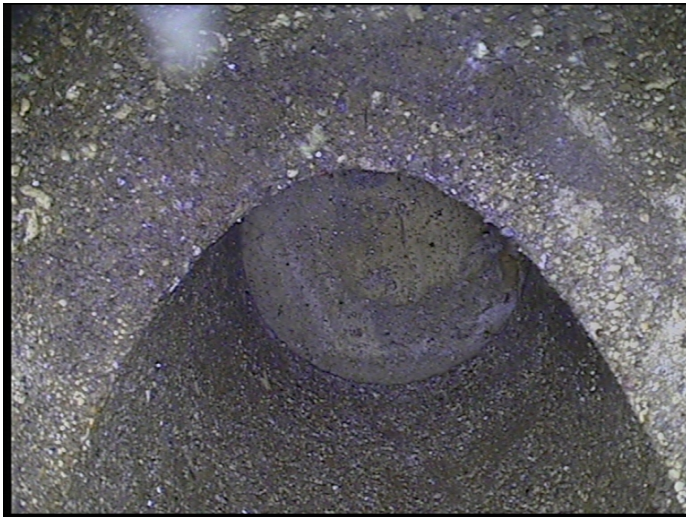
Code: **TFC**  
Description: **Tap Factory Capped**

Distance (ft): **199.4**  
Structural Grade: **0**  
O&M Grade: **0**  
Clock Start/From: **2**  
Clock To:  
1st Value: **4.000**  
2nd Value:  
Value Percent:  
Continuous Index:  
Within 8" of Joint: **NO**  
Remarks:

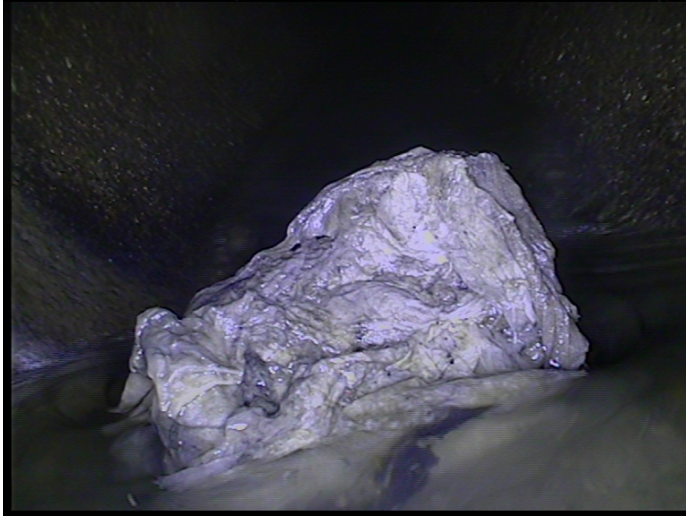
Code: **OBR**  
Description: **Obstacle Rocks**

Distance (ft): **219.6**  
Structural Grade: **0**  
O&M Grade: **3**  
Clock Start/From: **5**  
Clock To: **7**  
1st Value:  
2nd Value:  
Value Percent: **20.000**  
Continuous Index:  
Within 8" of Joint: **NO**  
Remarks:

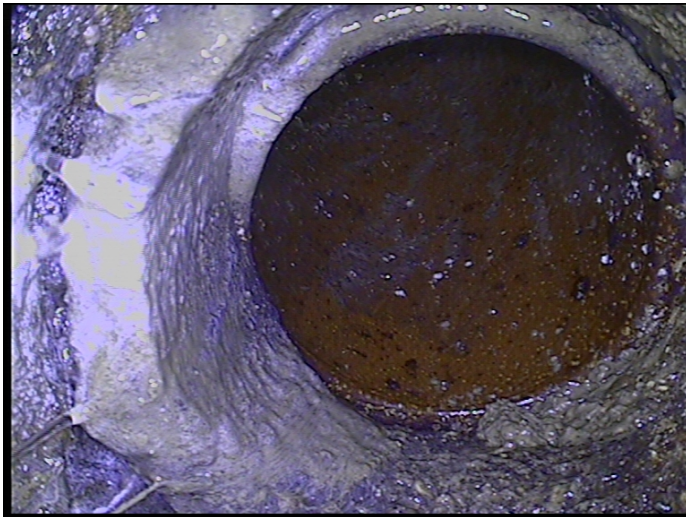
Code: **TBA**  
Description: **Tap Break-in Active**

Distance (ft): **220.4**  
Structural Grade: **0**  
O&M Grade: **0**  
Clock Start/From: **11**  
Clock To:  
1st Value: **4.000**  
2nd Value:  
Value Percent:  
Continuous Index:  
Within 8" of Joint: **NO**  
Remarks:

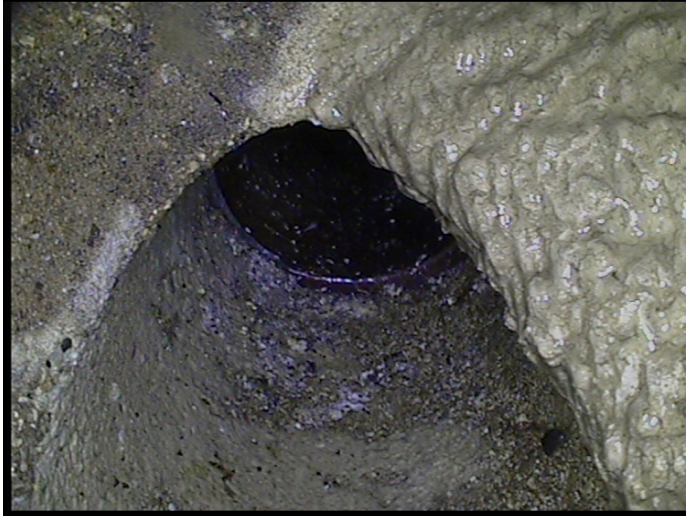
Code: **TF**  
Description: **Tap Factory**

Distance (ft): **226.7**  
Structural Grade: **0**  
O&M Grade: **0**  
Clock Start/From: **2**  
Clock To:  
1st Value: **4.000**  
2nd Value:  
Value Percent:  
Continuous Index:  
Within 8" of Joint: **NO**  
Remarks:

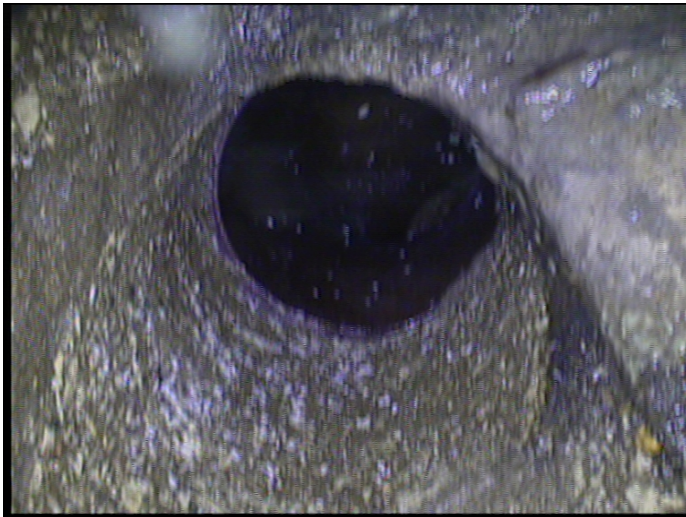
Code: **TF**  
Description: **Tap Factory**

Distance (ft): **254.0**  
Structural Grade: **0**  
O&M Grade: **0**  
Clock Start/From: **2**  
Clock To:  
1st Value: **4.000**  
2nd Value:  
Value Percent:  
Continuous Index:  
Within 8" of Joint: **NO**  
Remarks:

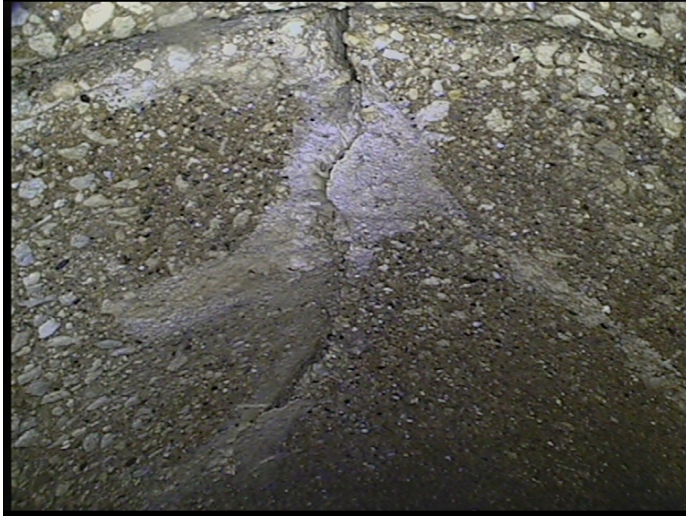
Code: **CL**  
Description: **Crack Longitudinal**

Distance (ft): **258.3**  
Structural Grade: **2**  
O&M Grade: **0**  
Clock Start/From: **10**  
Clock To:  
1st Value:  
2nd Value:  
Value Percent:  
Continuous Index:  
Within 8" of Joint: **YES**  
Remarks:

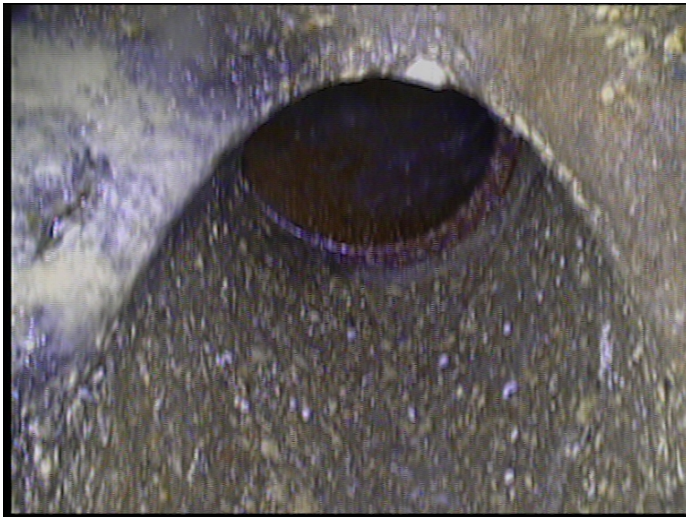
Code: **TF**  
Description: **Tap Factory**

Distance (ft): **287.5**  
Structural Grade: **0**  
O&M Grade: **0**  
Clock Start/From: **10**  
Clock To:  
1st Value: **4.000**  
2nd Value:  
Value Percent:  
Continuous Index:  
Within 8" of Joint: **NO**  
Remarks:

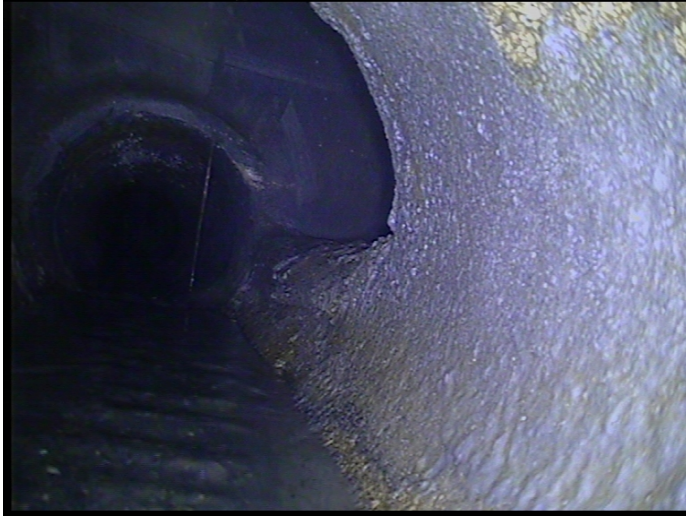
Code: **SAV**  
Description: **Surface Aggregate Visible**

Distance (ft): **292.7**  
Structural Grade: **3**  
O&M Grade: **0**  
Clock Start/From: **8**  
Clock To: **4**  
1st Value:  
2nd Value:  
Value Percent:  
Continuous Index: **F01**  
Within 8" of Joint: **NO**  
Remarks:

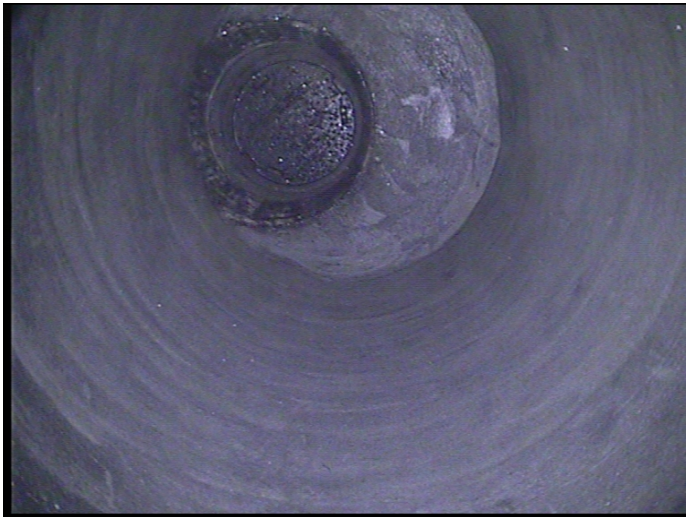
Code: **AMH**  
Description: **Manhole**

Distance (ft): **295.7**  
Structural Grade: **0**  
O&M Grade: **0**  
Clock Start/From:  
Clock To:  
1st Value:  
2nd Value:  
Value Percent:  
Continuous Index:  
Within 8" of Joint: **NO**  
Remarks: **M-605-057**
