Profile/Ph	oto Observatio	n Report			RedZon
Date:	04/23/2018	Weather:		Coding:	PACP 6.0
Pipe Length (ft): 319.0	Owner:	NA	Pre Clean:	Not Known
P.O.#:		Surveyor:	Jen Costello	PSR:	P-605-065-066
Customer:		Clean Date:	01/01/1900	Shape:	С
Street:	BEVERLY LN & BE	VERLY BLVD	Flow Control:	Not Controlled	l
City:	Hobart, IN		Year Renewed:		
Location:	Other		Tape/Media #:		
Purpose:	Not Known		Dia/Height:	8"	
Use:	Sanitary		Material:	СР	
Drain Area:	NA		Lining:		
Category:	NA				
Comment:					
Location Detail	ls:		Direction of Surv	ey: Downstream	
US MH:	M-605-066	DS MH:	M-605-065	Total Length Surveyed (ft)): 3.4
0&M Index:	4.00	O&M Quick:	410	0 O&M Rating:	4.00
tructural Index:	3.00	Structural Qu	uick: 310	0 Structural Rating:	3.00
Overall Index:	3.50	Overall Quick	c 413:		7.00

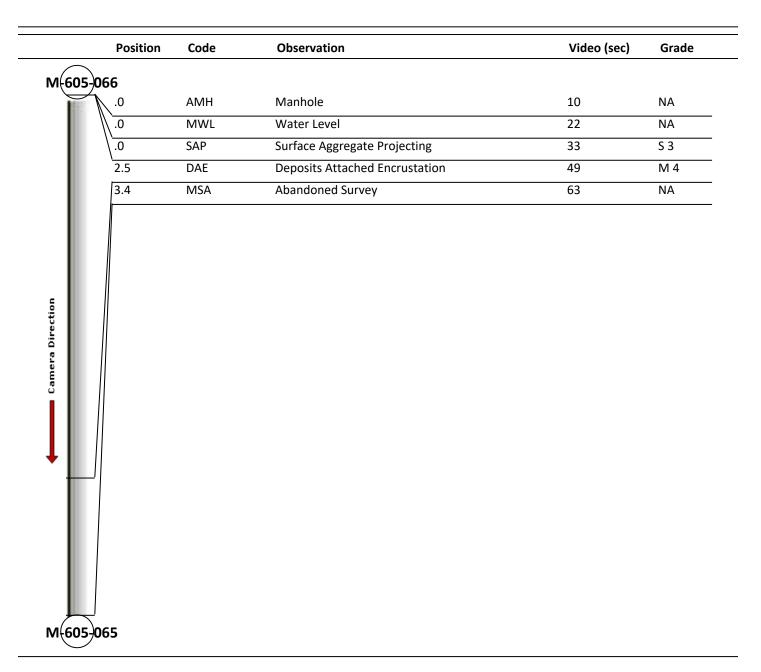
Code:	АМН
Description:	Manhole
Distance (ft):	.0
Structural Grade:	0
O&M Grade:	0
Clock Start/From:	
Clock To:	
1st Value:	
2nd Value:	
Value Percent:	
Continuous Index:	
Within 8" of Joint:	NO
Remarks:	M-605-066
