Profile/Photo Observation Report

Street:	BEVERLY LN & BEVERLY BLVD	Flow Control:	Not Controlled
City:	Hobart, IN	Year Renewed:	
Location:	Other	Tape/Media #:	
Purpose:	Not Known	Dia/Height:	8"
Use:	Sanitary	Material:	VCP
Drain Area:	NA	Lining:	
Category:	NA		
Comment:

Location Details:		Direction of Survey:	Upstream
US MH:	M-605-066	DS MH:	M-605-065
		Total Length Surveyed (ft):	8.7

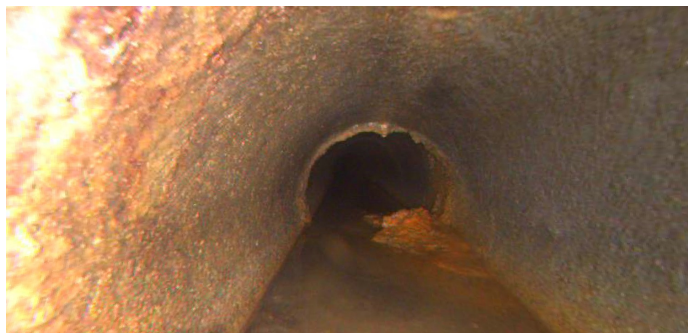
Code: **AMH**
 Description: **Manhole**
 Distance (ft): **.0**
 Structural Grade: **0**
 O&M Grade: **0**
 Clock Start/From:
 Clock To:
 1st Value:
 2nd Value:
 Value Percent:
 Continuous Index:
 Within 8" of Joint: **NO**
 Remarks: **M-605-065**

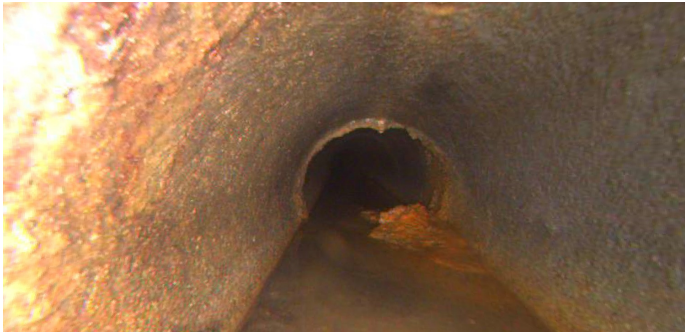
Code:	MWL
Description:	Water Level

Distance (ft):	.0
Structural Grade:	0
O&M Grade:	0
Clock Start/From:	
Clock To:	
1st Value:	
2nd Value:	
Value Percent:	10.000
Continuous Index:	
Within 8" of Joint:	NO
Remarks:

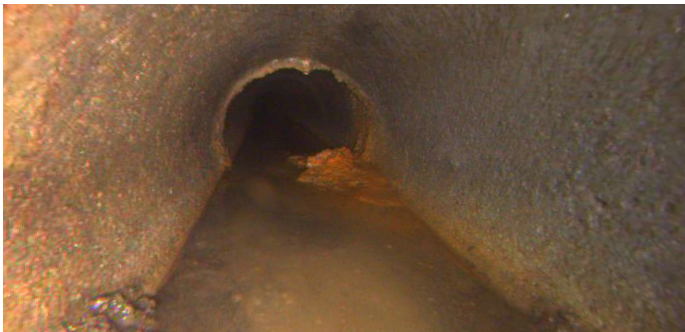
Code:	DAE
Description:	Deposits Attached Encrustation

Distance (ft):	.0
Structural Grade:	0
O&M Grade:	2
Clock Start/From:	8
Clock To:	4
1st Value:	
2nd Value:	
Value Percent:	5.000
Continuous Index:	S01
Within 8" of Joint:	NO
Remarks:

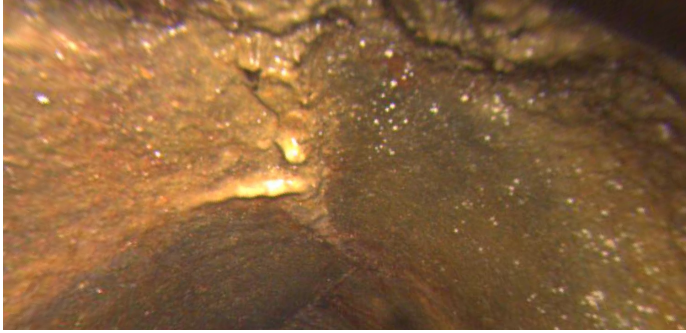
Code: **ID**
Description: **Infil Dripper**

Distance (ft): **2.4**
Structural Grade: **0**
O&M Grade: **3**
Clock Start/From: **12**
Clock To:
1st Value:
2nd Value:
Value Percent:
Continuous Index:
Within 8" of Joint: **YES**
Remarks:

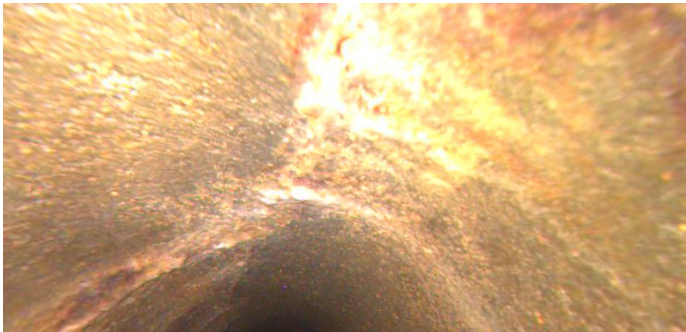
Code: **FL**
Description: **Fracture Longitudinal**

Distance (ft): **3.1**
Structural Grade: **3**
O&M Grade: **0**
Clock Start/From: **12**
Clock To:
1st Value:
2nd Value:
Value Percent:
Continuous Index:
Within 8" of Joint:
Remarks:

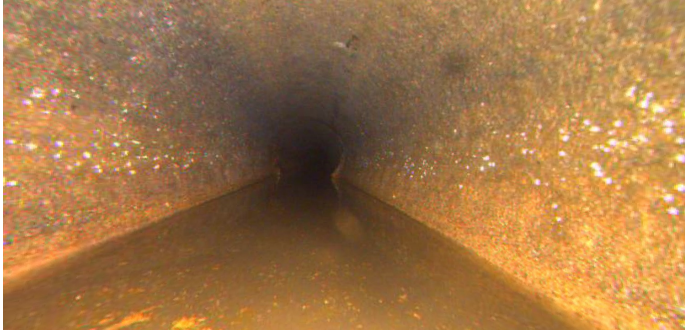
Code: **DAE**
Description: **Deposits Attached Encrustation**

Distance (ft): **8.7**
Structural Grade: **0**
O&M Grade: **2**
Clock Start/From: **8**
Clock To: **4**
1st Value:
2nd Value:
Value Percent: **5.000**
Continuous Index: **F01**
Within 8" of Joint: **NO**
Remarks:

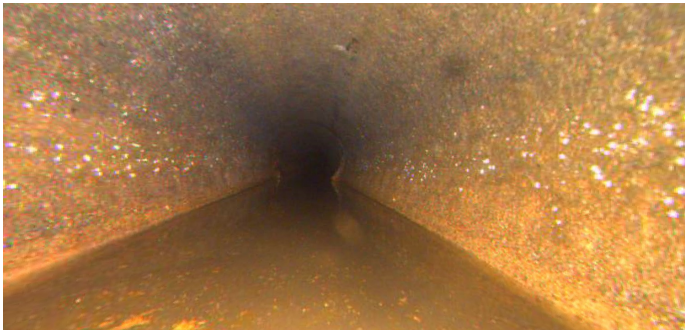
Code: **MSA**
Description: **Abandoned Survey**

Distance (ft): **8.7**
Structural Grade: **0**
O&M Grade: **0**
Clock Start/From:
Clock To:
1st Value:
2nd Value:
Value Percent:
Continuous Index:
Within 8" of Joint: **NO**
Remarks: **debris under water**
