Profile/Photo Observation Report

Date:	04/23/2018	Weather:		Coding:	PACP 6.0
Pipe Length (ft):	319.0	Owner:	NA	Pre Clean:	Not Known
P.O.#:		Surveyor:	Jen Costello	PSR:	P-605-065-066
Customer:		Clean Date:	01/01/1900	Shape:	C

Street:	Beverly Ln.	Flow Control:	Not Controlled
City:	Hobart, IN	Year Renewed:	
Location:	Other	Tape/Media #:	
Purpose:	Not Known	Dia/Height:	8"
Use:	Sanitary	Material:	VCP
Drain Area:	NA	Lining:	
Category:	NA		
Comment:

Location Details:		Direction of Survey:	Upstream
US MH:	M-605-066	DS MH:	M-605-065
		Total Length Surveyed (ft):	8.7

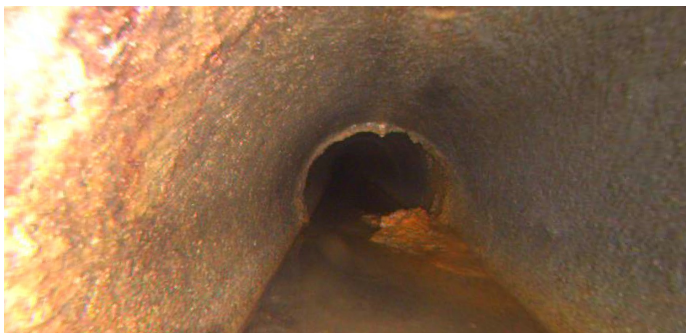
Code: **AMH**
Description: **Manhole**

Distance (ft): **.0**
Structural Grade: **0**
O&M Grade: **0**
Clock Start/From:
Clock To:
1st Value:
2nd Value:
Value Percent:
Continuous Index:
Within 8" of Joint: **NO**
Remarks: **M-605-065**

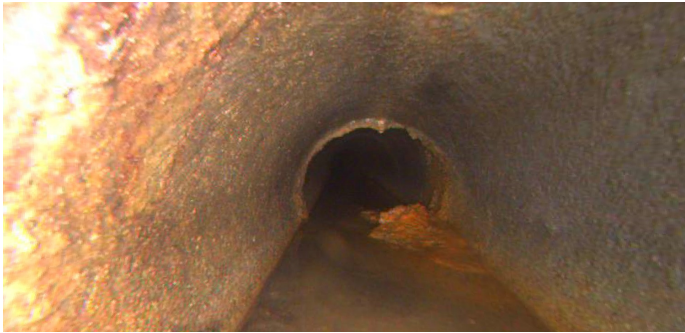
Code:	MWL
Description:	Water Level

Distance (ft):	.0
Structural Grade:	0
O&M Grade:	0
Clock Start/From:	
Clock To:	
1st Value:	
2nd Value:	
Value Percent:	10.000
Continuous Index:	
Within 8" of Joint:	NO
Remarks:

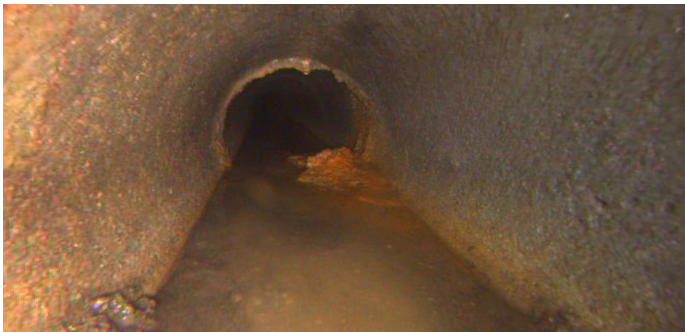
Code:	DAE
Description:	Deposits Attached Encrustation

Distance (ft):	.0
Structural Grade:	0
O&M Grade:	2
Clock Start/From:	8
Clock To:	4
1st Value:	
2nd Value:	
Value Percent:	5.000
Continuous Index:	S01
Within 8" of Joint:	NO
Remarks:

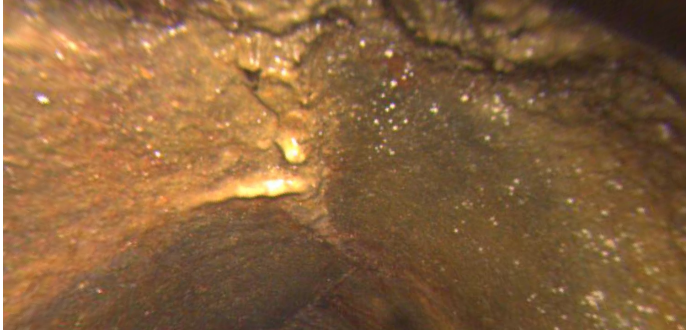
Code: **ID**
Description: **Infil Dripper**

Distance (ft): **2.4**
Structural Grade: **0**
O&M Grade: **3**
Clock Start/From: **12**
Clock To:
1st Value:
2nd Value:
Value Percent:
Continuous Index:
Within 8" of Joint: **YES**
Remarks:

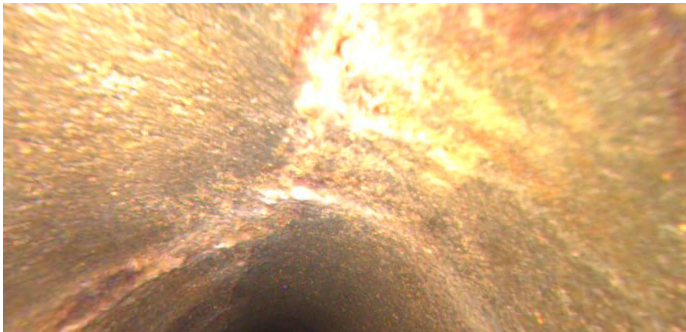
Code: **FL**
Description: **Fracture Longitudinal**

Distance (ft): **3.1**
Structural Grade: **3**
O&M Grade: **0**
Clock Start/From: **12**
Clock To:
1st Value:
2nd Value:
Value Percent:
Continuous Index:
Within 8" of Joint:
Remarks:

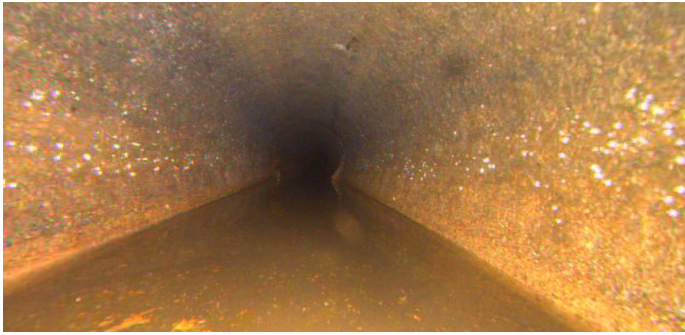
Code: **DAE**
Description: **Deposits Attached Encrustation**

Distance (ft): **8.7**
Structural Grade: **0**
O&M Grade: **2**
Clock Start/From: **8**
Clock To: **4**
1st Value:
2nd Value:
Value Percent: **5.000**
Continuous Index: **F01**
Within 8" of Joint: **NO**
Remarks:

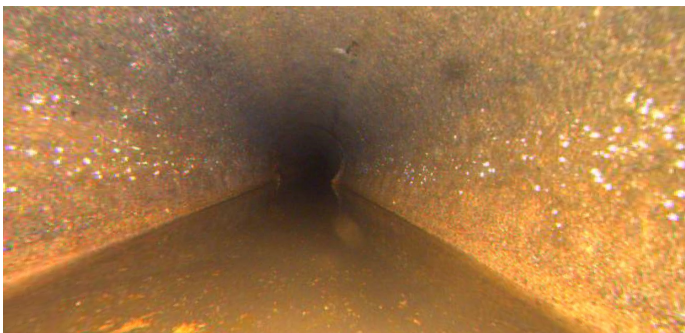
Code: **MSA**
Description: **Abandoned Survey**

Distance (ft): **8.7**
Structural Grade: **0**
O&M Grade: **0**
Clock Start/From:
Clock To:
1st Value:
2nd Value:
Value Percent:
Continuous Index:
Within 8" of Joint: **NO**
Remarks: **debris under water**
