Profile/Photo Observation Report

Date: **PACP 7.0** 11/12/2021 Weather: Coding: Pipe Length (ft): 319.3 Owner: **City of Hobart** Pre Clean: **Heavy Cleaning** P.O.#: Surveyor: Steven Bucklin PSR: P-605-065-066 YES502259

Street: Beverly Lane Flow Control: Not Controlled

US MH: M-605-066 DS MH: M-605-065 Total Length Surveyed (ft): **319.3**

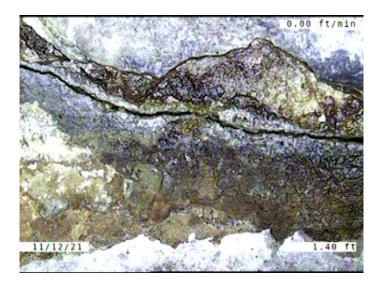
Code: FM

Description: Fracture Multiple

Distance (ft): 1.4
Structural Grade: 4

Clock Start/From: 9

Clock To: 1

Value Percent:
Continuous Index: S02
Within 8" of Joint: YES

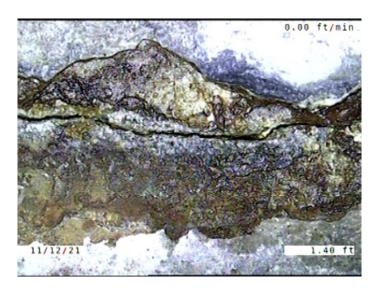
Code: IWB

Description: Infiltration Weeper Barrel

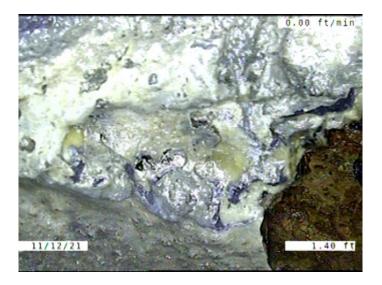
Code: DAE

Description: Deposits Attached Encrustation

Distance (ft): 1.4
Structural Grade: 0
O&M Grade: 2
Clock Start/From: 8
Clock To: 4

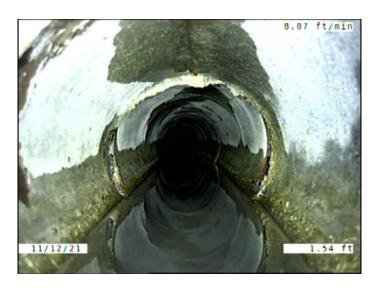
Code: IS

Description: Infitration Stain

Distance (ft): 1.5
Structural Grade: 0
O&M Grade: 1
Clock Start/From: 8
Clock To: 4
1st Value:
2nd Value:
Value Percent:

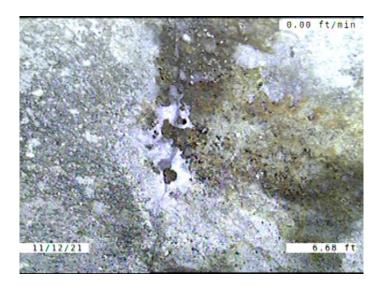
Code: CM
Description: Crack Multiple

Distance (ft): 6.7
Structural Grade: 3
O&M Grade: 0
Clock Start/From: 12
Clock To: 3
1st Value:
2nd Value:
Value Percent:

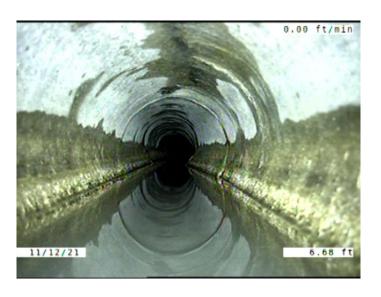
Code: FM

Description: Fracture Multiple

Distance (ft): 6.7
Structural Grade: 4

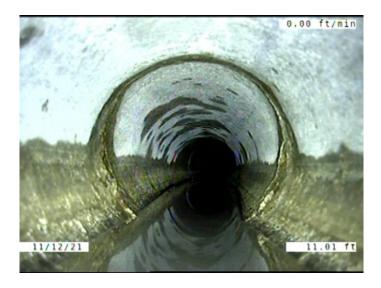
Code: CM

Description: Crack Multiple

Distance (ft): 11.0
Structural Grade: 3
O&M Grade: 0
Clock Start/From: 12
Clock To: 3

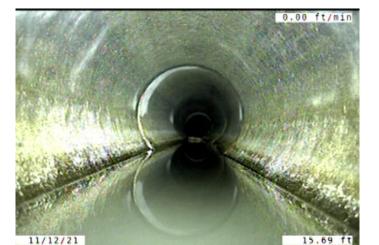
Code: MWLS

Description: Miscellaneous Water Level Sag

Distance (ft): 15.7
Structural Grade: 2
O&M Grade: 0

Value Percent: 10.000

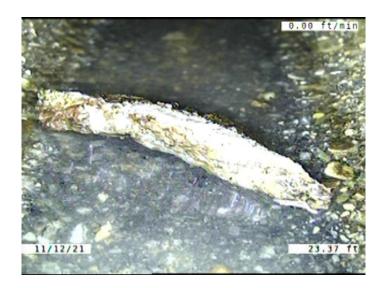
Code: OBZ

Description: Obstruction Other

Distance (ft): 23.4
Structural Grade: 0

Remarks: BROKEN OFF ENCRUSTATION

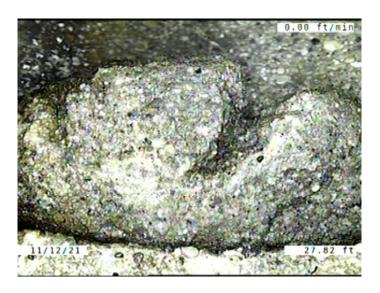
Code: ISGT

Description: Intruding Sealing Material Grout

Distance (ft): 27.8
Structural Grade: 0

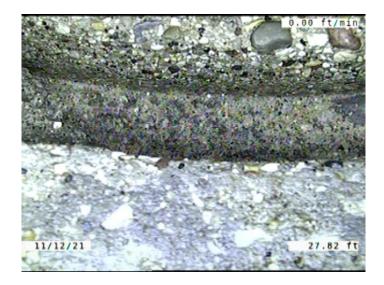
Code: JAM

Description: Joint Angular Medium

Distance (ft): 27.8
Structural Grade: 3
O&M Grade: 0

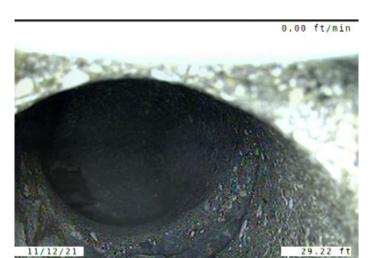
Code: **TF**

Description: Tap Factory

Distance (ft): 29.2
Structural Grade: 0
O&M Grade: 0
Clock Start/From: 10

Within 8" of Joint: YES
Remarks: OFFSET

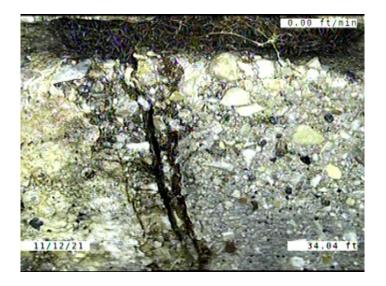
Code: FM
Description: Fracture Multiple

Distance (ft): **34.0** Structural Grade: **4**

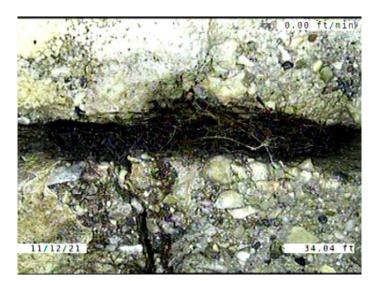
Code: RFJ

Description: Roots Fine Joint

Distance (ft): 34.0
Structural Grade: 0
O&M Grade: 1
Clock Start/From: 9
Clock To: 10
1st Value:
2nd Value:
Value Percent:

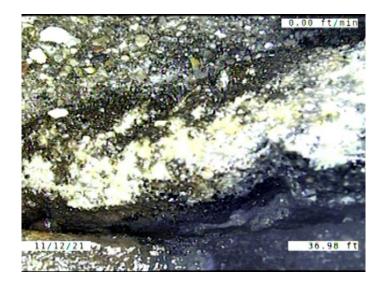
Code: ISGT

Description: Intruding Sealing Material Grout

Distance (ft): 37.0
Structural Grade: 0
O&M Grade: 2
Clock Start/From: 4
Clock To: 8

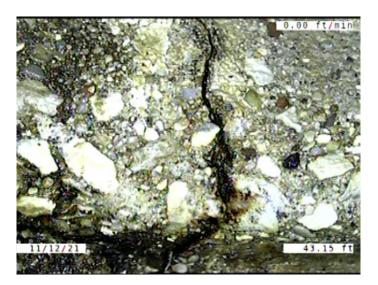
Code: FL

Description: Fracture Longitudinal

Distance (ft): 43.2
Structural Grade: 3
O&M Grade: 0
Clock Start/From: 4
Clock To:
1st Value:
2nd Value:

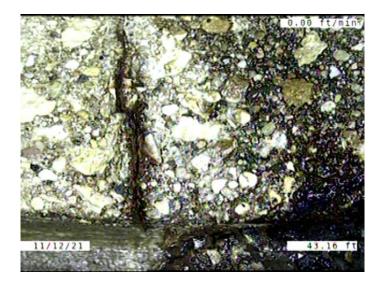
Code: **FL**

Description: Fracture Longitudinal

Distance (ft): 43.2
Structural Grade: 3
O&M Grade: 0
Clock Start/From: 8

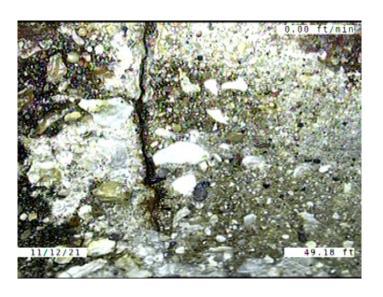
Code: FL

Description: Fracture Longitudinal

Distance (ft): 49.2
Structural Grade: 3
O&M Grade: 0
Clock Start/From: 9
Clock To:
1st Value:
2nd Value:

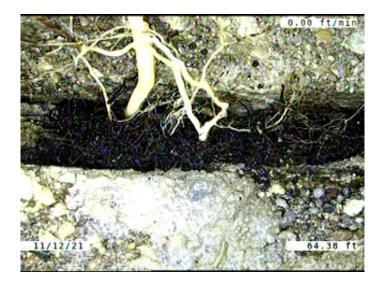
Code: RFJ

Description: **Roots Fine Joint**

Distance (ft): 64.4 Structural Grade: 0 O&M Grade: 1 Clock Start/From: 3 Clock To: 4

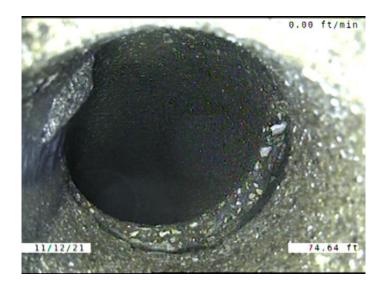
Code: **TF**

Description: Tap Factory

Distance (ft): 74.6
Structural Grade: 0

Remarks: ANGLED JOINT

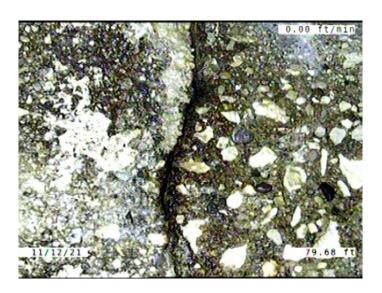
Code: FL

Description: Fracture Longitudinal

Distance (ft): 79.7
Structural Grade: 3
O&M Grade: 0
Clock Start/From: 3
Clock To:
1st Value:
2nd Value:

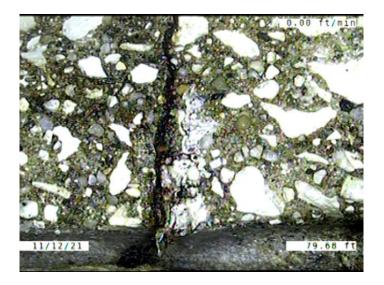
Code: FL

Description: Fracture Longitudinal

Distance (ft): 79.7
Structural Grade: 3
O&M Grade: 0
Clock Start/From: 10

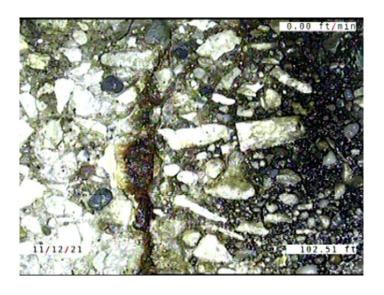
Code: FM

Description: Fracture Multiple

Distance (ft): 102.5
Structural Grade: 4
O&M Grade: 0
Clock Start/From: 7
Clock To: 8
1st Value:

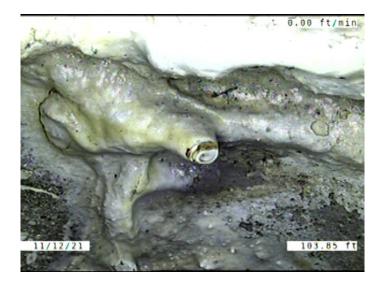
Code: IWJ

Description: Infiltration Weeper Joint

Distance (ft): 103.8
Structural Grade: 0
O&M Grade: 2

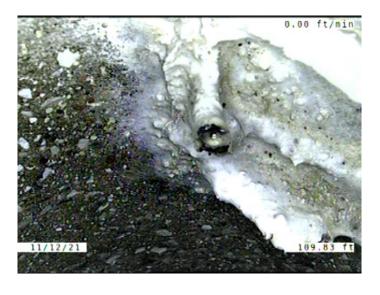
Code: IWB

Description: Infiltration Weeper Barrel

Distance (ft): 109.8
Structural Grade: 0
O&M Grade: 2
Clock Start/From: 1
Clock To:

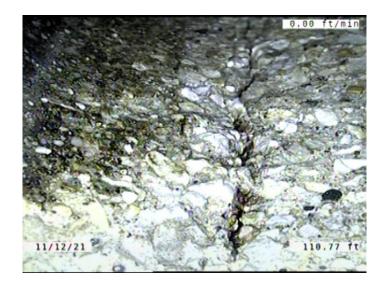
Code: FM
Description: Fracture Multiple

Distance (ft): 110.8
Structural Grade: 4
O&M Grade: 0
Clock Start/From: 4
Clock To: 5

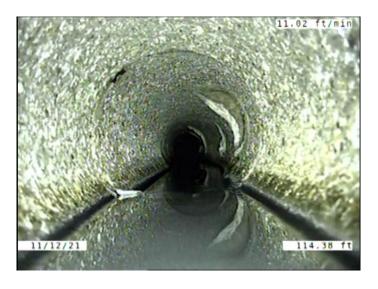
Code: FM

Description: Fracture Multiple

Distance (ft): 114.4
Structural Grade: 4
O&M Grade: 0
Clock Start/From: 4
Clock To: 5
1st Value:
2nd Value:

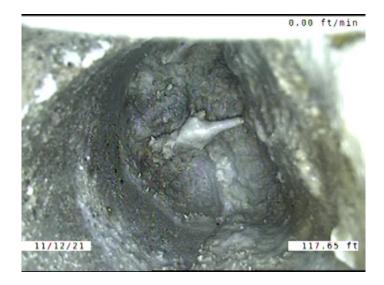
Code: TFC

Description: Tap Factory Capped

Distance (ft): 117.6
Structural Grade: 0
O&M Grade: 0
Clock Start/From: 2

Remarks: CAPPED. ENCRUSTATION COVERING

THE CAP

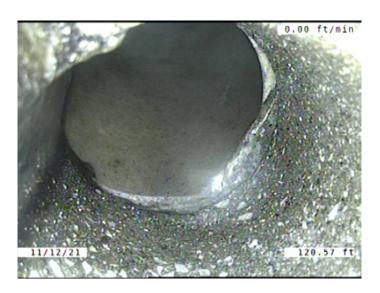
Code: TF

Description: Tap Factory

Distance (ft): 120.6
Structural Grade: 0
O&M Grade: 0
Clock Start/From: 10

Remarks: CONSTANTLY RUNNING WATER

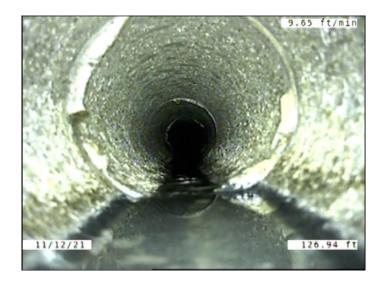
Code: **FM**

Description: Fracture Multiple

Distance (ft): 126.9
Structural Grade: 4

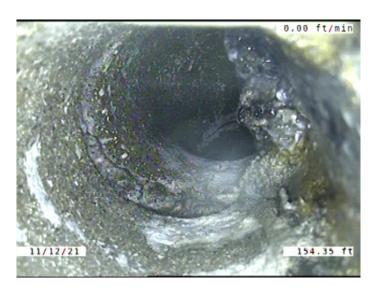
Code: **TFD**

Description: Tap Factory Defective

Distance (ft): 154.4
Structural Grade: 0
O&M Grade: 3
Clock Start/From: 2

Remarks: OFFSET. CONSTANTLY RUNNING

WATER.

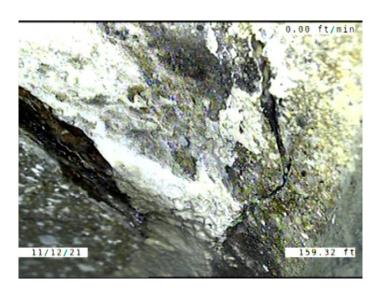
Code: В Description: Broken

Distance (ft): 159.3 Structural Grade: 4 O&M Grade: 0 Clock Start/From: 8 Clock To: 1st Value: 2nd Value: Value Percent: Continuous Index: Within 8" of Joint: NO

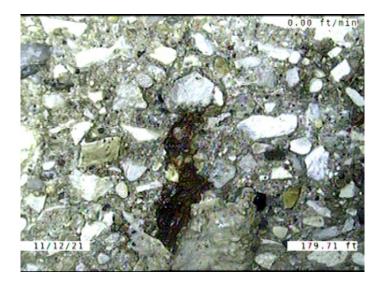
Code: **FM**

Description: Fracture Multiple

Distance (ft): 179.7
Structural Grade: 4
O&M Grade: 0
Clock Start/From: 8
Clock To: 4

Remarks: Wandering

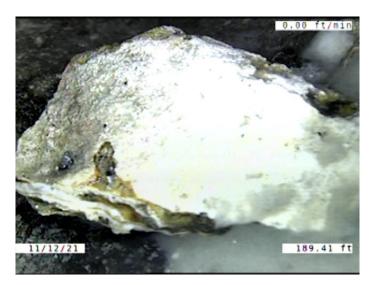
Code: OBZ

Description: Obstruction Other

Distance (ft): 189.4
Structural Grade: 0
O&M Grade: 2
Clock Start/From: 6
Clock To: 7
1st Value:

Remarks: ENCRUSTATION THAT HAS BROKEN

OFF

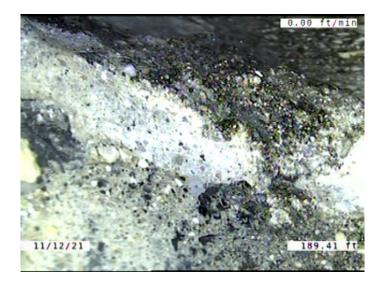
Code: ISGT
Description: Intruding Sealing Material Grout

Distance (ft): 189.4
Structural Grade: 0
O&M Grade: 2
Clock Start/From: 4
Clock To: 8
1st Value:
2nd Value:

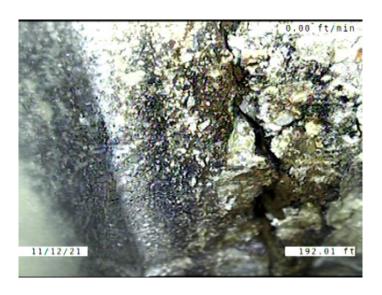
Code: B
Description: Broken

Distance (ft): 192.0 Structural Grade: 4 O&M Grade: 0 Clock Start/From: 8 9 Clock To: 1st Value: 2nd Value: Value Percent: Continuous Index: Within 8" of Joint: YES

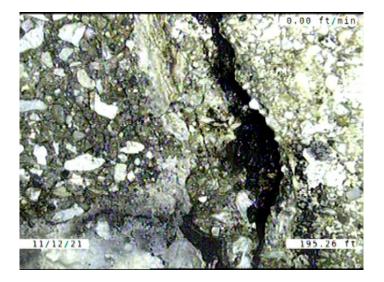
Code: Description: Broken

Distance (ft): 195.3 Structural Grade: 4 O&M Grade: 0 Clock Start/From: 3 Clock To: 4 1st Value: 2nd Value: Value Percent: Continuous Index: Within 8" of Joint:

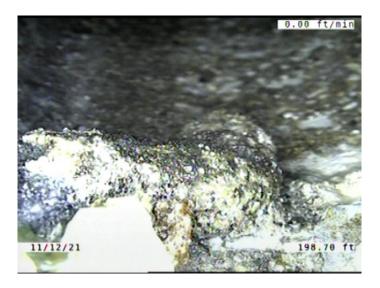
Code: ISGT

Description: **Intruding Sealing Material Grout**

Distance (ft): 198.7 Structural Grade: 0 O&M Grade: 2 Clock Start/From: 4 Clock To: 8 1st Value: 2nd Value:

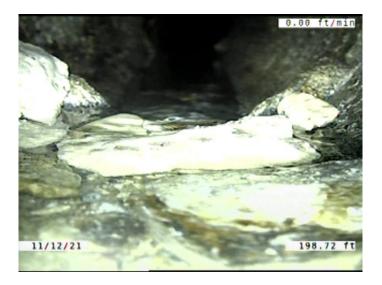
Code: OBZ

Description: Obstruction Other

Distance (ft): 198.7
Structural Grade: 0
O&M Grade: 2
Clock Start/From: 4
Clock To: 8

Remarks: PIECES OF ENCRUSTATION THAT

HAVE BEEN BROKEN OFF

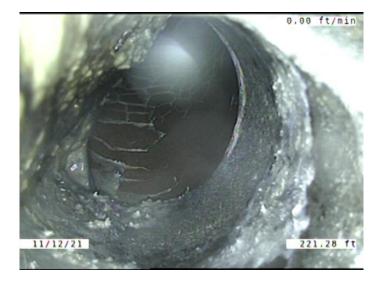
Code: **TFD**

Description: Tap Factory Defective

Distance (ft): 221.3
Structural Grade: 0
O&M Grade: 3
Clock Start/From: 10

Remarks: LOOKS TO BE 50% PLUGGED WITH

ENCRUSTATION

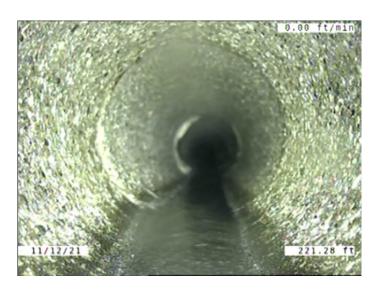
Code: FM

Description: Fracture Multiple

Distance (ft): 221.3
Structural Grade: 4
O&M Grade: 0
Clock Start/From: 8
Clock To: 4
1st Value:
2nd Value:

Remarks: Wandering

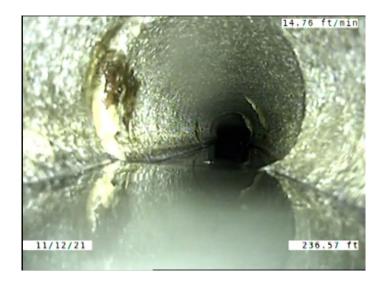
Code: LR

Description: **Line Right**

Distance (ft): 236.6 Structural Grade: 0 O&M Grade: 1

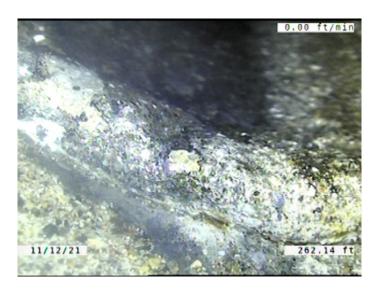
ISGT Code:

Description: **Intruding Sealing Material Grout**

Distance (ft): 262.1 Structural Grade: 0 O&M Grade: 2 Clock Start/From: 4 7 Clock To: 1st Value:

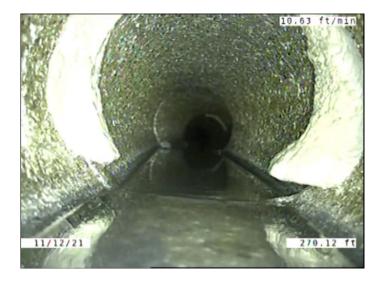
Code: IS

Description: **Infitration Stain**

Distance (ft): 270.1 Structural Grade: 0 O&M Grade: 1 Clock Start/From: 8 Clock To:

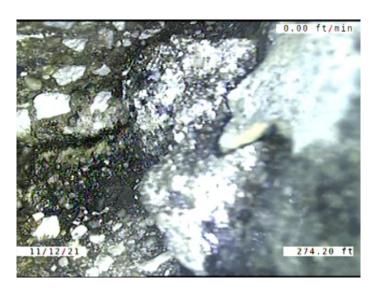
ISGT Code:

Description: **Intruding Sealing Material Grout**

Distance (ft): 274.2 Structural Grade: 0 O&M Grade: 2 Clock Start/From: 4 Clock To: 8 1st Value:

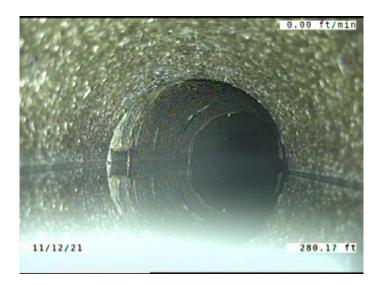
Code: **MWLS**

Description: **Miscellaneous Water Level Sag**

280.2 Distance (ft): Structural Grade: 2 0 O&M Grade:

Value Percent: 30.000 **S07** Continuous Index: Within 8" of Joint: NO

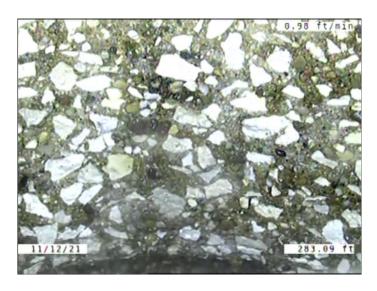
Code: DAE

Description: **Deposits Attached Encrustation**

Distance (ft): 283.1 Structural Grade: 0 O&M Grade: 2 Clock Start/From: 8 Clock To: 1st Value:

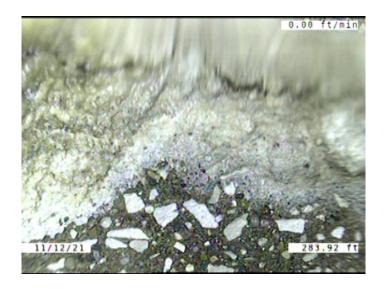
Code: MCU

Description: Miscellaneous Camera Underwater

Distance (ft): 283.9
Structural Grade: 0
O&M Grade: 4

Remarks: Out at 286.5

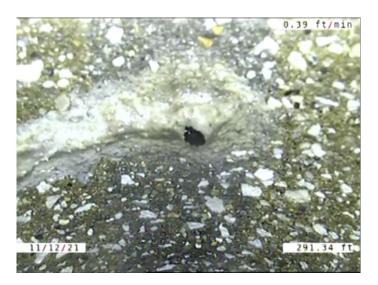
Code: DAE

Description: Deposits Attached Encrustation

Distance (ft): 291.3
Structural Grade: 0
O&M Grade: 2
Clock Start/From: 8
Clock To: 4
1st Value:

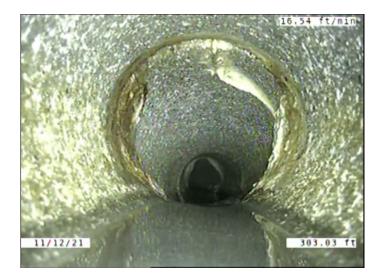
Code: IS

Description: **Infitration Stain**

Distance (ft): 303.0 Structural Grade: 0 O&M Grade: 1 Clock Start/From: 7 5

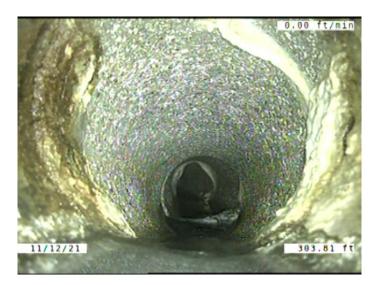
Code: **MWLS**

Description: **Miscellaneous Water Level Sag**

Distance (ft): 303.8 Structural Grade: 2 O&M Grade: 0

Value Percent: 30.000 Continuous Index: F07 Within 8" of Joint: NO

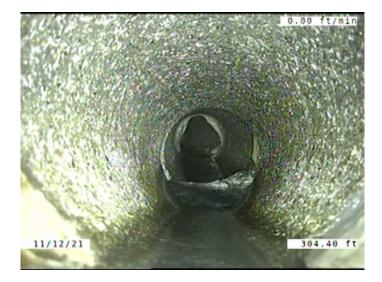
Code: LD

Description: **Line Down**

Distance (ft): 304.4 Structural Grade: 0 O&M Grade: 1

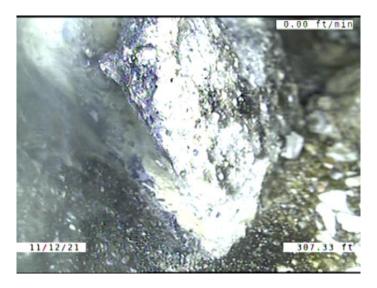
Code: **ISGT**

Description: **Intruding Sealing Material Grout**

Distance (ft): 307.3 Structural Grade: 0 O&M Grade: 2 Clock Start/From: 4 Clock To: 8 1st Value:

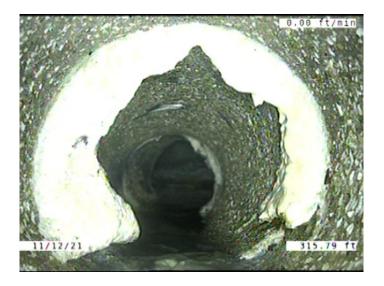
Code: DAE

Description: Deposits Attached Encrustation

Distance (ft): 315.8
Structural Grade: 0
O&M Grade: 3
Clock Start/From: 7
Clock To: 4

Value Percent: 15.000

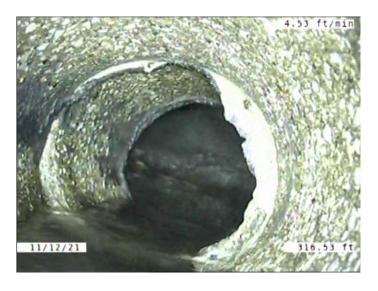
Code: DAE

Description: Deposits Attached Encrustation

Distance (ft): 316.5
Structural Grade: 0
O&M Grade: 2
Clock Start/From: 8
Clock To: 4
1st Value:
