## **Profile/Photo Observation Report**

Customer: City of Hobart, IN (Red Clean Date: 11/12/2021 Shape: C

Street: Beverly Lane Flow Control: Not Controlled

US MH: M-605-066 DS MH: M-605-065 Total Length Surveyed (ft): **319.3**

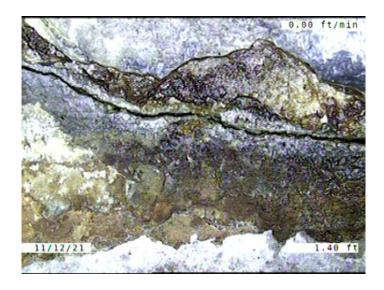
Code: FM
Description: Fracture Multiple

Distance (ft): 1.4
Structural Grade: 4

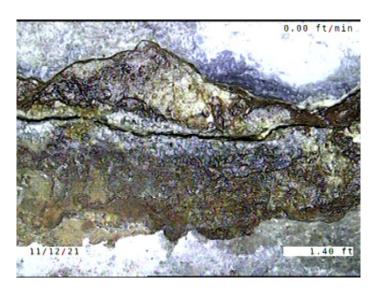
Code: IWB

Description: Infiltration Weeper Barrel

Distance (ft): 1.4
Structural Grade: 0
O&M Grade: 2
Clock Start/From: 11
Clock To: 1st Value: 2nd Value: Value Percent: Continuous Index:

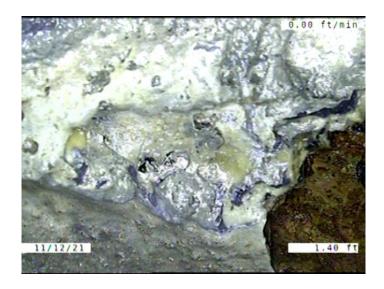
Code: DAE

Description: Deposits Attached Encrustation

Distance (ft): 1.4
Structural Grade: 0
O&M Grade: 2
Clock Start/From: 8
Clock To: 4

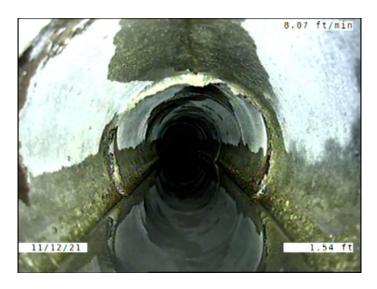
Code: IS

Description: Infitration Stain

Distance (ft): 1.5
Structural Grade: 0
O&M Grade: 1
Clock Start/From: 8
Clock To: 4
1st Value:
2nd Value:

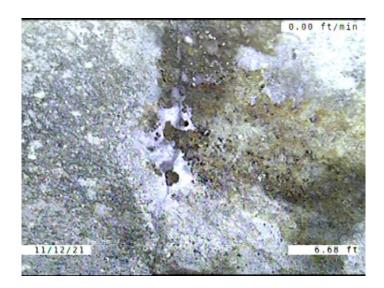
Code: CM
Description: Crack Multiple

Distance (ft): 6.7
Structural Grade: 3

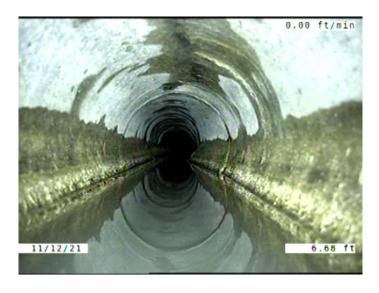
Code: **FM**

Description: Fracture Multiple

Distance (ft): 6.7 Structural Grade: 4 O&M Grade: 0 Clock Start/From: 9 Clock To: 1 1st Value: 2nd Value: Value Percent: Continuous Index: F02 Within 8" of Joint: YES

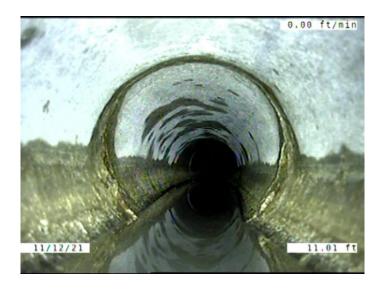
Code: CM

Description: Crack Multiple

Distance (ft): 11.0
Structural Grade: 3
O&M Grade: 0
Clock Start/From: 12
Clock To: 3

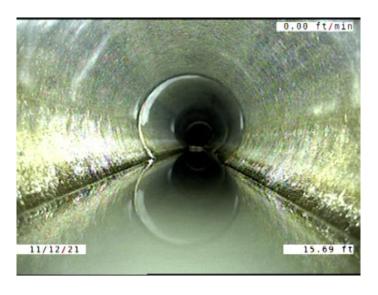
Code: MWLS

Description: Miscellaneous Water Level Sag

Distance (ft): 15.7
Structural Grade: 2
O&M Grade: 0

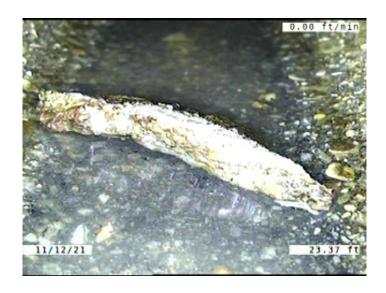
Code: OBZ

Description: Obstruction Other

Distance (ft): 23.4
Structural Grade: 0

Remarks: BROKEN OFF ENCRUSTATION

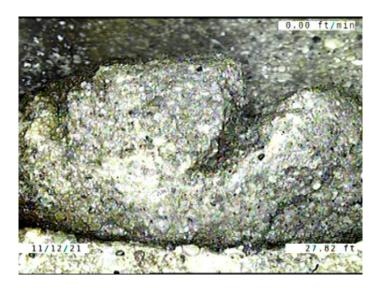
Code: ISGT

Description: Intruding Sealing Material Grout

Distance (ft): 27.8
Structural Grade: 0

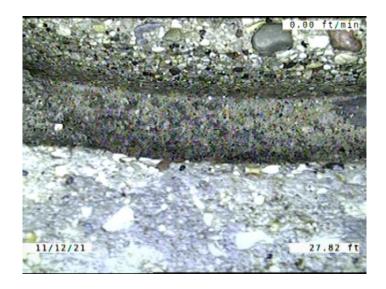
Code: JAM

Description: **Joint Angular Medium**

Distance (ft): 27.8
Structural Grade: 3
O&M Grade: 0

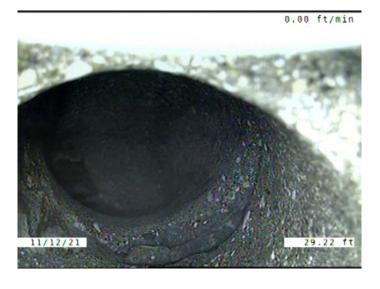
Code: **TF**

Description: Tap Factory

Within 8" of Joint: YES
Remarks: OFFSET

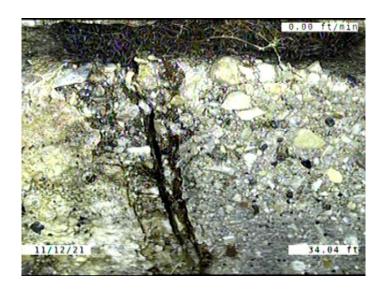
Code: **FM**

Description: Fracture Multiple

Distance (ft): 34.0
Structural Grade: 4

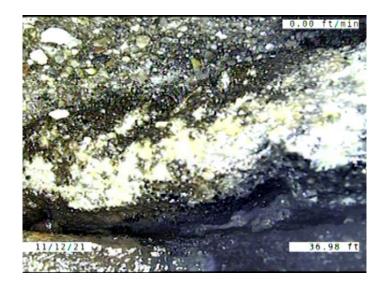
Code: ISGT

Description: Intruding Sealing Material Grout

Distance (ft): 37.0
Structural Grade: 0
O&M Grade: 2
Clock Start/From: 4
Clock To: 8

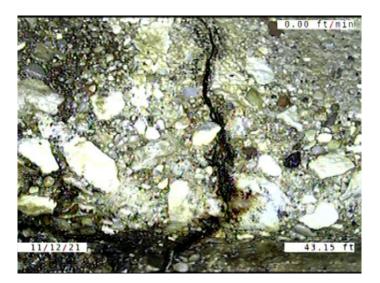
Code: FL

Description: Fracture Longitudinal

Distance (ft): 43.2
Structural Grade: 3
O&M Grade: 0
Clock Start/From: 4
Clock To:
1st Value:
2nd Value:
Value Percent:

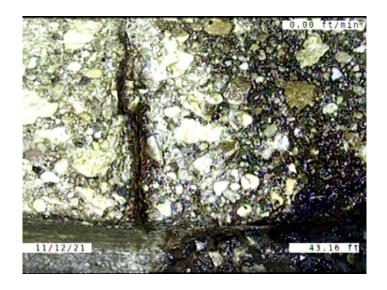
Code: **FL**

Description: Fracture Longitudinal

Distance (ft): 43.2
Structural Grade: 3
O&M Grade: 0
Clock Start/From: 8

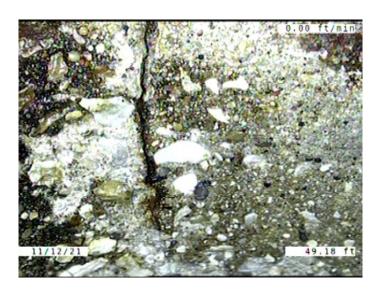
Code: FL

Description: Fracture Longitudinal

Distance (ft): 49.2
Structural Grade: 3
O&M Grade: 0
Clock Start/From: 9
Clock To:
1st Value:
2nd Value:
Value Percent:

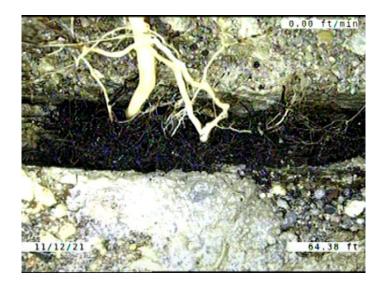
Code: RFJ

Description: Roots Fine Joint

Distance (ft): 64.4
Structural Grade: 0
O&M Grade: 1
Clock Start/From: 3
Clock To: 4

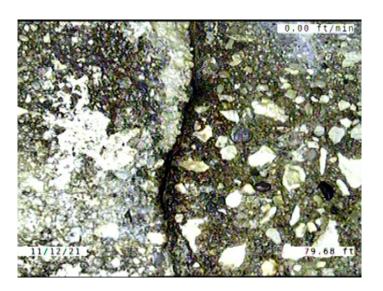
Code: FL

Description: Fracture Longitudinal

Distance (ft): 79.7
Structural Grade: 3
O&M Grade: 0
Clock Start/From: 3
Clock To:
1st Value:
2nd Value:
Value Percent:

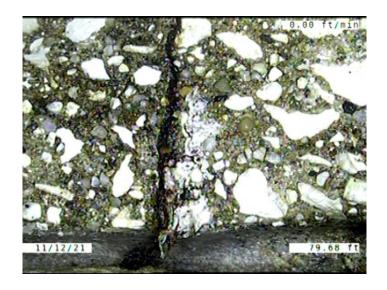
Code: FL

Description: Fracture Longitudinal

Distance (ft): 79.7
Structural Grade: 3
O&M Grade: 0
Clock Start/From: 10

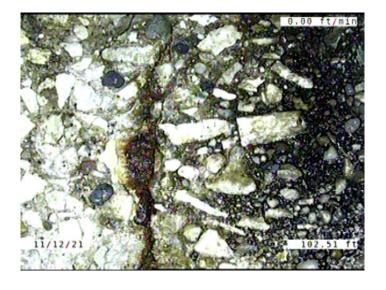
Code: FM

Description: Fracture Multiple

Distance (ft): 102.5
Structural Grade: 4
O&M Grade: 0
Clock Start/From: 7
Clock To: 8
1st Value:

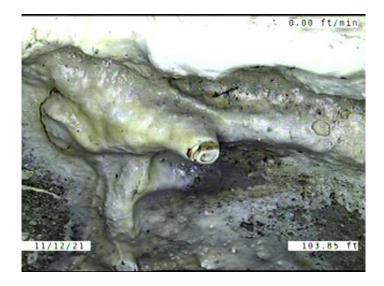
Code: IWJ

Description: Infiltration Weeper Joint

Distance (ft): 103.8
Structural Grade: 0
O&M Grade: 2

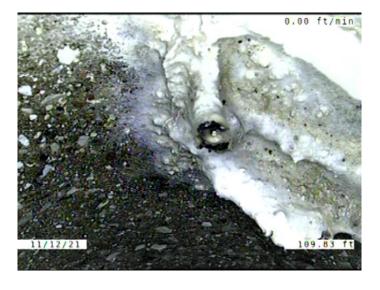
Code: IWB

Description: Infiltration Weeper Barrel

Distance (ft): 109.8
Structural Grade: 0
O&M Grade: 2
Clock Start/From: 1
Clock To:
1st Value:

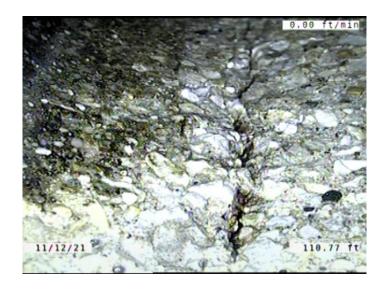
Code: FM

Description: Fracture Multiple

Distance (ft): 110.8
Structural Grade: 4
O&M Grade: 0
Clock Start/From: 4
Clock To: 5

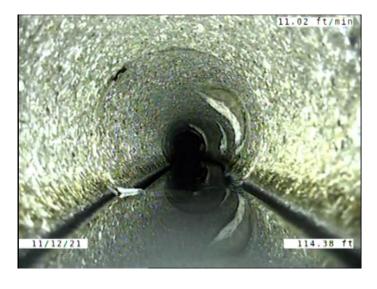
Code: FM

Description: Fracture Multiple

Distance (ft): 114.4
Structural Grade: 4
O&M Grade: 0
Clock Start/From: 4
Clock To: 5
1st Value:
2nd Value:

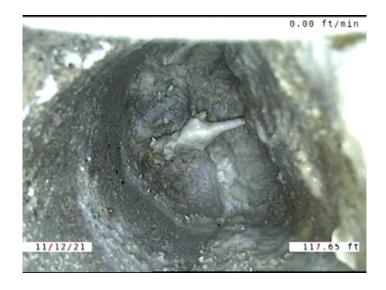
Code: **TFC**

Description: Tap Factory Capped

Remarks: CAPPED. ENCRUSTATION COVERING

THE CAP

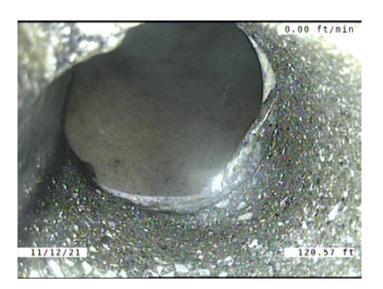
Code: TF

Description: Tap Factory

Remarks: CONSTANTLY RUNNING WATER

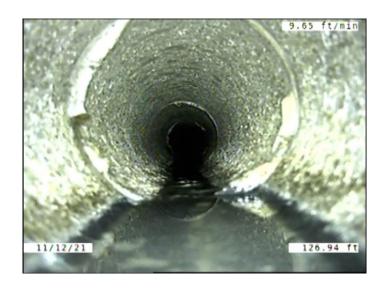
Code: FM

Description: Fracture Multiple

Distance (ft): 126.9
Structural Grade: 4

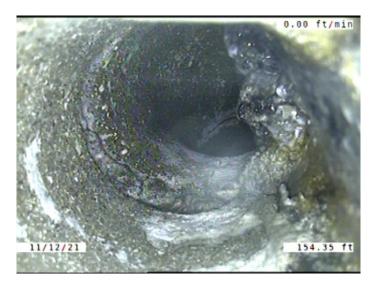
Code: **TFD**

Description: Tap Factory Defective

Distance (ft): 154.4
Structural Grade: 0
O&M Grade: 3
Clock Start/From: 2

Remarks: OFFSET. CONSTANTLY RUNNING

WATER.

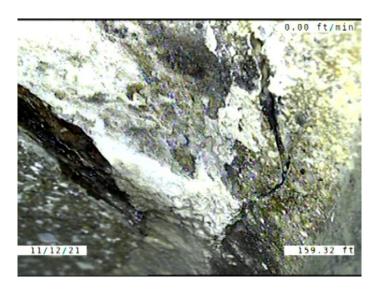
Code: B
Description: Broken

Distance (ft): 159.3
Structural Grade: 4

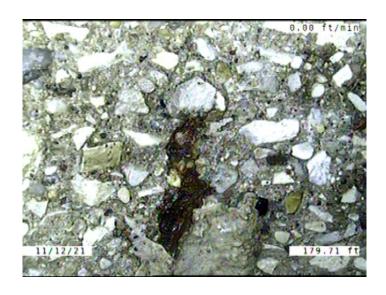
Code: FM

Description: Fracture Multiple

Distance (ft): 179.7
Structural Grade: 4
O&M Grade: 0
Clock Start/From: 8
Clock To: 4

Remarks: Wandering

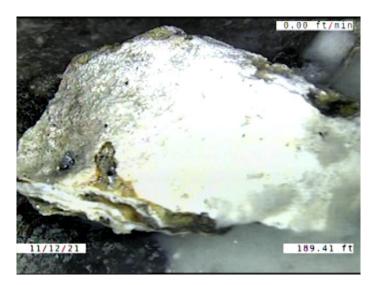
Code: OBZ

Description: Obstruction Other

Distance (ft): 189.4
Structural Grade: 0
O&M Grade: 2
Clock Start/From: 6
Clock To: 7
1st Value:

Remarks: ENCRUSTATION THAT HAS BROKEN

OFF

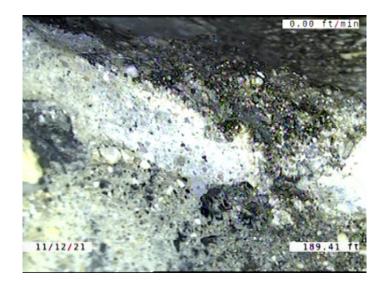
Code: ISGT
Description: Intruding Sealing Material Grout

Distance (ft): 189.4
Structural Grade: 0
O&M Grade: 2
Clock Start/From: 4
Clock To: 8
1st Value:

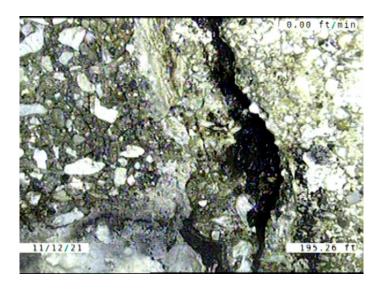
Code: B
Description: Broken

Distance (ft): 195.3 Structural Grade: 4 O&M Grade: 0 Clock Start/From: 3 Clock To: 4 1st Value: 2nd Value: Value Percent: Continuous Index: Within 8" of Joint: YES

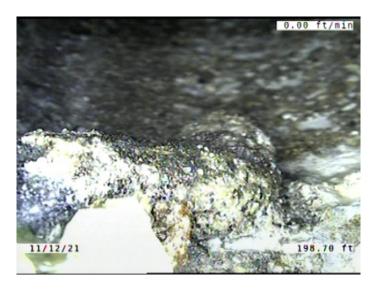
Code: ISGT

Description: Intruding Sealing Material Grout

Distance (ft): 198.7
Structural Grade: 0
O&M Grade: 2
Clock Start/From: 4
Clock To: 8
1st Value:
2nd Value:

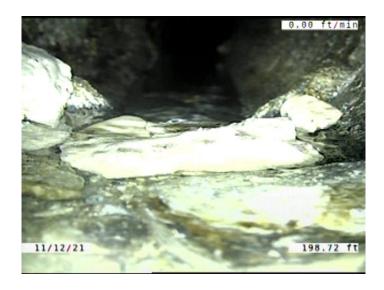
Code: OBZ

Description: Obstruction Other

Distance (ft): 198.7
Structural Grade: 0
O&M Grade: 2
Clock Start/From: 4
Clock To: 8

Remarks: PIECES OF ENCRUSTATION THAT

**HAVE BEEN BROKEN OFF**

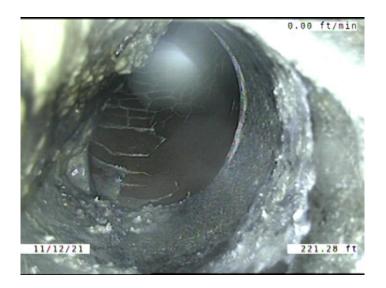
Code: **TFD**

Description: Tap Factory Defective

Distance (ft): 221.3
Structural Grade: 0
O&M Grade: 3
Clock Start/From: 10

Remarks: LOOKS TO BE 50% PLUGGED WITH

**ENCRUSTATION**

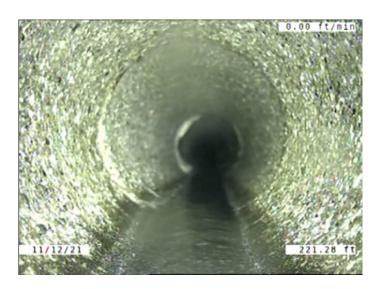
Code: FM

Description: Fracture Multiple

Distance (ft): 221.3
Structural Grade: 4
O&M Grade: 0
Clock Start/From: 8
Clock To: 4
1st Value:
2nd Value:

Remarks: Wandering

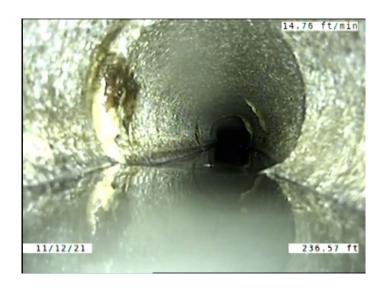
Code: LR

Description: Line Right

Distance (ft): 236.6
Structural Grade: 0
O&M Grade: 1

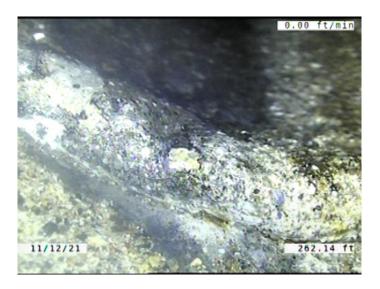
Code: ISGT

Description: Intruding Sealing Material Grout

Distance (ft): 262.1
Structural Grade: 0
O&M Grade: 2
Clock Start/From: 4
Clock To: 7
1st Value:

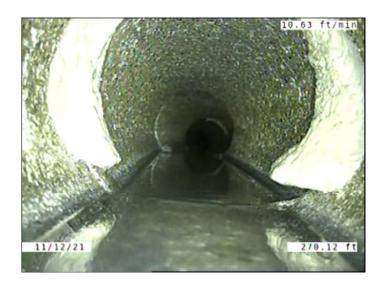
Code: IS

Description: Infitration Stain

Distance (ft): 270.1
Structural Grade: 0
O&M Grade: 1
Clock Start/From: 8
Clock To: 4

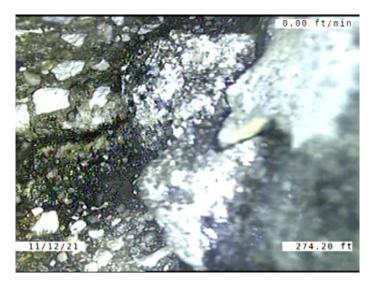
Code: ISGT

Description: Intruding Sealing Material Grout

Distance (ft): 274.2
Structural Grade: 0
O&M Grade: 2
Clock Start/From: 4
Clock To: 8
1st Value:

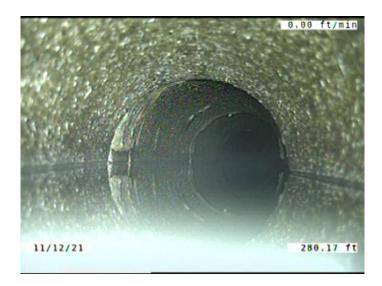
Code: MWLS

Description: Miscellaneous Water Level Sag

Distance (ft): 280.2
Structural Grade: 2
O&M Grade: 0

Value Percent: 30.000
Continuous Index: S07
Within 8" of Joint: NO

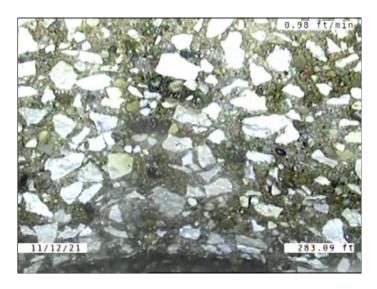
Code: DAE

Description: Deposits Attached Encrustation

Distance (ft): 283.1
Structural Grade: 0
O&M Grade: 2
Clock Start/From: 8
Clock To: 4
1st Value:

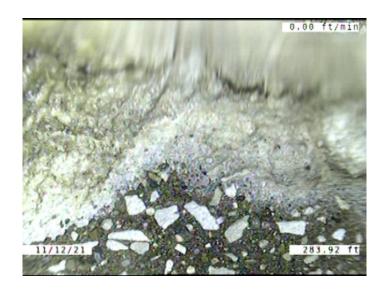
Code: MCU

Description: Miscellaneous Camera Underwater

Distance (ft): 283.9
Structural Grade: 0
O&M Grade: 4

Remarks: Out at 286.5

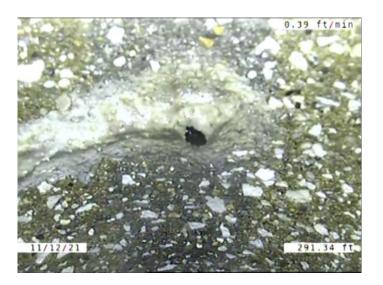
Code: DAE

Description: Deposits Attached Encrustation

Distance (ft): 291.3
Structural Grade: 0
O&M Grade: 2
Clock Start/From: 8
Clock To: 4
1st Value:

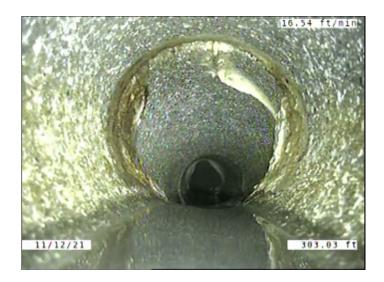
Code: IS

Description: **Infitration Stain**

Distance (ft): 303.0 Structural Grade: 0 O&M Grade: 1 Clock Start/From: 7 5

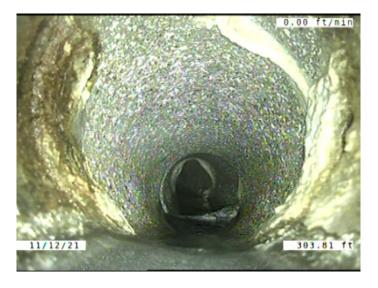
Code: **MWLS**

Description: **Miscellaneous Water Level Sag**

Distance (ft): 303.8 Structural Grade: 2 O&M Grade: 0

Value Percent: 30.000 Continuous Index: F07 Within 8" of Joint: NO

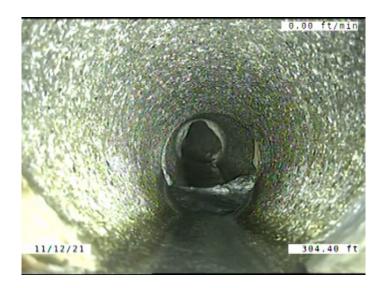
Code: LD

Description: Line Down

Distance (ft): 304.4
Structural Grade: 0
O&M Grade: 1

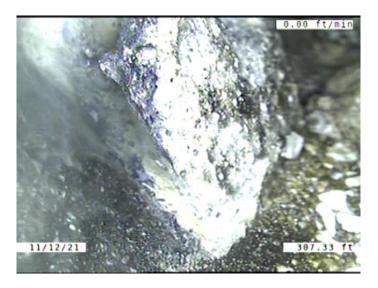
Code: ISGT

Description: Intruding Sealing Material Grout

Distance (ft): 307.3
Structural Grade: 0
O&M Grade: 2
Clock Start/From: 4
Clock To: 8
1st Value:

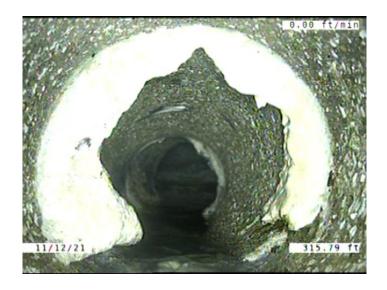
Code: DAE

Description: Deposits Attached Encrustation

Distance (ft): 315.8
Structural Grade: 0
O&M Grade: 3
Clock Start/From: 7
Clock To: 4

Value Percent: 15.000

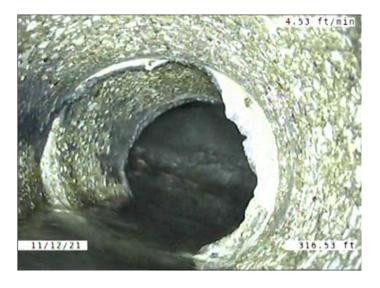
Code: DAE

Description: Deposits Attached Encrustation

Distance (ft): 316.5
Structural Grade: 0
O&M Grade: 2
Clock Start/From: 8
Clock To: 4
1st Value:
