Profile/Photo Observation Report

Street:	Ellendale Street	Flow Control:	Not Controlled
City:	Hobart, IN	Year Renewed:	
Location:	Light Highway	Tape/Media #:	DEP102
Purpose:	Routine Assessment	Dia/Height:	15"
Use:	Sanitary	Material:	CP
Drain Area:		Lining:	
Category:	NA		
Comment:	YES501824 Submittal 2		
Location Details:		Direction of Survey:	Downstream
US MH:	M-605-013	DS MH:	M-605-070
		Total Length Surveyed (ft):	3.2

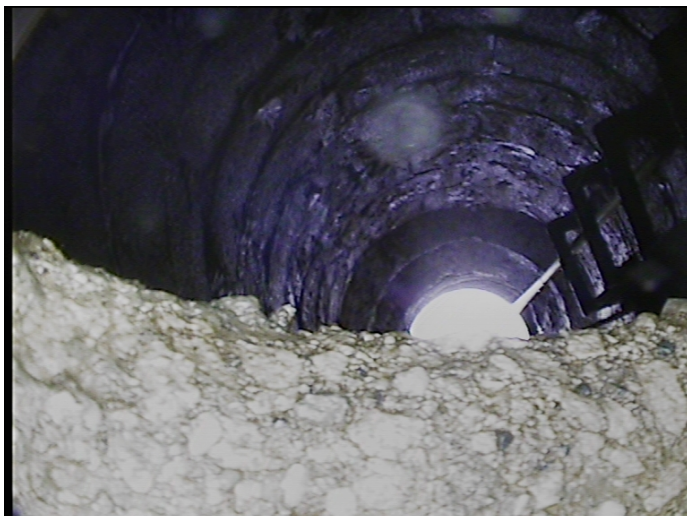
Code: **AMH**
Description: **Manhole**

Distance (ft): **.0**
Structural Grade: **0**
O&M Grade: **0**
Clock Start/From:
Clock To:
1st Value:
2nd Value:
Value Percent:
Continuous Index:
Within 8" of Joint: **NO**
Remarks: **M-605-013**

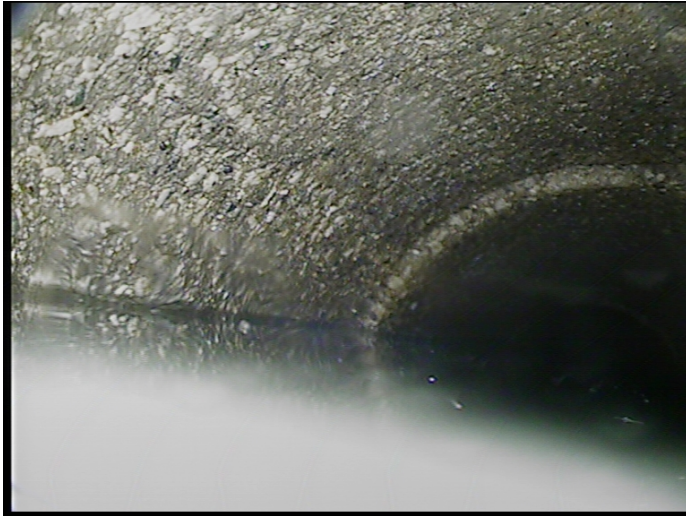
Code: **MWL**
Description: **Water Level**

Distance (ft): **.0**
Structural Grade: **0**
O&M Grade: **0**
Clock Start/From:
Clock To:
1st Value:
2nd Value:
Value Percent: **45.000**
Continuous Index:
Within 8" of Joint: **NO**
Remarks:

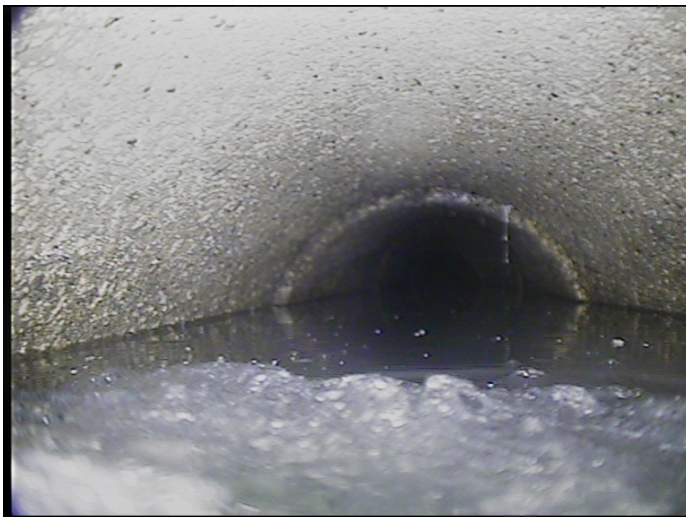
Code: **DSF**
Description: **Deposits Settled Fine**

Distance (ft): **3.2**
Structural Grade: **0**
O&M Grade: **4**
Clock Start/From: **4**
Clock To: **8**
1st Value:
2nd Value:
Value Percent: **30.000**
Continuous Index:
Within 8" of Joint: **NO**
Remarks:

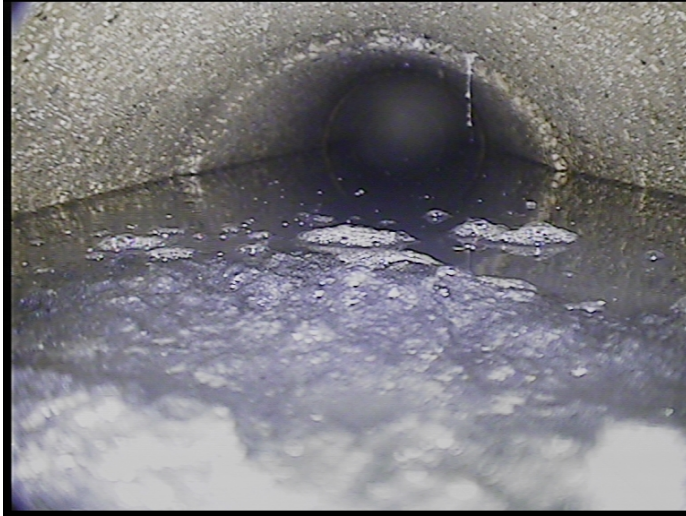
Code:	MSA
Description:	Abandoned Survey
Distance (ft):	3.2
Structural Grade:	0
O&M Grade:	0
Clock Start/From:	
Clock To:	
1st Value:	
2nd Value:	
Value Percent:	
Continuous Index:	
Within 8" of Joint:	NO
Remarks:	sediment
