Profile/Photo Observation Report

Date:	04/26/2018	Weather:		Coding:	PACP 6.0
Pipe Length (ft):		Owner:	City of Hobart	Pre Clean:	No Pre-Cleaning
P.O.#:	103	Surveyor:	M. Pielacha	PSR:	P-605-013-070
Customer:	City of Hobart	Clean Date:		Shape:	C

Street:	Ellendale Street	Flow Control:	Not Controlled
City:	Hobart, IN	Year Renewed:	
Location:	Light Highway	Tape/Media #:	DEP 103
Purpose:	Routine Assessment	Dia/Height:	15"
Use:	Sanitary	Material:	CP
Drain Area:		Lining:	
Category:	NA		
Comment:	YES501824 Submittal 2		
Location Details:		Direction of Survey:	Downstream
US MH:	M-605-013	DS MH:	M-605-070
		Total Length Surveyed (ft):	117.6

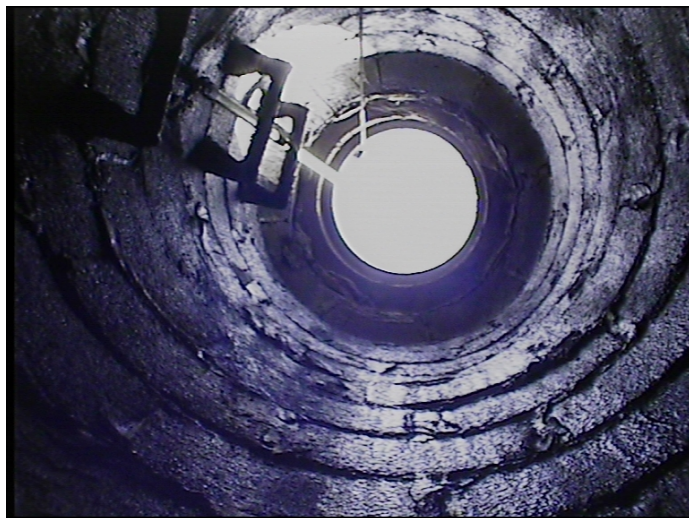
Code: **AMH**
Description: **Manhole**

Distance (ft): **.0**
Structural Grade: **0**
O&M Grade: **0**
Clock Start/From:
Clock To:
1st Value:
2nd Value:
Value Percent:
Continuous Index:
Within 8" of Joint: **NO**
Remarks: **M-605-013**

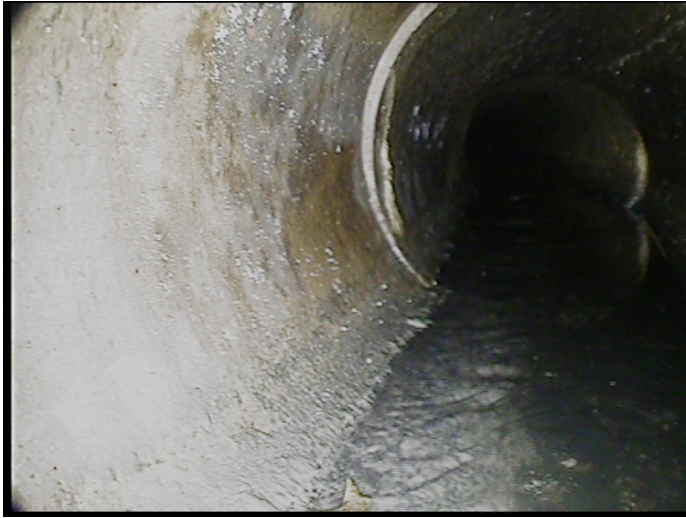
Code: **MWL**
Description: **Water Level**

Distance (ft): **.0**
Structural Grade: **0**
O&M Grade: **0**
Clock Start/From:
Clock To:
1st Value:
2nd Value:
Value Percent: **5.000**
Continuous Index:
Within 8" of Joint: **NO**
Remarks:

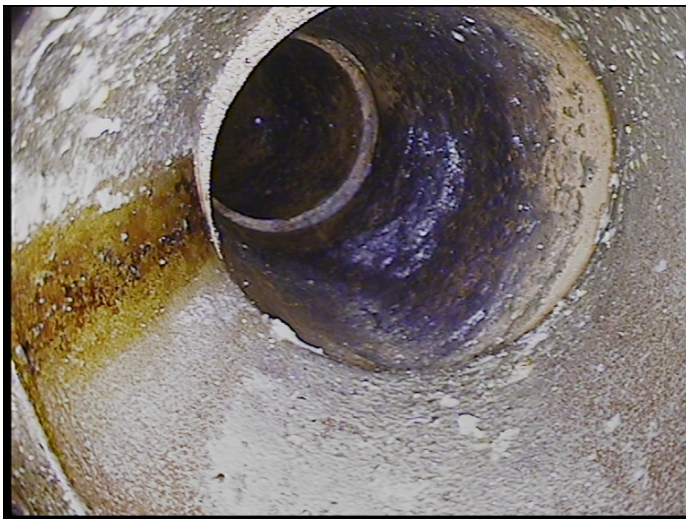
Code: **TBA**
Description: **Tap Break-in Active**

Distance (ft): **15.8**
Structural Grade: **0**
O&M Grade: **0**
Clock Start/From: **10**
Clock To:
1st Value: **4.000**
2nd Value:
Value Percent:
Continuous Index:
Within 8" of Joint: **NO**
Remarks:

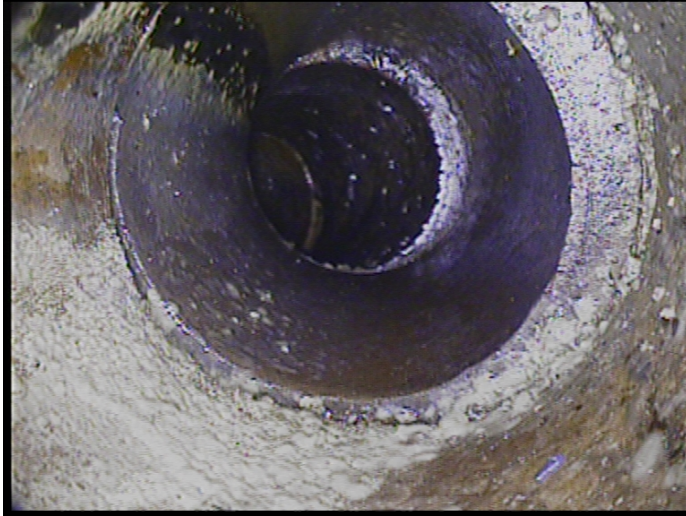
Code: **TF**
Description: **Tap Factory**

Distance (ft): **89.5**
Structural Grade: **0**
O&M Grade: **0**
Clock Start/From: **10**
Clock To:
1st Value: **4.000**
2nd Value:
Value Percent:
Continuous Index:
Within 8" of Joint: **NO**
Remarks:

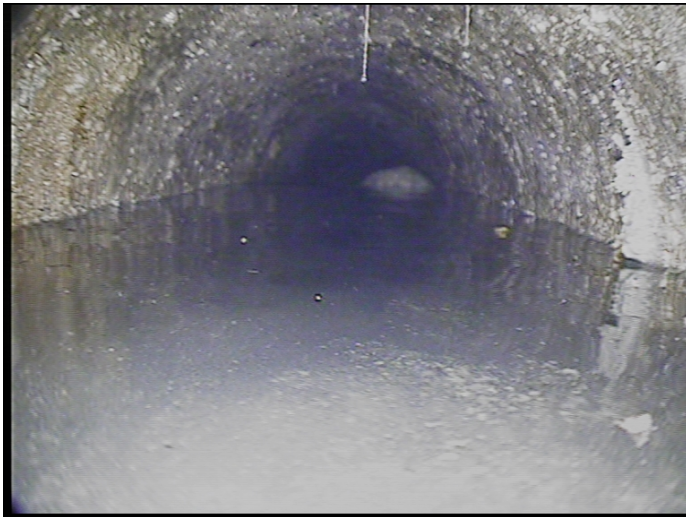
Code: **MWL**
Description: **Water Level**

Distance (ft): **114.0**
Structural Grade: **0**
O&M Grade: **0**
Clock Start/From:
Clock To:
1st Value:
2nd Value:
Value Percent: **45.000**
Continuous Index:
Within 8" of Joint: **NO**
Remarks:

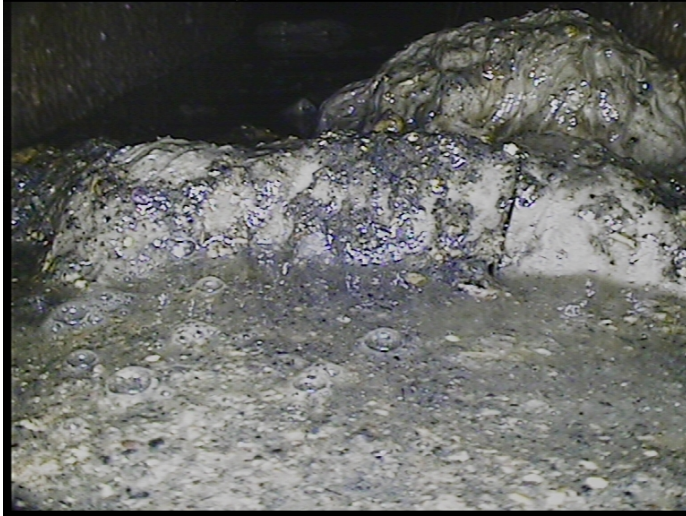
Code:	DSZ
Description:	Deposits Settled Other
Distance (ft):	117.6
Structural Grade:	0
O&M Grade:	5
Clock Start/From:	3
Clock To:	9
1st Value:	
2nd Value:	
Value Percent:	35.000
Continuous Index:	
Within 8" of Joint:	NO
Remarks:	sediment/debris

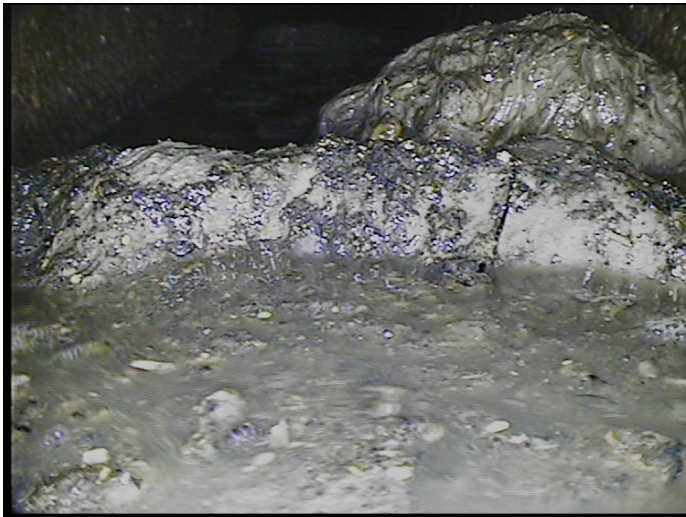
Code:	MSA
Description:	Abandoned Survey
Distance (ft):	117.6
Structural Grade:	0
O&M Grade:	0
Clock Start/From:	
Clock To:	
1st Value:	
2nd Value:	
Value Percent:	
Continuous Index:	
Within 8" of Joint:	NO
Remarks:	debris
