Profile/Photo Observation Report

Date:	08/11/2022	Weather:		Coding:	PACP 7.0
Pipe Length (ft):	283.0	Owner:	City of Hobart	Pre Clean:	Heavy Cleaning
P.O.#:	YES502259	Surveyor:	S. Bucklin	PSR:	P-605-013-070
Customer:	City of Hobart	Clean Date:	08/01/2022	Shape:	C

Street:	Ellendale Street	Flow Control:	Not Controlled
City:	Hobart, IN	Year Renewed:	
Location:	Local rural streets with light traffic, t	Tape/Media #:	
Purpose:	Routine Assessment	Dia/Height:	12"
Use:	Sanitary Sewage Pipe	Material:	CP
Drain Area:		Lining:	None
Category:	NA		
Comment:

Location Details:		Direction of Survey:	Downstream
US MH:	M-605-070	DS MH:	M-605-013
		Total Length Surveyed (ft):	280.7

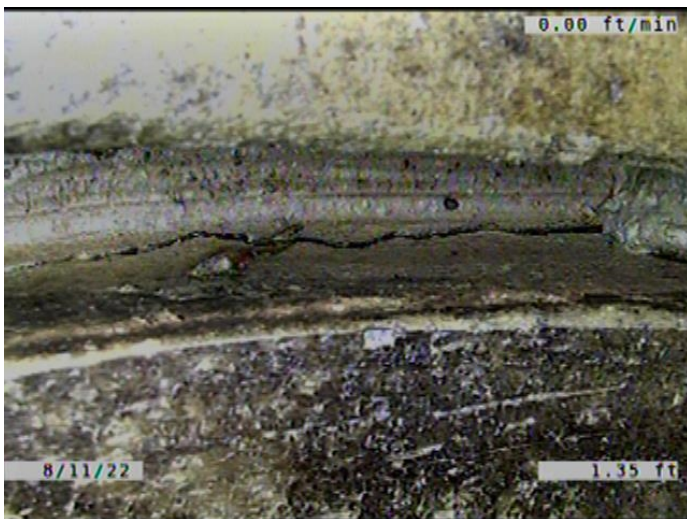
Code: **CM**
Description: **Crack Multiple**

Distance (ft): **1.4**
Structural Grade: **3**
O&M Grade: **0**
Clock Start/From: **8**
Clock To: **3**
1st Value:
2nd Value:
Value Percent:
Continuous Index:
Within 8" of Joint: **YES**
Remarks:

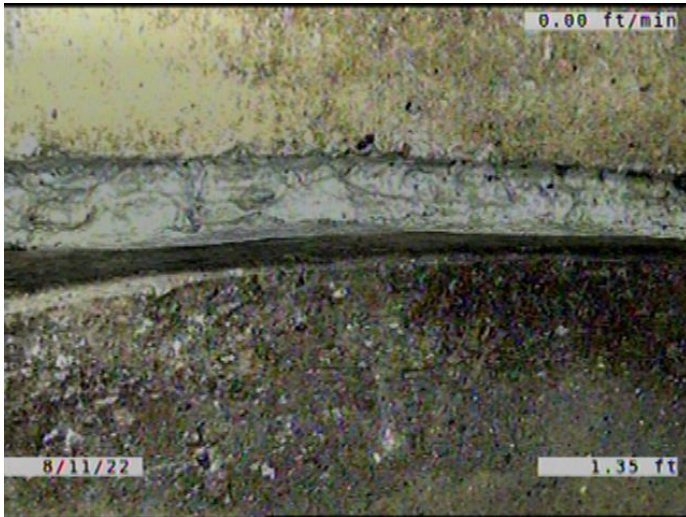
Code: **DAE**
Description: **Deposits Attached Encrustation**

Distance (ft): **1.4**
Structural Grade: **0**
O&M Grade: **2**
Clock Start/From: **3**
Clock To: **10**
1st Value:
2nd Value:
Value Percent: **5.000**
Continuous Index:
Within 8" of Joint: **YES**
Remarks:

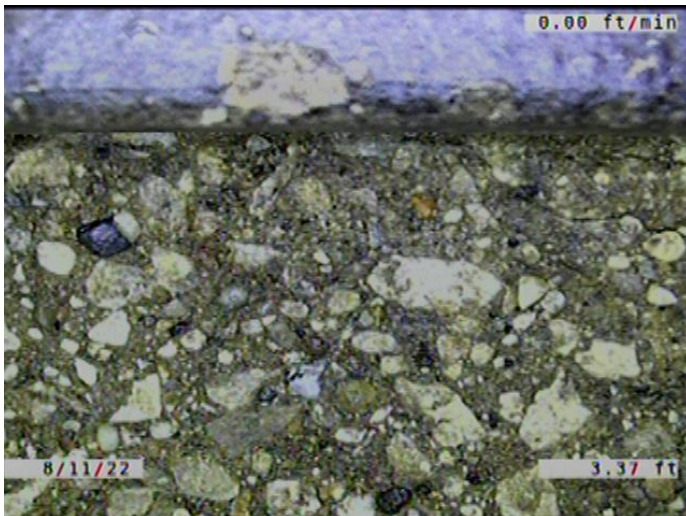
Code: **MMC**
Description: **Miscellaneous Material Change**

Distance (ft): **3.4**
Structural Grade: **0**
O&M Grade: **0**
Clock Start/From:
Clock To:
1st Value:
2nd Value:
Value Percent:
Continuous Index:
Within 8" of Joint: **NO**
Remarks: **VCP TO CONCRETE**

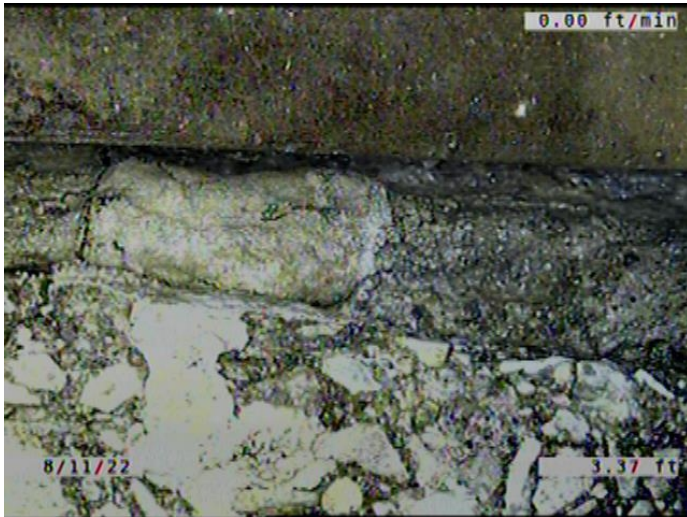
Code: **JAM**
 Description: **Joint Angular Medium**

Distance (ft): **3.4**
 Structural Grade: **3**
 O&M Grade: **0**
 Clock Start/From:
 Clock To:
 1st Value:
 2nd Value:
 Value Percent:
 Continuous Index:
 Within 8" of Joint: **NO**
 Remarks:

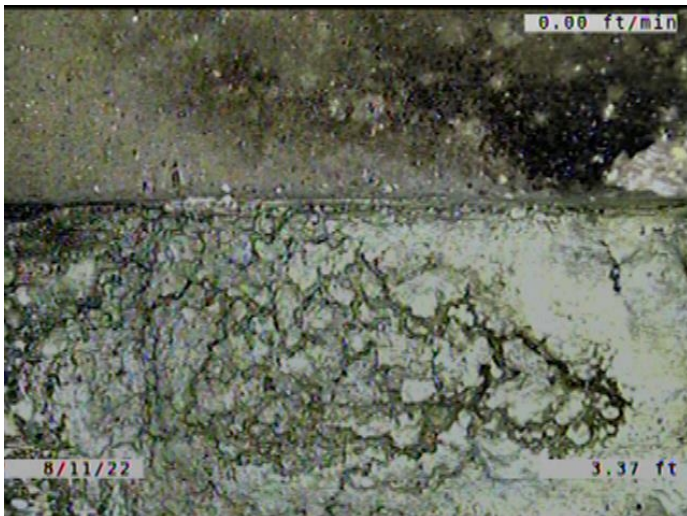
Code: **DAE**
 Description: **Deposits Attached Encrustation**

Distance (ft): **3.4**
 Structural Grade: **0**
 O&M Grade: **2**
 Clock Start/From: **12**
 Clock To: **12**
 1st Value:
 2nd Value:
 Value Percent: **5.000**
 Continuous Index: **S01**
 Within 8" of Joint: **YES**
 Remarks:

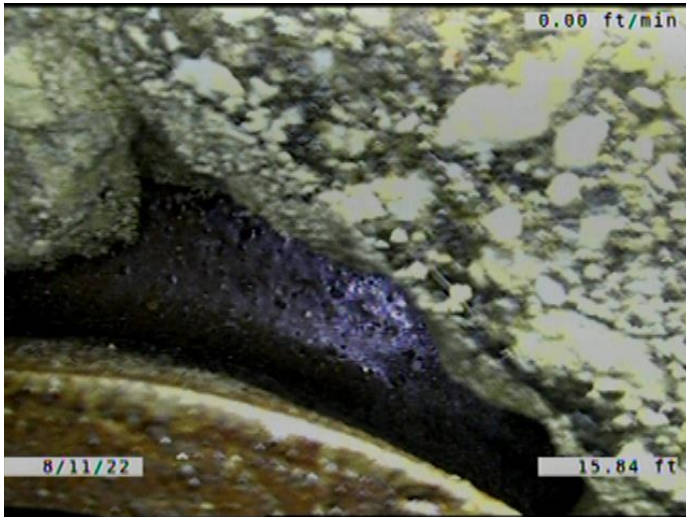
Code: **SMW**
Description: **Surface Damage Missing Wall**

Distance (ft): **15.8**
Structural Grade: **5**
O&M Grade: **0**
Clock Start/From: **9**
Clock To: **12**
1st Value:
2nd Value:
Value Percent:
Continuous Index:
Within 8" of Joint: **YES**
Remarks:

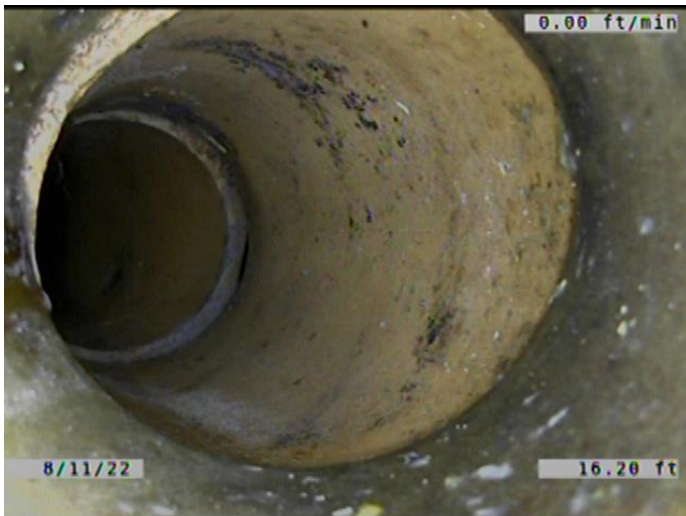
Code: **TBI**
Description: **Tap Break-in Intruding**

Distance (ft): **16.2**
Structural Grade: **0**
O&M Grade: **2**
Clock Start/From: **11**
Clock To:
1st Value: **8.000**
2nd Value: **1.000**
Value Percent:
Continuous Index:
Within 8" of Joint: **YES**
Remarks:

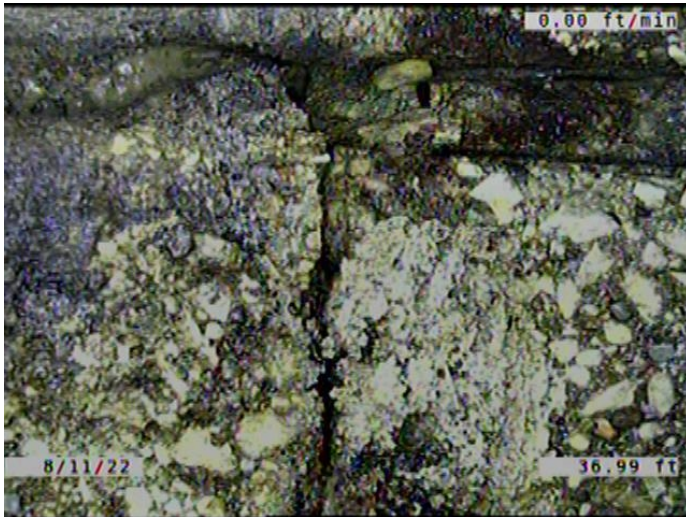
Code: **B**
 Description: **Broken**

Distance (ft): **37.0**
 Structural Grade: **4**
 O&M Grade: **0**
 Clock Start/From: **8**
 Clock To: **4**
 1st Value:
 2nd Value:
 Value Percent:
 Continuous Index:
 Within 8" of Joint: **YES**
 Remarks:

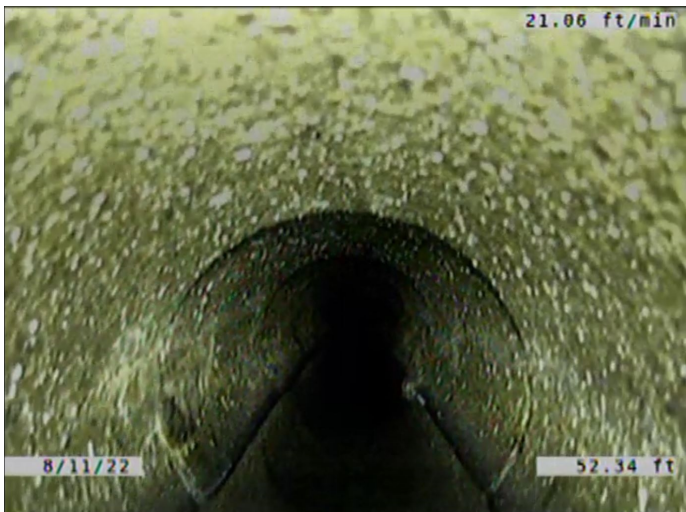
Code: **FM**
 Description: **Fracture Multiple**

Distance (ft): **52.3**
 Structural Grade: **4**
 O&M Grade: **0**
 Clock Start/From: **7**
 Clock To: **5**
 1st Value:
 2nd Value:
 Value Percent:
 Continuous Index: **S04**
 Within 8" of Joint: **YES**
 Remarks: **Wandering**

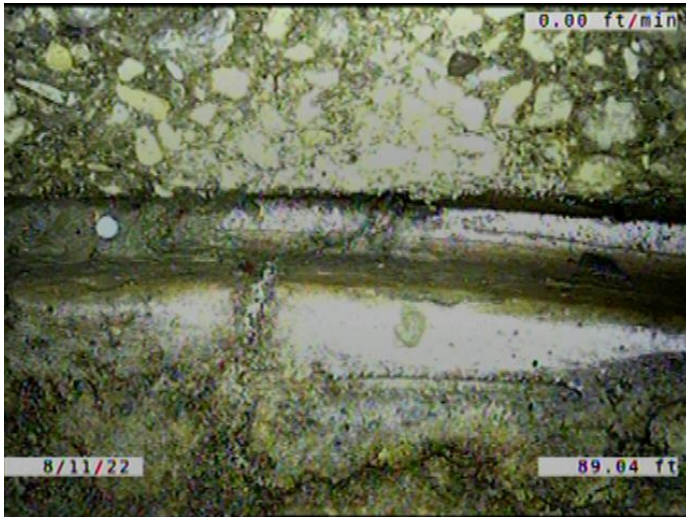
Code: **MMC**
 Description: **Miscellaneous Material Change**

Distance (ft): **89.0**
 Structural Grade: **0**
 O&M Grade: **0**
 Clock Start/From:
 Clock To:
 1st Value:
 2nd Value:
 Value Percent:
 Continuous Index:
 Within 8" of Joint: **NO**
 Remarks: **CONCRETE TO VCP**

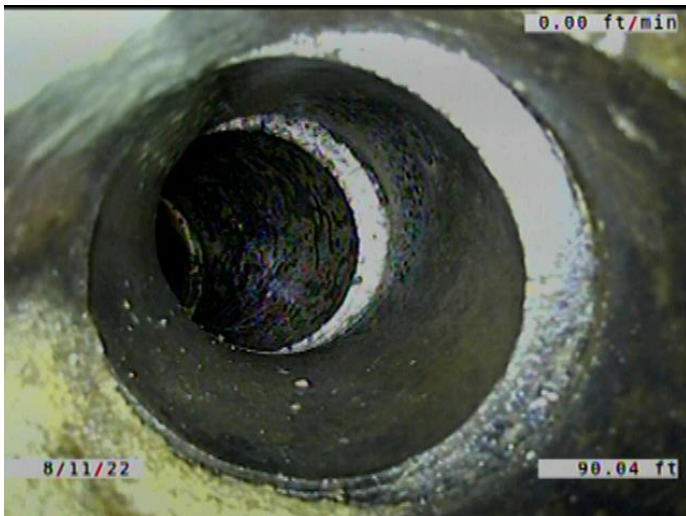
Code: **TFD**
 Description: **Tap Factory Defective**

Distance (ft): **90.0**
 Structural Grade: **0**
 O&M Grade: **3**
 Clock Start/From: **11**
 Clock To:
 1st Value: **6.000**
 2nd Value:
 Value Percent:
 Continuous Index:
 Within 8" of Joint: **YES**
 Remarks: **TAP BROKEN. SERVICE OFFSET.**

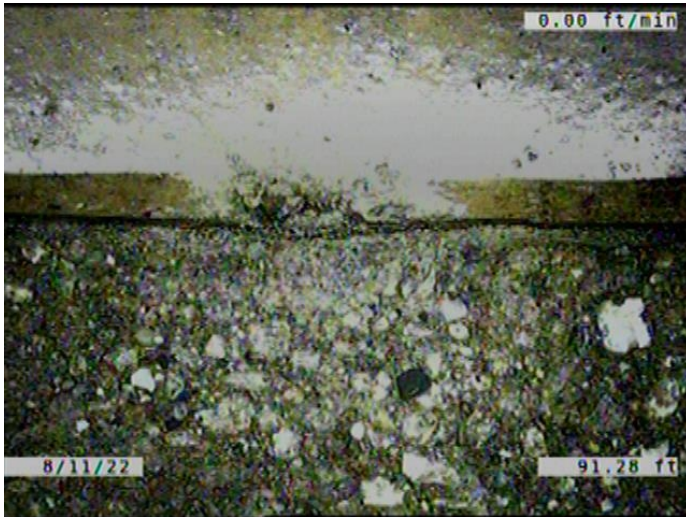
Code: **MMC**
Description: **Miscellaneous Material Change**

Distance (ft): **91.3**
Structural Grade: **0**
O&M Grade: **0**
Clock Start/From:
Clock To:
1st Value:
2nd Value:
Value Percent:
Continuous Index:
Within 8" of Joint: **NO**
Remarks: **VCP TO CONCRETE**

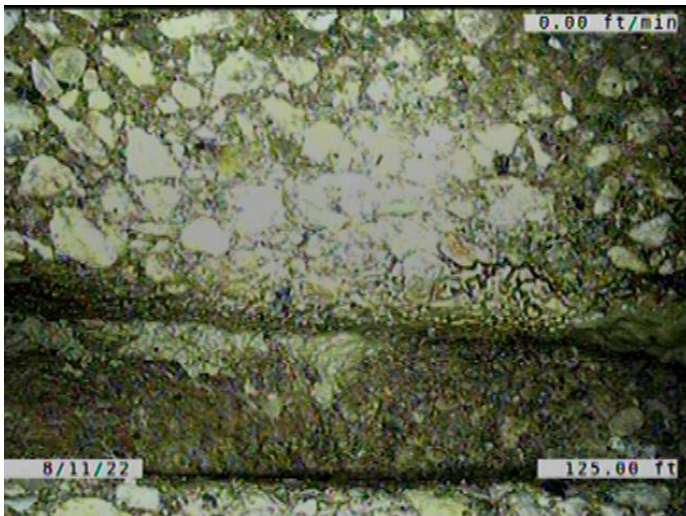
Code: **JAM**
Description: **Joint Angular Medium**

Distance (ft): **125.0**
Structural Grade: **3**
O&M Grade: **0**
Clock Start/From:
Clock To:
1st Value:
2nd Value:
Value Percent:
Continuous Index:
Within 8" of Joint: **NO**
Remarks:

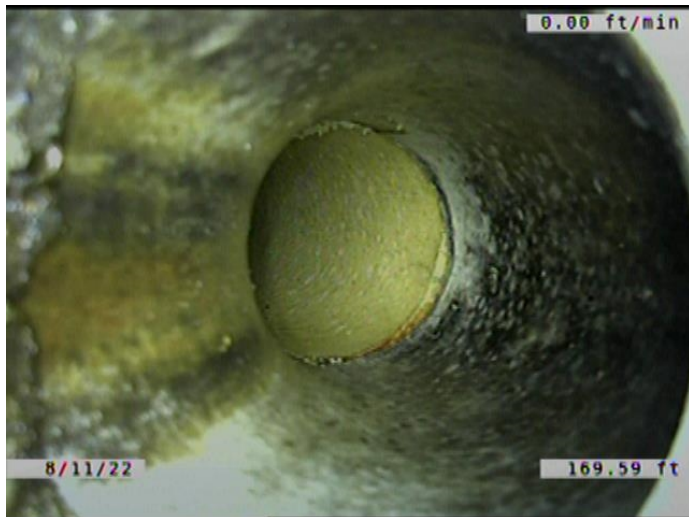
Code: **TBI**
 Description: **Tap Break-in Intruding**

Distance (ft): **169.6**
 Structural Grade: **0**
 O&M Grade: **2**
 Clock Start/From: **11**
 Clock To:
 1st Value: **8.000**
 2nd Value: **1.000**
 Value Percent:
 Continuous Index:
 Within 8" of Joint: **YES**
 Remarks:

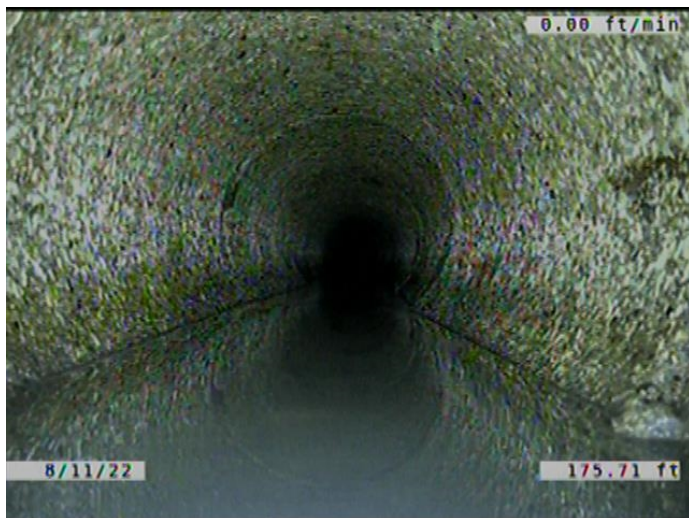
Code: **MWLS**
 Description: **Miscellaneous Water Level Sag**

Distance (ft): **175.7**
 Structural Grade: **2**
 O&M Grade: **0**
 Clock Start/From:
 Clock To:
 1st Value:
 2nd Value:
 Value Percent: **15.000**
 Continuous Index:
 Within 8" of Joint: **NO**
 Remarks:

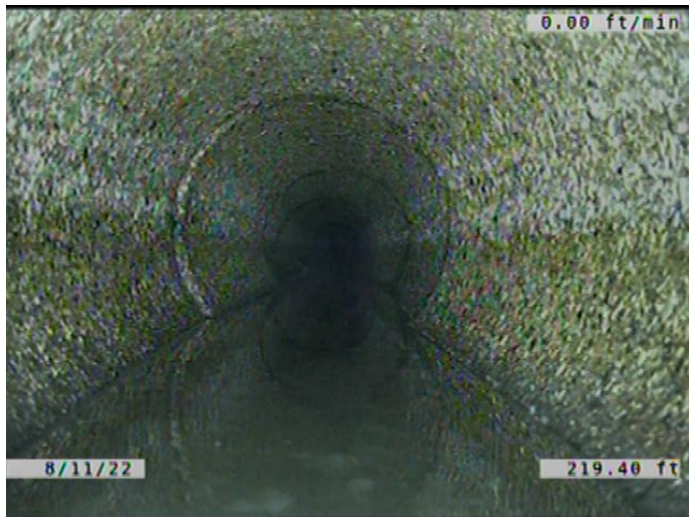
Code: **MWLS**
Description: **Miscellaneous Water Level Sag**

Distance (ft): **219.4**
Structural Grade: **2**
O&M Grade: **0**
Clock Start/From:
Clock To:
1st Value:
2nd Value:
Value Percent: **15.000**
Continuous Index: **S03**
Within 8" of Joint: **NO**
Remarks:

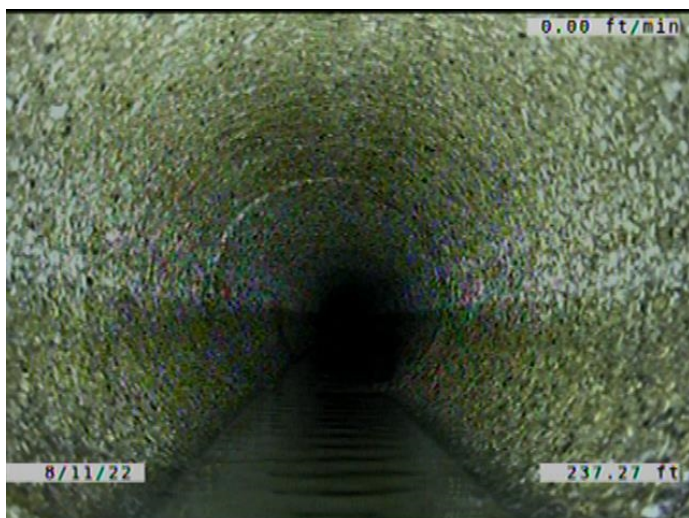
Code: **MWLS**
Description: **Miscellaneous Water Level Sag**

Distance (ft): **237.3**
Structural Grade: **2**
O&M Grade: **0**
Clock Start/From:
Clock To:
1st Value:
2nd Value:
Value Percent: **15.000**
Continuous Index: **F03**
Within 8" of Joint: **NO**
Remarks:

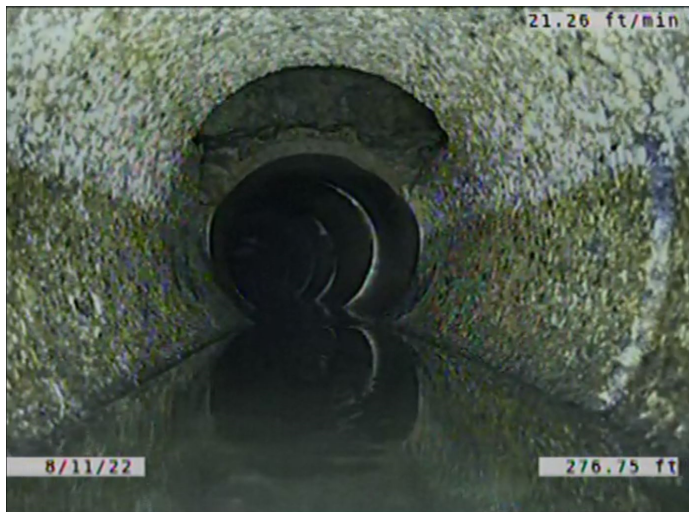
Code: **FM**
 Description: **Fracture Multiple**

Distance (ft): **276.8**
 Structural Grade: **4**
 O&M Grade: **0**
 Clock Start/From: **7**
 Clock To: **5**
 1st Value:
 2nd Value:
 Value Percent:
 Continuous Index: **F04**
 Within 8" of Joint: **YES**
 Remarks: **Wandering**

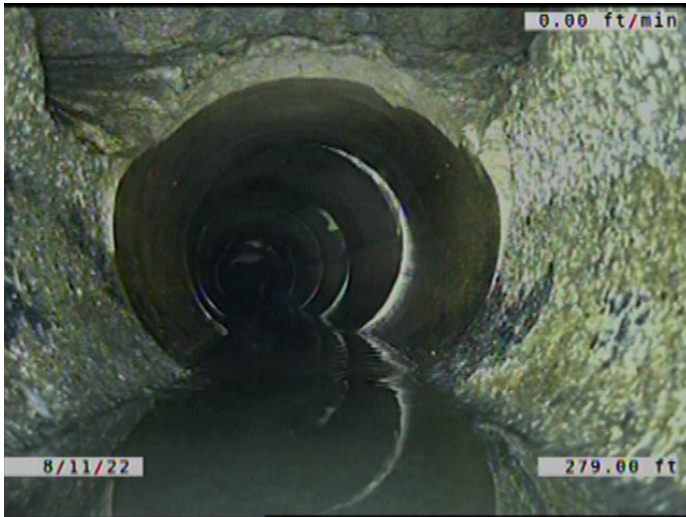
Code: **DAE**
 Description: **Deposits Attached Encrustation**

Distance (ft): **279.0**
 Structural Grade: **0**
 O&M Grade: **2**
 Clock Start/From: **12**
 Clock To: **12**
 1st Value:
 2nd Value:
 Value Percent: **5.000**
 Continuous Index: **F01**
 Within 8" of Joint: **YES**
 Remarks:
