Profile/Photo Observation Report

Street:	COURT ST & S ASH ST	Flow Control:	Not Controlled
City:	Hobart, IN	Year Renewed:	
Location:	Other	Tape/Media #:	
Purpose:	Not Known	Dia/Height:	12"
Use:	Sanitary	Material:	VCP
Drain Area:	NA	Lining:	
Category:	NA		
Comment:	Flow direction wrong. Debris at 65'.

Location Details:		Direction of Survey:	Downstream
US MH:	M-605-072	DS MH:	M-605-019
		Total Length Surveyed (ft):	67.0

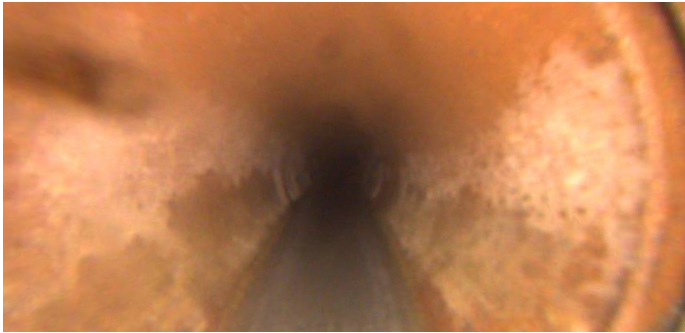
Code:	MWL
Description:	Water Level

Distance (ft):	.0
Structural Grade:	0
O&M Grade:	0
Clock Start/From:	
Clock To:	
1st Value:	
2nd Value:	
Value Percent:	5.000
Continuous Index:	
Within 8" of Joint:	NO
Remarks:

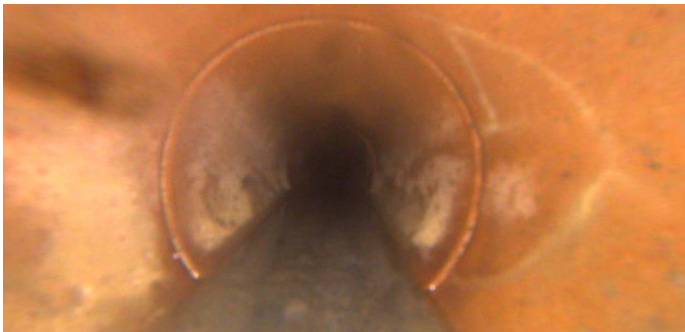
Code:	FM
Description:	Fracture Multiple

Distance (ft):	2.1
Structural Grade:	4
O&M Grade:	0
Clock Start/From:	1
Clock To:	4
1st Value:	
2nd Value:	
Value Percent:	
Continuous Index:	
Within 8" of Joint:	YES
Remarks:

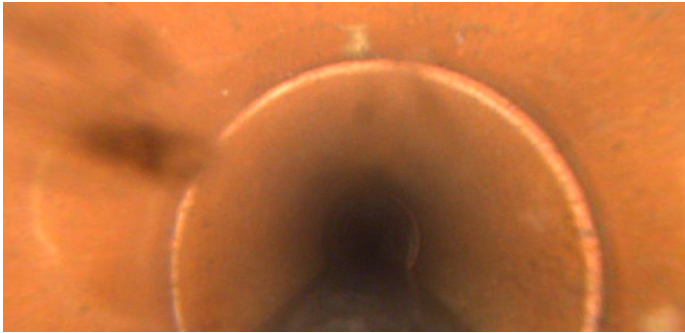
Code: **FM**
Description: **Fracture Multiple**

Distance (ft): **6.0**
Structural Grade: **4**
O&M Grade: **0**
Clock Start/From: **8**
Clock To: **4**
1st Value:
2nd Value:
Value Percent:
Continuous Index:
Within 8" of Joint: **YES**
Remarks:

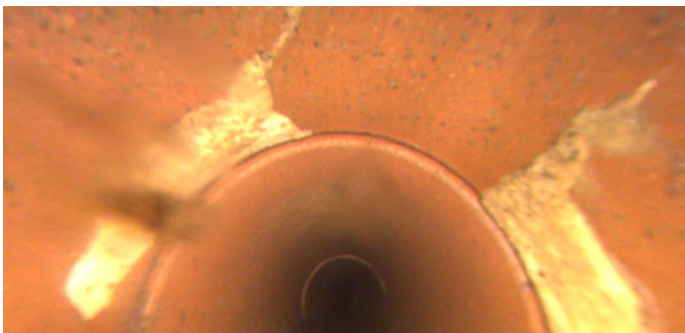
Code: **DAE**
Description: **Deposits Attached Encrustation**

Distance (ft): **20.0**
Structural Grade: **0**
O&M Grade: **2**
Clock Start/From: **8**
Clock To: **4**
1st Value:
2nd Value:
Value Percent: **5.000**
Continuous Index:
Within 8" of Joint: **YES**
Remarks:

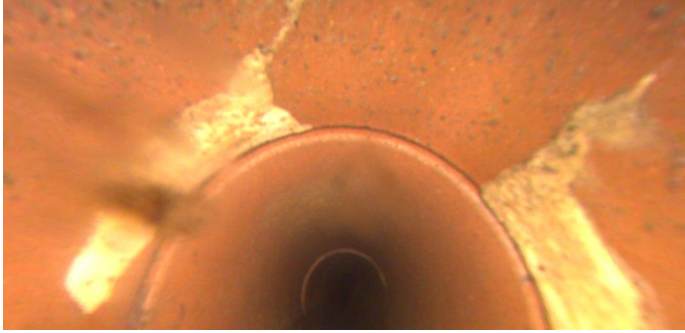
Code: **CM**
Description: **Crack Multiple**

Distance (ft): **20.0**
Structural Grade: **3**
O&M Grade: **0**
Clock Start/From: **12**
Clock To: **2**
1st Value:
2nd Value:
Value Percent:
Continuous Index:
Within 8" of Joint: **YES**
Remarks:

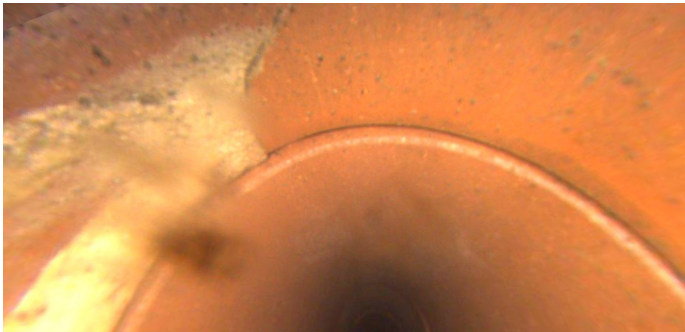
Code: **CL**
Description: **Crack Longitudinal**

Distance (ft): **24.2**
Structural Grade: **2**
O&M Grade: **0**
Clock Start/From: **11**
Clock To:
1st Value:
2nd Value:
Value Percent:
Continuous Index:
Within 8" of Joint: **YES**
Remarks:

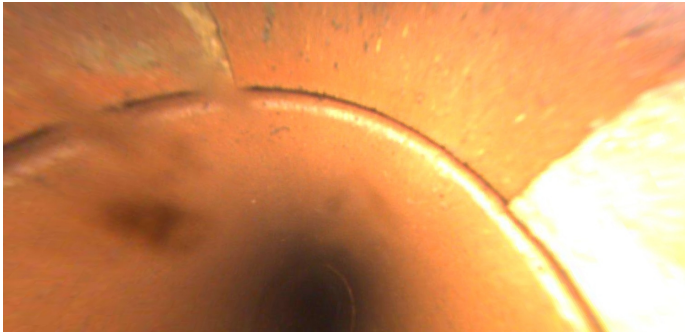
Code: **FL**
Description: **Fracture Longitudinal**

Distance (ft): **30.3**
Structural Grade: **3**
O&M Grade: **0**
Clock Start/From: **12**
Clock To:
1st Value:
2nd Value:
Value Percent:
Continuous Index:
Within 8" of Joint: **YES**
Remarks:

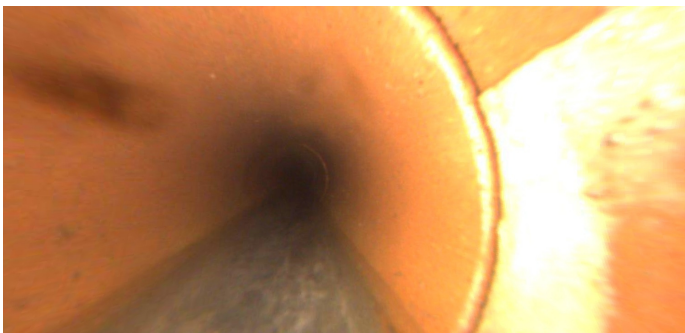
Code: **DAE**
Description: **Deposits Attached Encrustation**

Distance (ft): **30.3**
Structural Grade: **0**
O&M Grade: **2**
Clock Start/From: **2**
Clock To: **4**
1st Value:
2nd Value:
Value Percent: **5.000**
Continuous Index:
Within 8" of Joint: **YES**
Remarks:

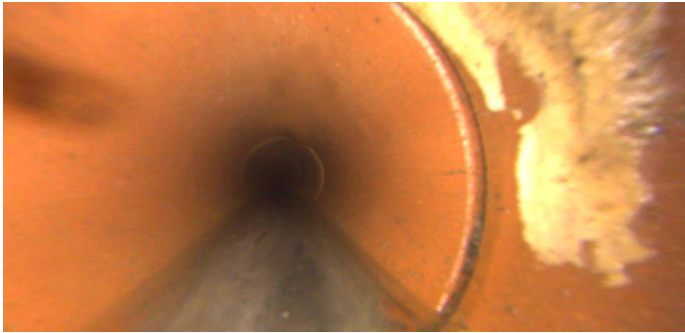
Code: **DAE**
Description: **Deposits Attached Encrustation**

Distance (ft): **34.2**
Structural Grade: **0**
O&M Grade: **2**
Clock Start/From: **8**
Clock To: **4**
1st Value:
2nd Value:
Value Percent: **5.000**
Continuous Index: **S01**
Within 8" of Joint: **YES**
Remarks:

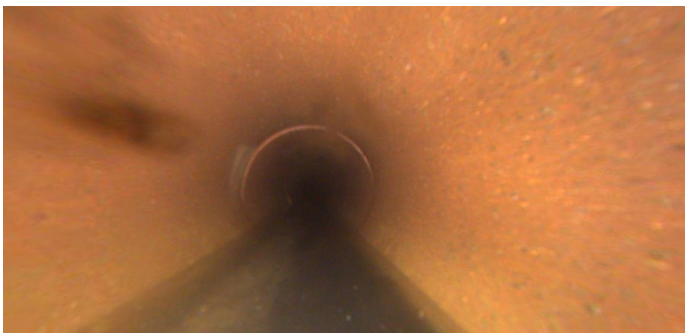
Code: **DAE**
Description: **Deposits Attached Encrustation**

Distance (ft): **67.0**
Structural Grade: **0**
O&M Grade: **2**
Clock Start/From: **8**
Clock To: **4**
1st Value:
2nd Value:
Value Percent: **5.000**
Continuous Index: **F01**
Within 8" of Joint: **YES**
Remarks:

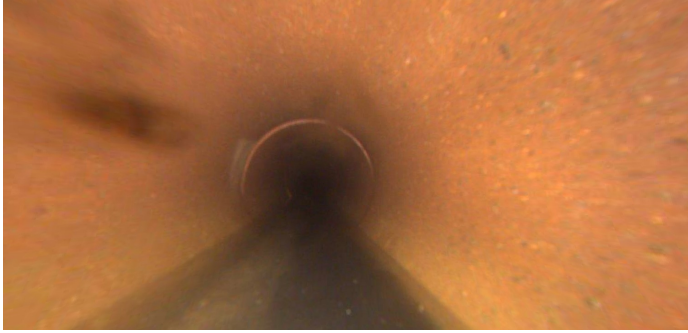
Code:	MSA
Description:	Abandoned Survey
Distance (ft):	67.0
Structural Grade:	0
O&M Grade:	0
Clock Start/From:	
Clock To:	
1st Value:	
2nd Value:	
Value Percent:	
Continuous Index:	
Within 8" of Joint:	NO
Remarks:	unknown
