Profile/Photo Observation Report

Street:	Ash	Flow Control:	Not Controlled
City:	Hobart, IN	Year Renewed:	
Location:	Other	Tape/Media #:	
Purpose:	Not Known	Dia/Height:	12"
Use:	Sanitary	Material:	VCP
Drain Area:	NA	Lining:	
Category:	NA		
Comment:	Flow direction wrong. Debris at 65'.

Location Details:		Direction of Survey:	Downstream
US MH:	M-605-072	DS MH:	M-605-019
		Total Length Surveyed (ft):	67.0

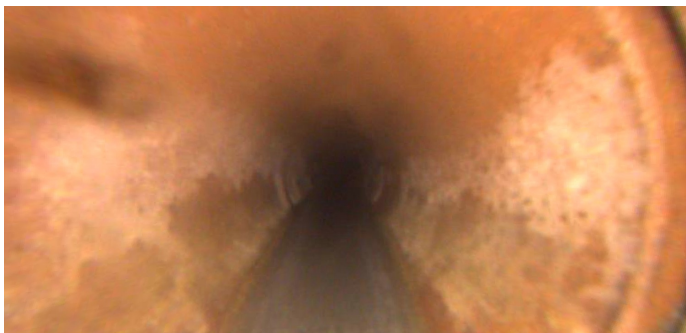
Code: **AMH**
Description: **Manhole**

Distance (ft): **.0**
Structural Grade: **0**
O&M Grade: **0**
Clock Start/From:
Clock To:
1st Value:
2nd Value:
Value Percent:
Continuous Index:
Within 8" of Joint: **NO**
Remarks: **M-605-072**

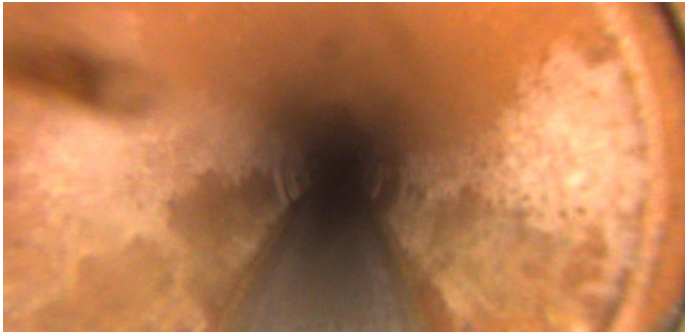
Code:	MWL
Description:	Water Level

Distance (ft):	.0
Structural Grade:	0
O&M Grade:	0
Clock Start/From:	
Clock To:	
1st Value:	
2nd Value:	
Value Percent:	5.000
Continuous Index:	
Within 8" of Joint:	NO
Remarks:

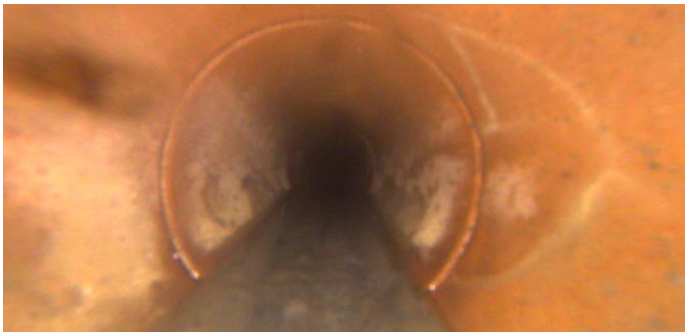
Code:	FM
Description:	Fracture Multiple

Distance (ft):	2.1
Structural Grade:	4
O&M Grade:	0
Clock Start/From:	1
Clock To:	4
1st Value:	
2nd Value:	
Value Percent:	
Continuous Index:	
Within 8" of Joint:	YES
Remarks:

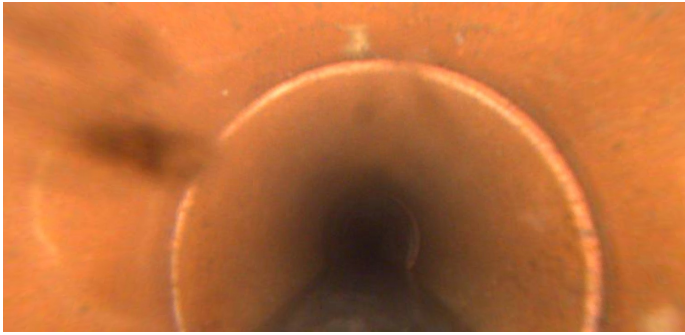
Code: **FM**
Description: **Fracture Multiple**

Distance (ft): **6.0**
Structural Grade: **4**
O&M Grade: **0**
Clock Start/From: **8**
Clock To: **4**
1st Value:
2nd Value:
Value Percent:
Continuous Index:
Within 8" of Joint: **YES**
Remarks:

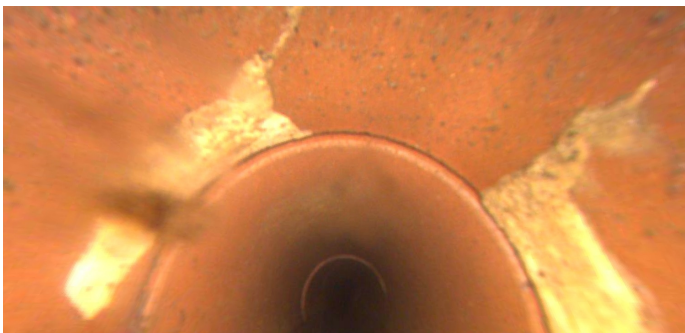
Code: **DAE**
Description: **Deposits Attached Encrustation**

Distance (ft): **20.0**
Structural Grade: **0**
O&M Grade: **2**
Clock Start/From: **8**
Clock To: **4**
1st Value:
2nd Value:
Value Percent: **5.000**
Continuous Index:
Within 8" of Joint: **YES**
Remarks:

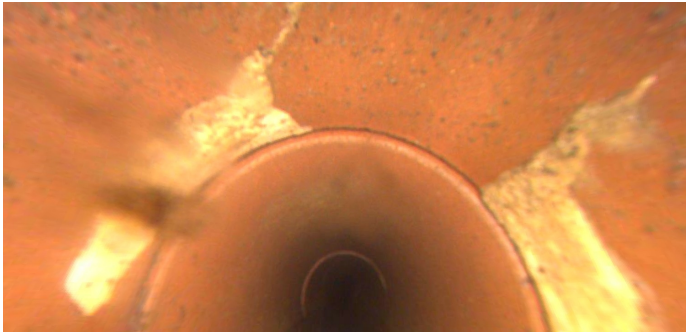
Code: **CM**
Description: **Crack Multiple**

Distance (ft): **20.0**
Structural Grade: **3**
O&M Grade: **0**
Clock Start/From: **12**
Clock To: **2**
1st Value:
2nd Value:
Value Percent:
Continuous Index:
Within 8" of Joint: **YES**
Remarks:

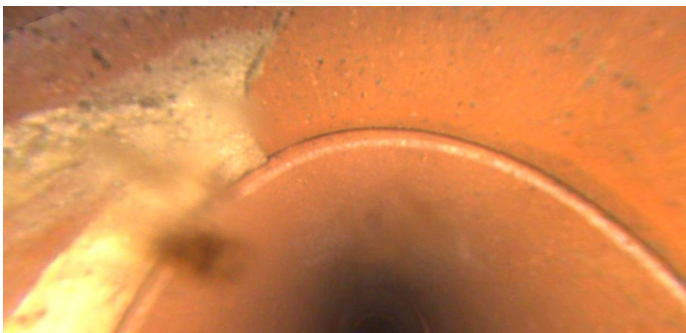
Code: **CL**
Description: **Crack Longitudinal**

Distance (ft): **24.2**
Structural Grade: **2**
O&M Grade: **0**
Clock Start/From: **11**
Clock To:
1st Value:
2nd Value:
Value Percent:
Continuous Index:
Within 8" of Joint: **YES**
Remarks:

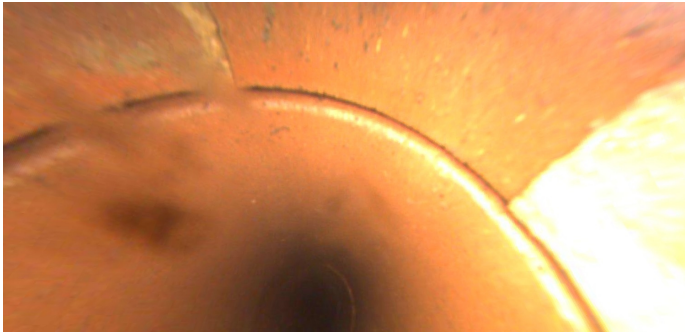
Code: **FL**
Description: **Fracture Longitudinal**

Distance (ft): **30.3**
Structural Grade: **3**
O&M Grade: **0**
Clock Start/From: **12**
Clock To:
1st Value:
2nd Value:
Value Percent:
Continuous Index:
Within 8" of Joint: **YES**
Remarks:

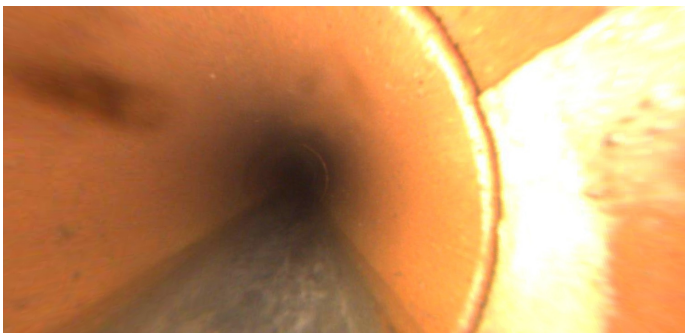
Code: **DAE**
Description: **Deposits Attached Encrustation**

Distance (ft): **30.3**
Structural Grade: **0**
O&M Grade: **2**
Clock Start/From: **2**
Clock To: **4**
1st Value:
2nd Value:
Value Percent: **5.000**
Continuous Index:
Within 8" of Joint: **YES**
Remarks:

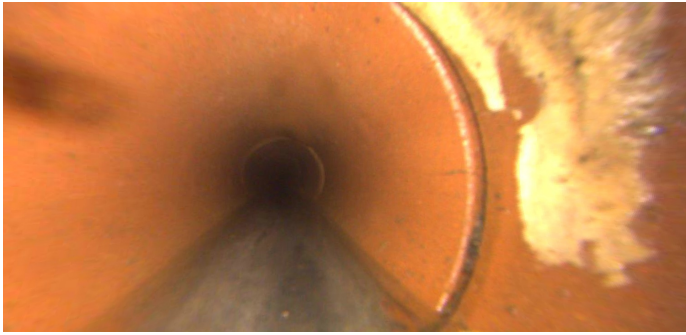
Code: **DAE**
Description: **Deposits Attached Encrustation**

Distance (ft): **34.2**
Structural Grade: **0**
O&M Grade: **2**
Clock Start/From: **8**
Clock To: **4**
1st Value:
2nd Value:
Value Percent: **5.000**
Continuous Index: **S01**
Within 8" of Joint: **YES**
Remarks:

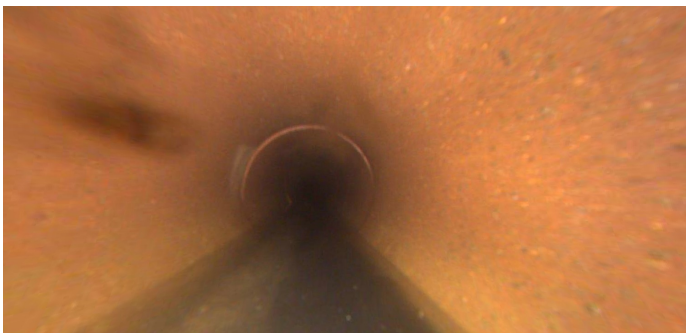
Code: **DAE**
Description: **Deposits Attached Encrustation**

Distance (ft): **67.0**
Structural Grade: **0**
O&M Grade: **2**
Clock Start/From: **8**
Clock To: **4**
1st Value:
2nd Value:
Value Percent: **5.000**
Continuous Index: **F01**
Within 8" of Joint: **YES**
Remarks:

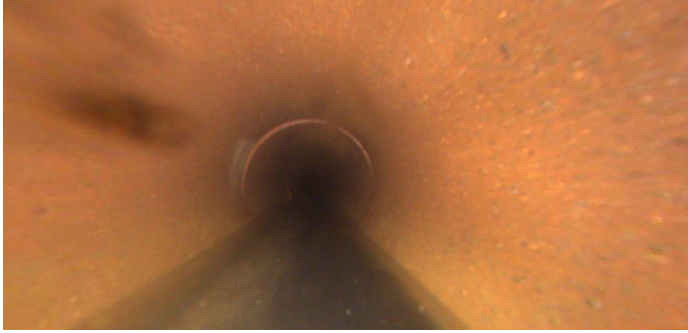
Code:	MSA
Description:	Abandoned Survey
Distance (ft):	67.0
Structural Grade:	0
O&M Grade:	0
Clock Start/From:	
Clock To:	
1st Value:	
2nd Value:	
Value Percent:	
Continuous Index:	
Within 8" of Joint:	NO
Remarks:	unknown
