Profile/Photo Observation Report

Date:	11/16/2021	Weather:		Coding:	PACP 7.0
Pipe Length (ft):	167.8	Owner:	City of Hobart	Pre Clean:	Light Cleaning
P.O.#:	YES502259	Surveyor:	S. Bucklin	PSR:	P-605-019-072
Customer:	City of Hobart	Clean Date:	11/16/2021	Shape:	C

Street:	Court Street	Flow Control:	Not Controlled
City:	Hobart, IN	Year Renewed:	
Location:	Local rural streets with light traffic, t	Tape/Media #:	
Purpose:	Routine Assessment	Dia/Height:	10"
Use:	Sanitary Sewage Pipe	Material:	VCP
Drain Area:		Lining:	None
Category:	NA		
Comment:			
Location Details:		Direction of Survey:	Upstream
US MH:	M-605-072	DS MH:	M-605-019
		Total Length Surveyed (ft):	167.8

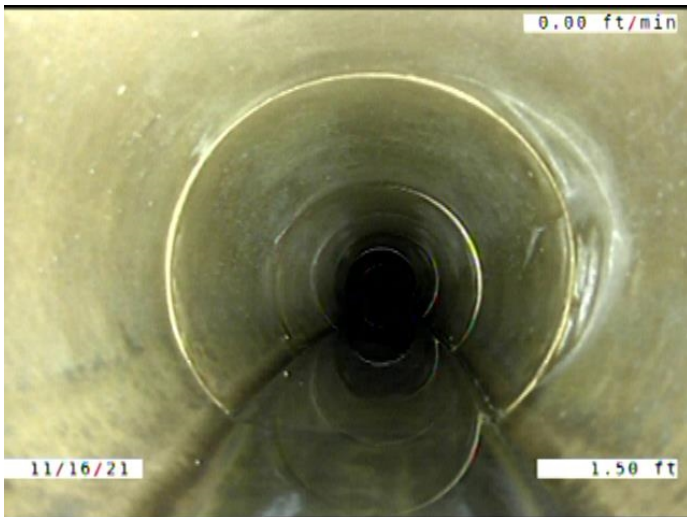
Code: **MGO**
Description: **Miscellaneous General Observation**

Distance (ft): **1.5**
Structural Grade: **0**
O&M Grade: **0**
Clock Start/From:
Clock To:
1st Value:
2nd Value:
Value Percent:
Continuous Index:
Within 8" of Joint: **NO**
Remarks: **DROP INTO THE MANHOLE. HAD TO START IN THE PIPE.**

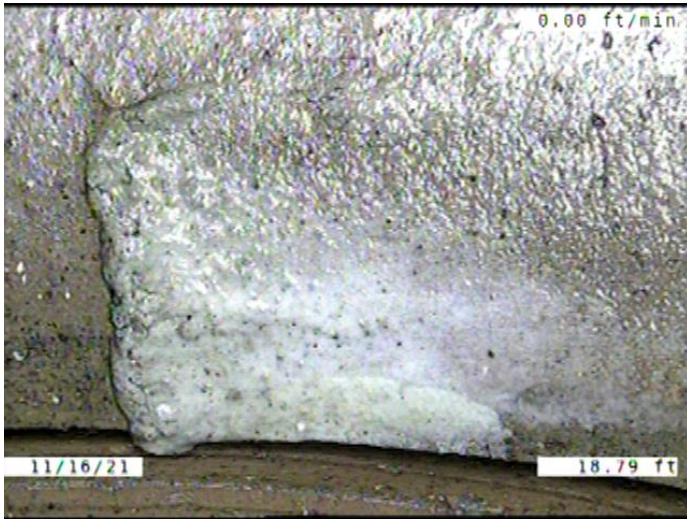
Code: **DAE**
 Description: **Deposits Attached Encrustation**

Distance (ft): **18.8**
 Structural Grade: **0**
 O&M Grade: **2**
 Clock Start/From: **1**
 Clock To: **3**
 1st Value:
 2nd Value:
 Value Percent: **5.000**
 Continuous Index:
 Within 8" of Joint: **YES**
 Remarks:

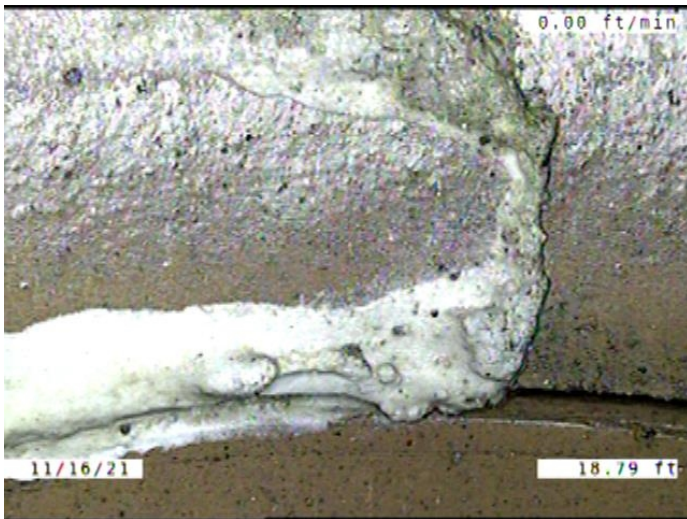
Code: **DAE**
 Description: **Deposits Attached Encrustation**

Distance (ft): **18.8**
 Structural Grade: **0**
 O&M Grade: **2**
 Clock Start/From: **9**
 Clock To: **11**
 1st Value:
 2nd Value:
 Value Percent: **5.000**
 Continuous Index:
 Within 8" of Joint: **YES**
 Remarks:

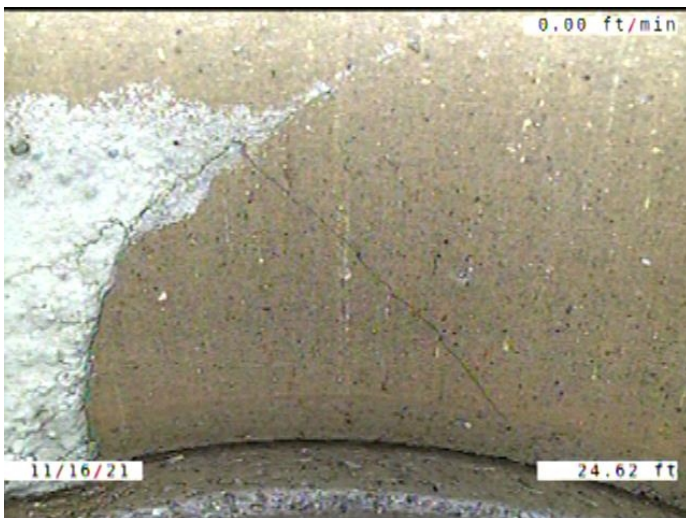
Code: **CM**
 Description: **Crack Multiple**

Distance (ft): **24.6**
 Structural Grade: **3**
 O&M Grade: **0**
 Clock Start/From: **11**
 Clock To: **12**
 1st Value:
 2nd Value:
 Value Percent:
 Continuous Index:
 Within 8" of Joint: **YES**
 Remarks:

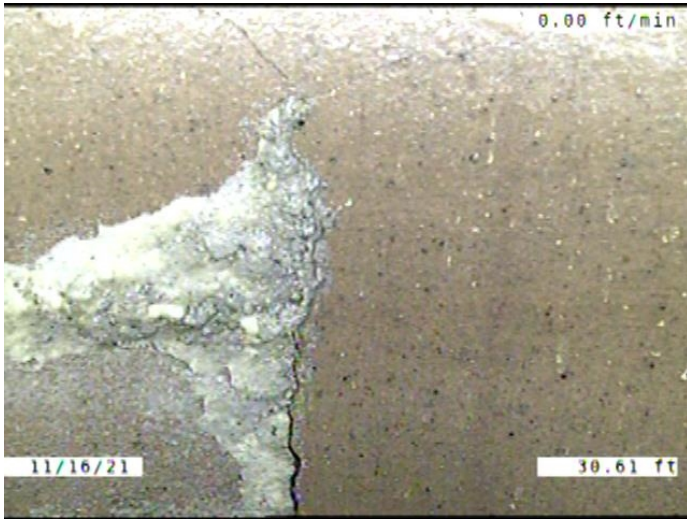
Code: **FM**
 Description: **Fracture Multiple**

Distance (ft): **30.6**
 Structural Grade: **4**
 O&M Grade: **0**
 Clock Start/From: **10**
 Clock To: **2**
 1st Value:
 2nd Value:
 Value Percent:
 Continuous Index:
 Within 8" of Joint: **YES**
 Remarks:

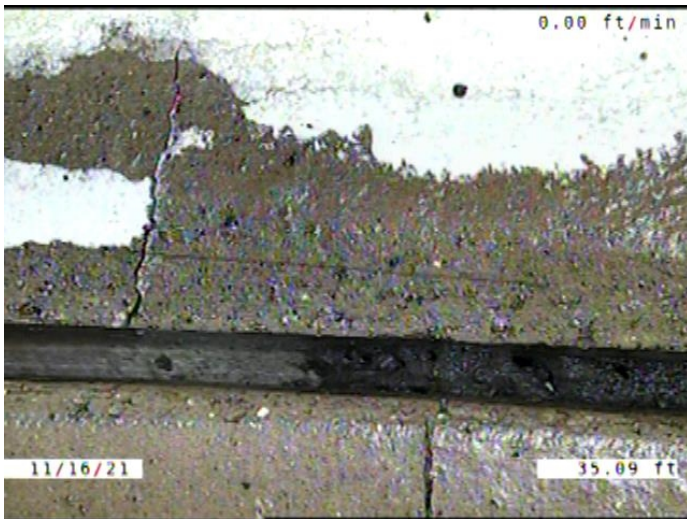
Code: **FM**
 Description: **Fracture Multiple**

Distance (ft): **35.1**
 Structural Grade: **4**
 O&M Grade: **0**
 Clock Start/From: **1**
 Clock To: **4**
 1st Value:
 2nd Value:
 Value Percent:
 Continuous Index:
 Within 8" of Joint: **YES**
 Remarks:

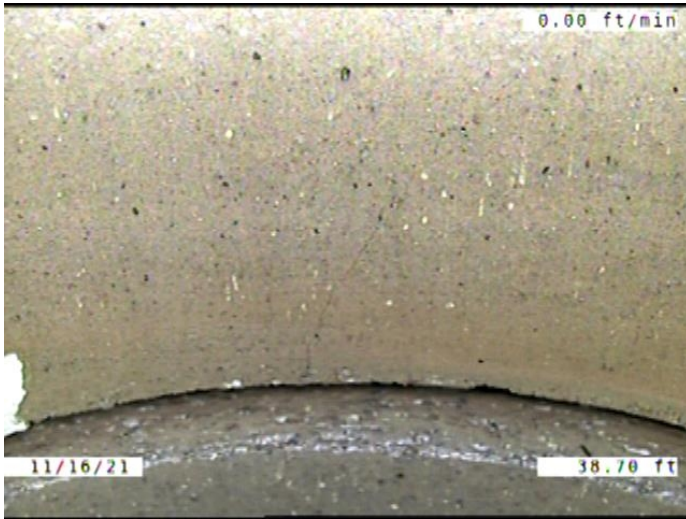
Code: **CL**
Description: **Crack Longitudinal**

Distance (ft): **38.7**
Structural Grade: **2**
O&M Grade: **0**
Clock Start/From: **12**
Clock To:
1st Value:
2nd Value:
Value Percent:
Continuous Index:
Within 8" of Joint: **YES**
Remarks:

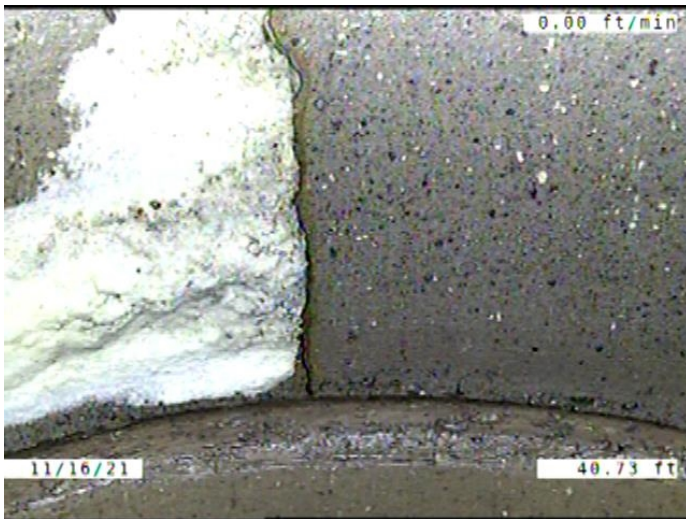
Code: **CL**
Description: **Crack Longitudinal**

Distance (ft): **40.7**
Structural Grade: **2**
O&M Grade: **0**
Clock Start/From: **11**
Clock To:
1st Value:
2nd Value:
Value Percent:
Continuous Index:
Within 8" of Joint: **NO**
Remarks:

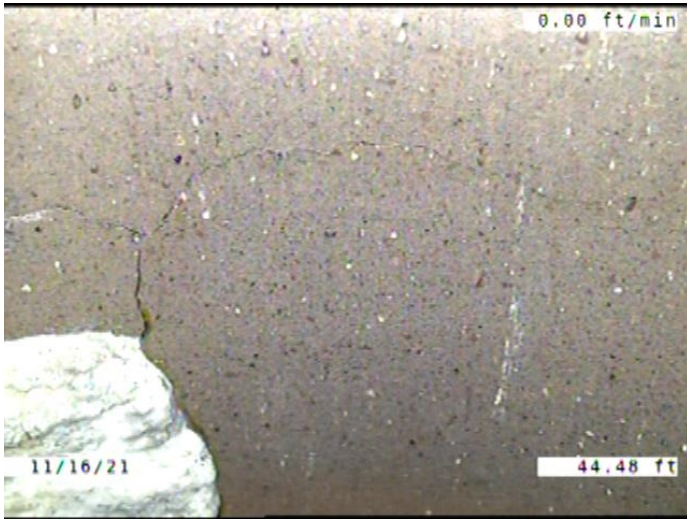
Code: **CM**
 Description: **Crack Multiple**

Distance (ft): **44.5**
 Structural Grade: **3**
 O&M Grade: **0**
 Clock Start/From: **11**
 Clock To: **2**
 1st Value:
 2nd Value:
 Value Percent:
 Continuous Index:
 Within 8" of Joint: **YES**
 Remarks:

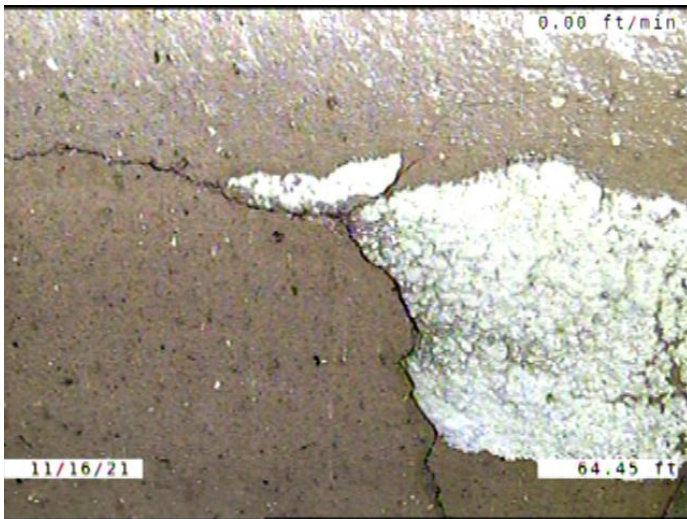
Code: **CM**
 Description: **Crack Multiple**

Distance (ft): **64.5**
 Structural Grade: **3**
 O&M Grade: **0**
 Clock Start/From: **11**
 Clock To: **5**
 1st Value:
 2nd Value:
 Value Percent:
 Continuous Index:
 Within 8" of Joint: **YES**
 Remarks:

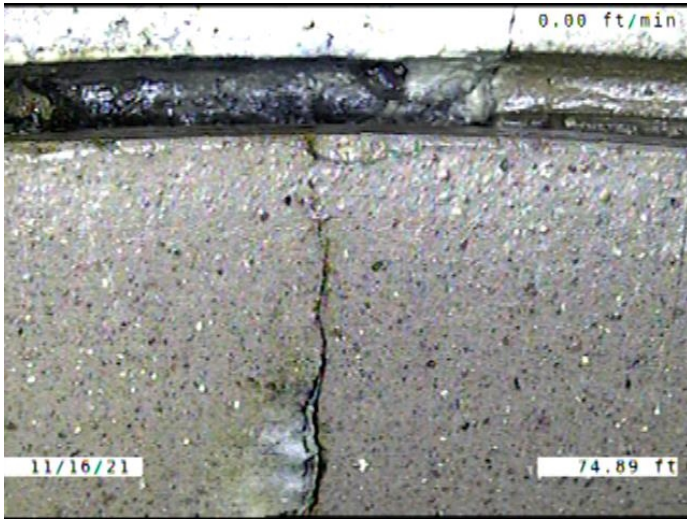
Code: **CM**
Description: **Crack Multiple**

Distance (ft): **74.9**
Structural Grade: **3**
O&M Grade: **0**
Clock Start/From: **10**
Clock To: **11**
1st Value:
2nd Value:
Value Percent:
Continuous Index:
Within 8" of Joint: **YES**
Remarks:

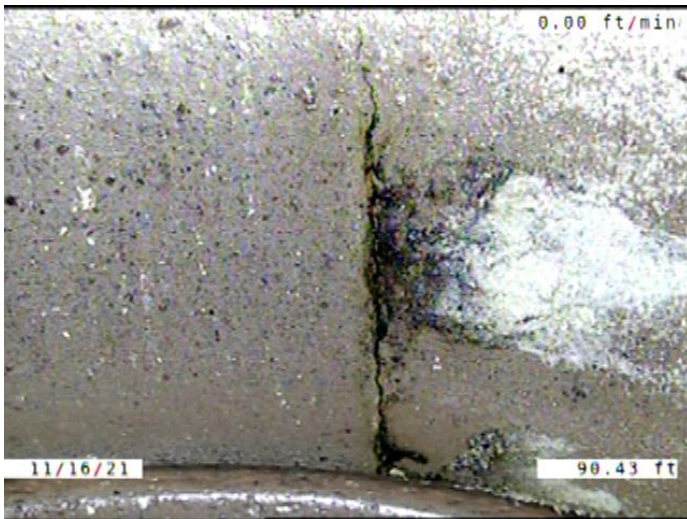
Code: **CL**
Description: **Crack Longitudinal**

Distance (ft): **90.4**
Structural Grade: **2**
O&M Grade: **0**
Clock Start/From: **1**
Clock To:
1st Value:
2nd Value:
Value Percent:
Continuous Index:
Within 8" of Joint: **YES**
Remarks:

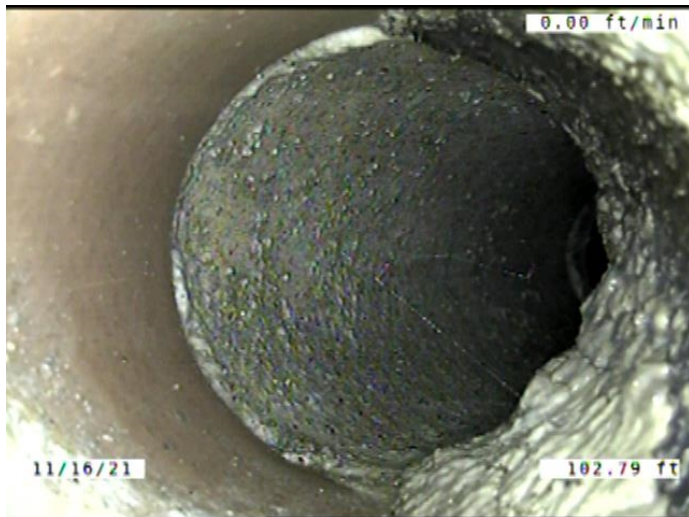
Code:	TFD
Description:	Tap Factory Defective
Distance (ft):	102.8
Structural Grade:	0
O&M Grade:	3
Clock Start/From:	1
Clock To:	
1st Value:	4.000
2nd Value:	
Value Percent:	
Continuous Index:	
Within 8" of Joint:	YES
Remarks:	ENCRUSTATION IN THE TAP AND COMING INTO THE MAIN

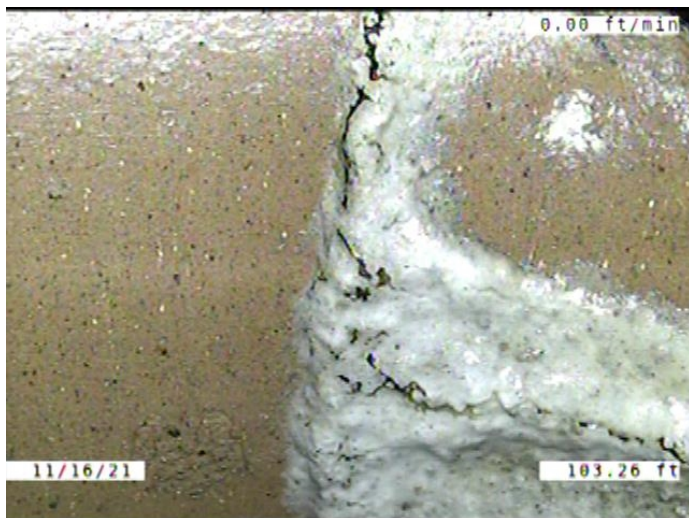
Code:	CM
Description:	Crack Multiple
Distance (ft):	103.3
Structural Grade:	3
O&M Grade:	0
Clock Start/From:	12
Clock To:	3
1st Value:	
2nd Value:	
Value Percent:	
Continuous Index:	
Within 8" of Joint:	YES
Remarks:

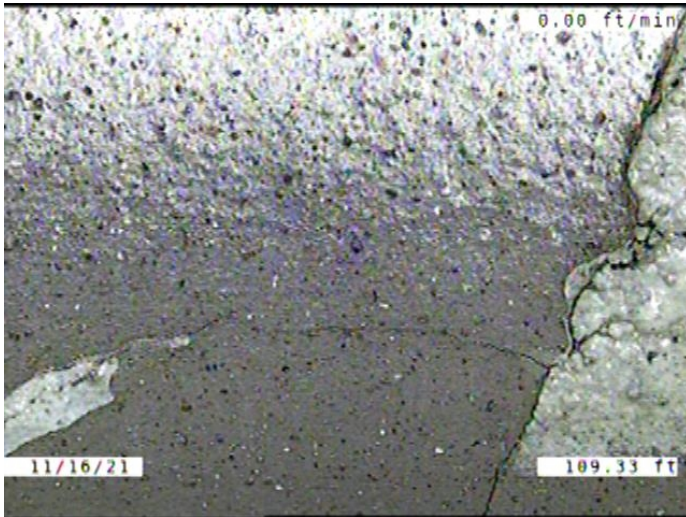
Code: **CM**
Description: **Crack Multiple**

Distance (ft): **109.3**
Structural Grade: **3**
O&M Grade: **0**
Clock Start/From: **11**
Clock To: **1**
1st Value:
2nd Value:
Value Percent:
Continuous Index:
Within 8" of Joint: **YES**
Remarks:

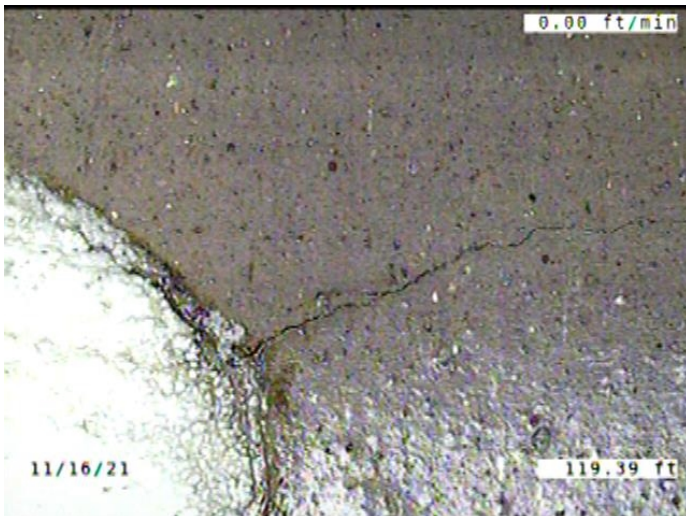
Code: **CM**
Description: **Crack Multiple**

Distance (ft): **119.4**
Structural Grade: **3**
O&M Grade: **0**
Clock Start/From: **10**
Clock To: **11**
1st Value:
2nd Value:
Value Percent:
Continuous Index:
Within 8" of Joint: **YES**
Remarks:

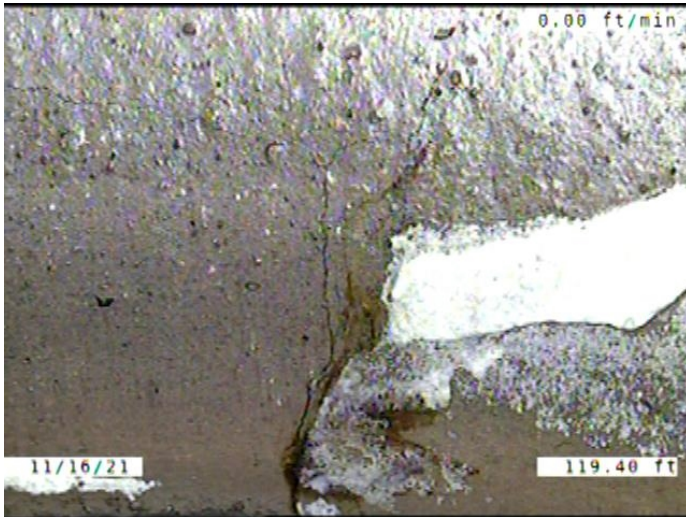
Code: **CM**
Description: **Crack Multiple**

Distance (ft): **119.4**
Structural Grade: **3**
O&M Grade: **0**
Clock Start/From: **1**
Clock To: **3**
1st Value:
2nd Value:
Value Percent:
Continuous Index:
Within 8" of Joint: **YES**
Remarks:

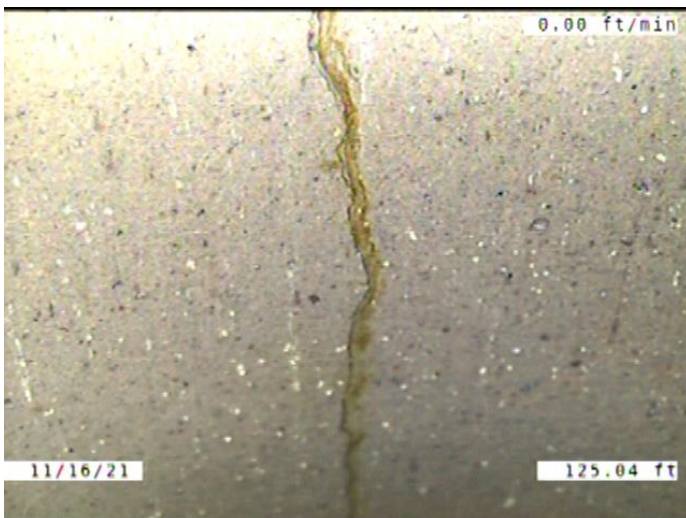
Code: **CL**
Description: **Crack Longitudinal**

Distance (ft): **125.0**
Structural Grade: **2**
O&M Grade: **0**
Clock Start/From: **9**
Clock To:
1st Value:
2nd Value:
Value Percent:
Continuous Index:
Within 8" of Joint: **YES**
Remarks:

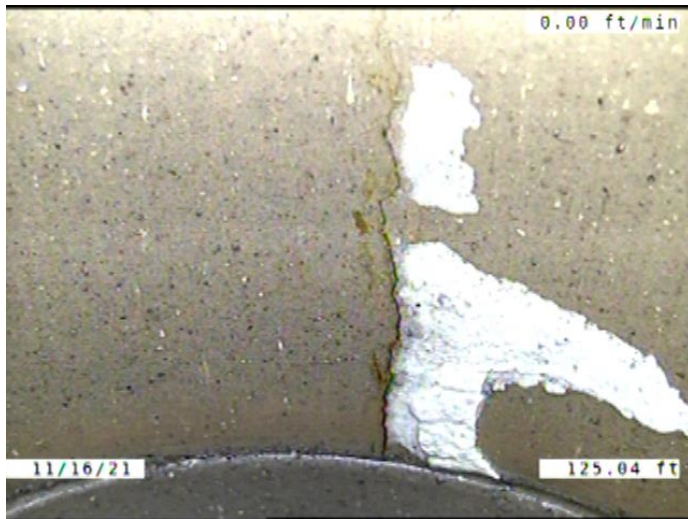
Code: **CL**
 Description: **Crack Longitudinal**

Distance (ft): **125.0**
 Structural Grade: **2**
 O&M Grade: **0**
 Clock Start/From: **1**
 Clock To:
 1st Value:
 2nd Value:
 Value Percent:
 Continuous Index:
 Within 8" of Joint: **YES**
 Remarks:

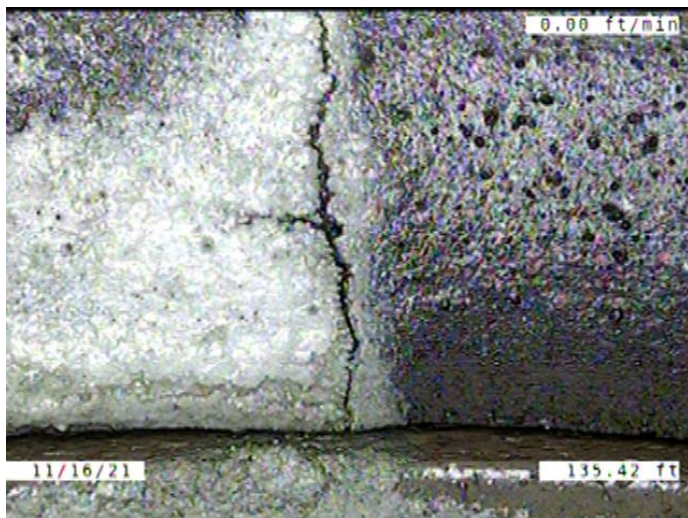
Code: **FL**
 Description: **Fracture Longitudinal**

Distance (ft): **135.4**
 Structural Grade: **3**
 O&M Grade: **0**
 Clock Start/From: **12**
 Clock To:
 1st Value:
 2nd Value:
 Value Percent:
 Continuous Index:
 Within 8" of Joint: **YES**
 Remarks:

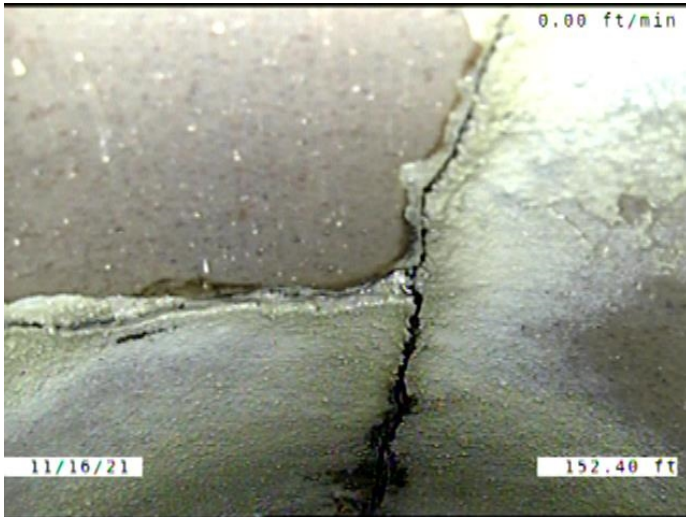
Code: **B**
Description: **Broken**

Distance (ft): **152.4**
Structural Grade: **4**
O&M Grade: **0**
Clock Start/From: **12**
Clock To: **12**
1st Value:
2nd Value:
Value Percent:
Continuous Index:
Within 8" of Joint: **YES**
Remarks:

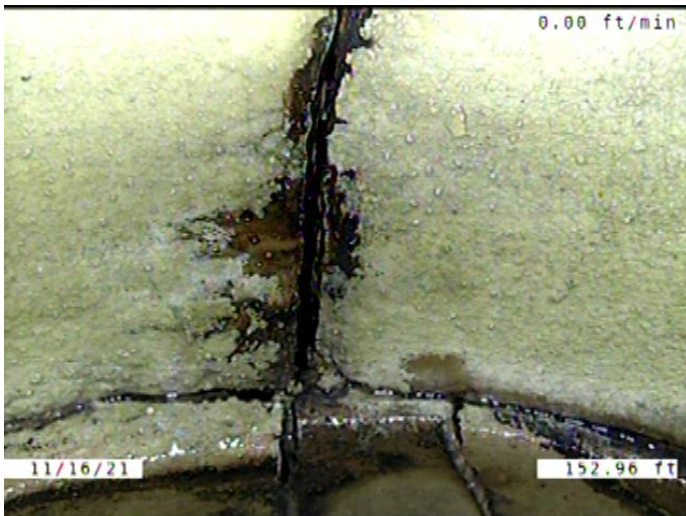
Code: **IDB**
Description: **Infiltration Dripper Barrel**

Distance (ft): **153.0**
Structural Grade: **0**
O&M Grade: **3**
Clock Start/From: **12**
Clock To:
1st Value:
2nd Value:
Value Percent:
Continuous Index:
Within 8" of Joint: **YES**
Remarks:

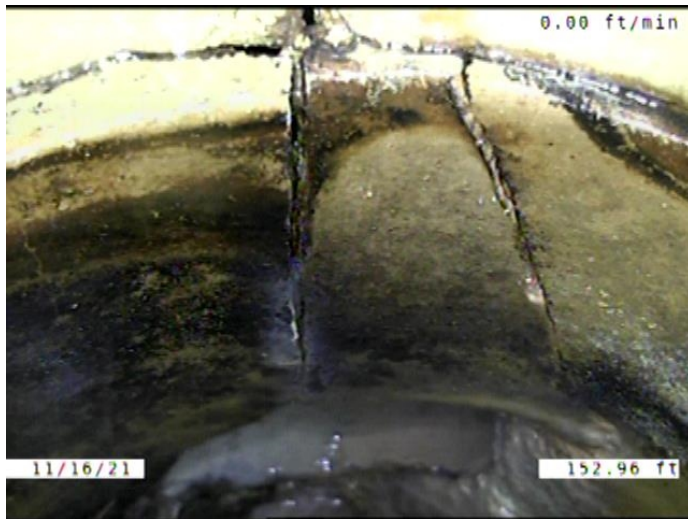
Code: **DR**
Description: **Deformed Rigid**

Distance (ft): **153.0**
Structural Grade: **4**
O&M Grade: **0**
Clock Start/From:
Clock To:
1st Value:
2nd Value:
Value Percent: **5.000**
Continuous Index:
Within 8" of Joint: **NO**
Remarks:

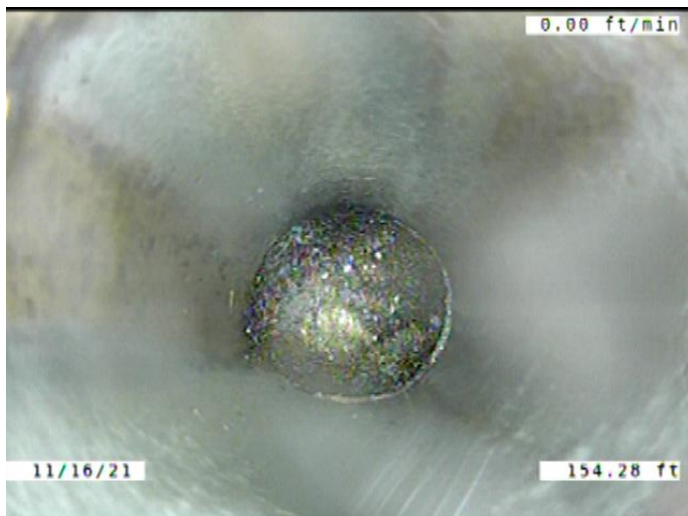
Code: **TBD**
Description: **Tap Break-in/Hammer Defective**

Distance (ft): **154.3**
Structural Grade: **0**
O&M Grade: **3**
Clock Start/From: **12**
Clock To:
1st Value: **4.000**
2nd Value:
Value Percent:
Continuous Index:
Within 8" of Joint: **YES**
Remarks: **CONSTANTLY RUNNING WATER.
LOOKS TO BE 95% PLUGGED WITH R**

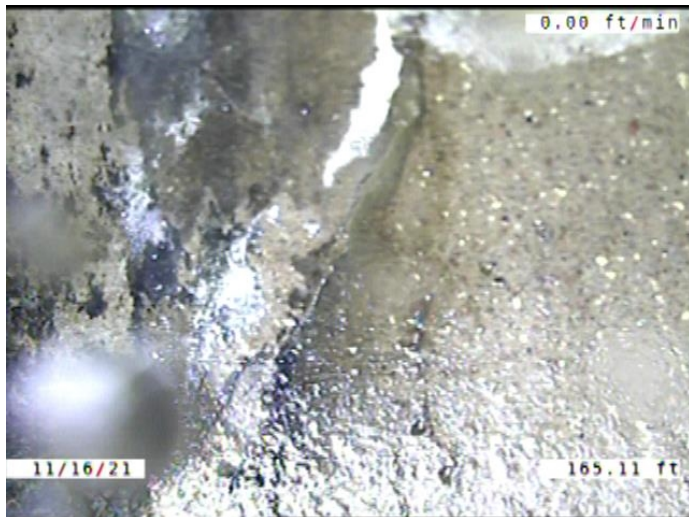
Code: **CM**
 Description: **Crack Multiple**

Distance (ft): **165.1**
 Structural Grade: **3**
 O&M Grade: **0**
 Clock Start/From: **4**
 Clock To: **5**
 1st Value:
 2nd Value:
 Value Percent:
 Continuous Index:
 Within 8" of Joint: **YES**
 Remarks:

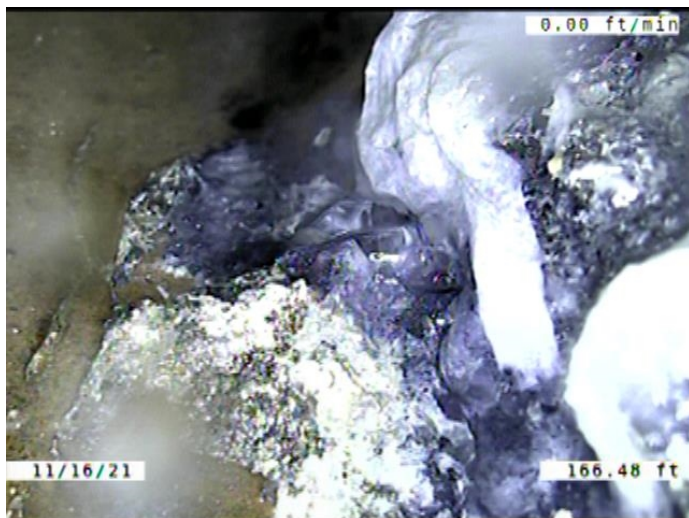
Code: **DSC**
 Description: **Deposits Settled Hard/Compacted**

Distance (ft): **166.5**
 Structural Grade: **0**
 O&M Grade: **2**
 Clock Start/From: **5**
 Clock To: **7**
 1st Value:
 2nd Value:
 Value Percent: **5.000**
 Continuous Index:
 Within 8" of Joint: **YES**
 Remarks:

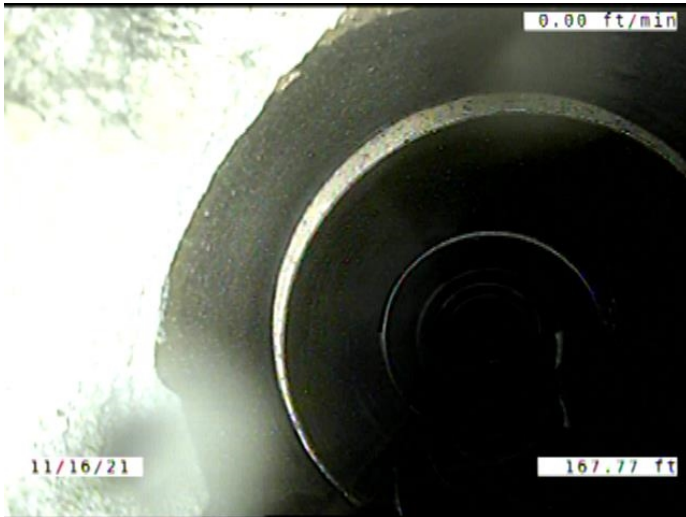
Code: **DAE**
Description: **Deposits Attached Encrustation**

Distance (ft): **167.8**
Structural Grade: **0**
O&M Grade: **2**
Clock Start/From: **8**
Clock To: **12**
1st Value:
2nd Value:
Value Percent: **5.000**
Continuous Index: **F02**
Within 8" of Joint: **YES**
Remarks:

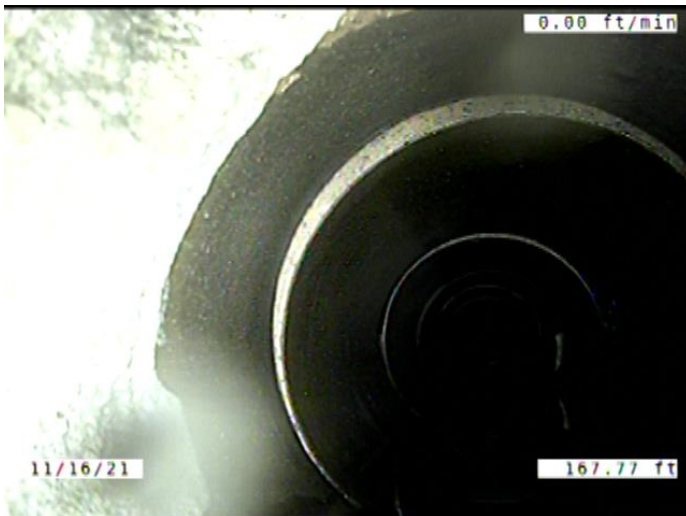
Code: **DAE**
Description: **Deposits Attached Encrustation**

Distance (ft): **167.8**
Structural Grade: **0**
O&M Grade: **2**
Clock Start/From: **1**
Clock To: **5**
1st Value:
2nd Value:
Value Percent: **5.000**
Continuous Index: **F01**
Within 8" of Joint: **YES**
Remarks:
