# Profile/Photo Observation Report

Date:	11/16/2021	Weather:		Coding:	PACP 7.0
Pipe Length (ft):	167.8	Owner:	City of Hobart	Pre Clean:	Light Cleaning
P.O.#:	YES502259	Surveyor:	S. Bucklin	PSR:	P-605-019-072
Customer:	City of Hobart	Clean Date:	11/16/2021	Shape:	C

Street:	Court Street	Flow Control:	Not Controlled
City:	Hobart, IN	Year Renewed:	
Location:	Local rural streets with light traffic, t	Tape/Media #:	
Purpose:	Routine Assessment	Dia/Height:	10"
Use:	Sanitary Sewage Pipe	Material:	VCP
Drain Area:		Lining:	None
Category:	NA		
Comment:			
Location Details:		Direction of Survey:	Upstream
US MH:	M-605-072	DS MH:	M-605-019
		Total Length Surveyed (ft):	167.8

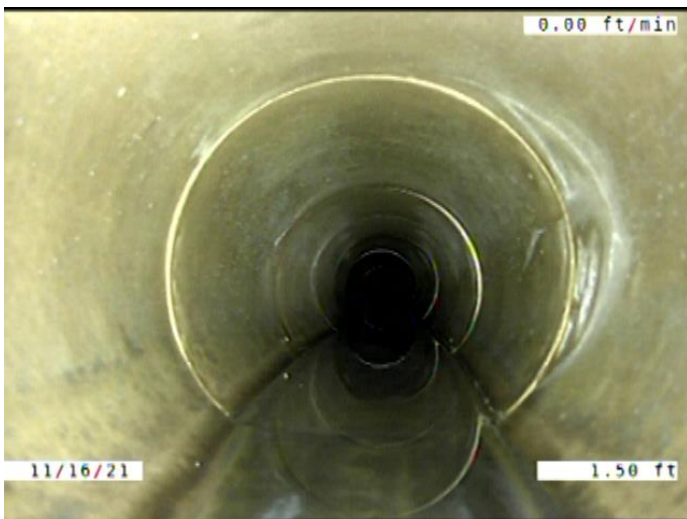
Code: **MGO**  
Description: **Miscellaneous General Observation**

Distance (ft): **1.5**  
Structural Grade: **0**  
O&M Grade: **0**  
Clock Start/From:  
Clock To:  
1st Value:  
2nd Value:  
Value Percent:  
Continuous Index:  
Within 8" of Joint: **NO**  
Remarks: **DROP INTO THE MANHOLE. HAD TO START IN THE PIPE.**

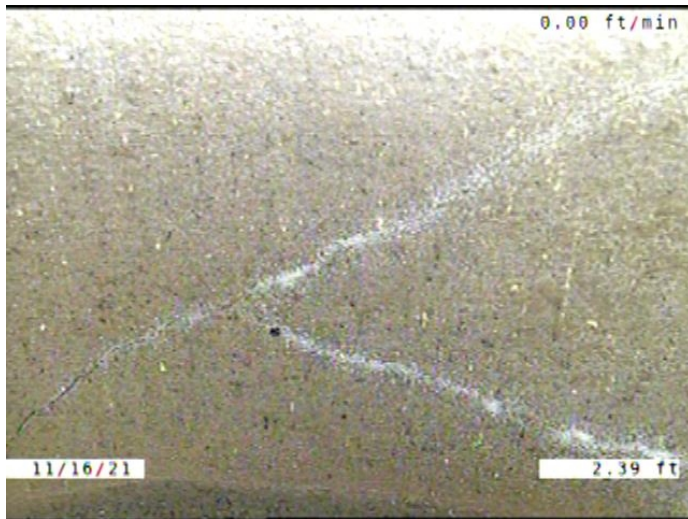
Code: **CM**  
Description: **Crack Multiple**

Distance (ft): **2.4**  
Structural Grade: **3**  
O&M Grade: **0**  
Clock Start/From: **10**  
Clock To: **4**  
1st Value:  
2nd Value:  
Value Percent:  
Continuous Index:  
Within 8" of Joint: **YES**  
Remarks:

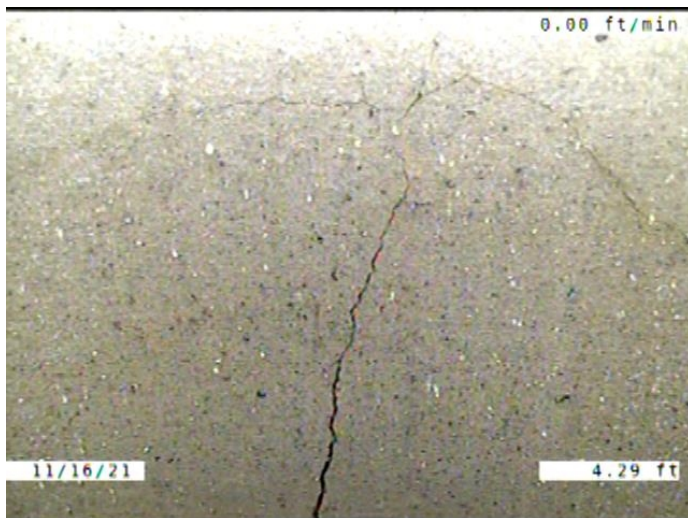
Code: **FM**  
Description: **Fracture Multiple**

Distance (ft): **4.3**  
Structural Grade: **4**  
O&M Grade: **0**  
Clock Start/From: **9**  
Clock To: **3**  
1st Value:  
2nd Value:  
Value Percent:  
Continuous Index:  
Within 8" of Joint: **YES**  
Remarks:

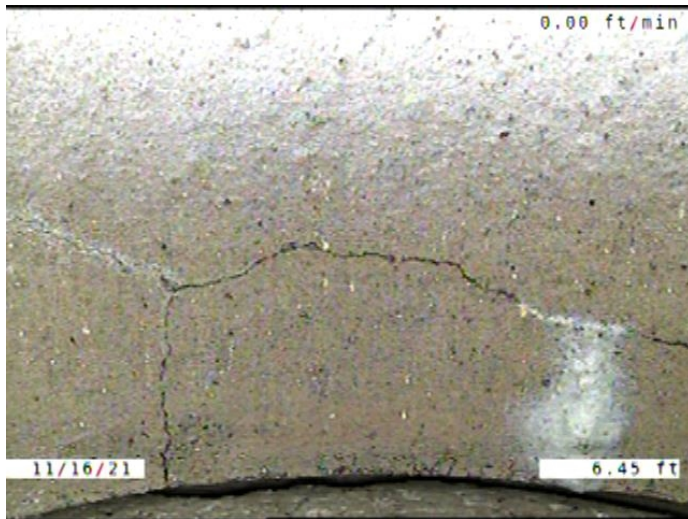
Code: **CM**  
Description: **Crack Multiple**

Distance (ft): **6.5**  
Structural Grade: **3**  
O&M Grade: **0**  
Clock Start/From: **9**  
Clock To: **3**  
1st Value:  
2nd Value:  
Value Percent:  
Continuous Index:  
Within 8" of Joint: **YES**  
Remarks:

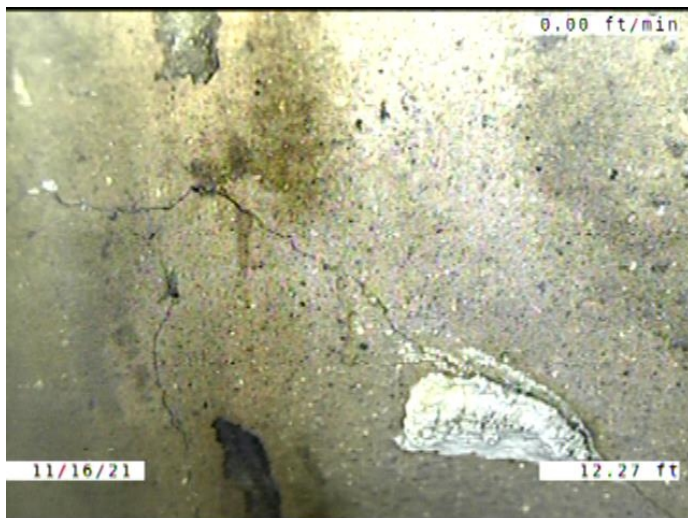
Code: **CM**  
Description: **Crack Multiple**

Distance (ft): **12.3**  
Structural Grade: **3**  
O&M Grade: **0**  
Clock Start/From: **2**  
Clock To: **10**  
1st Value:  
2nd Value:  
Value Percent:  
Continuous Index:  
Within 8" of Joint: **YES**  
Remarks:

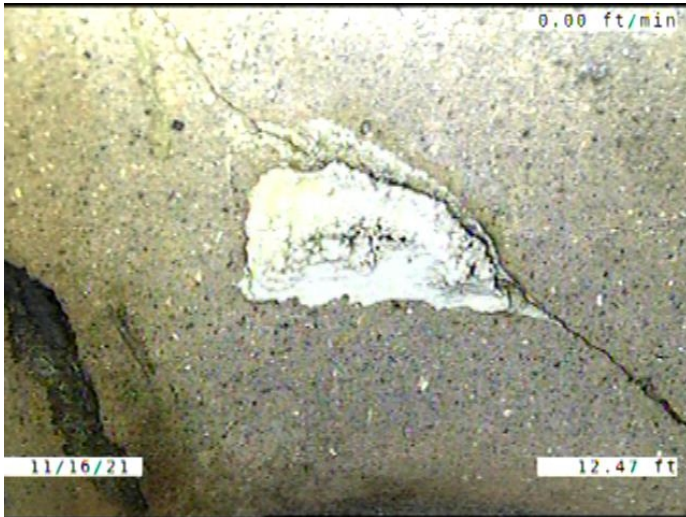
Code: **DAE**  
 Description: **Deposits Attached Encrustation**

Distance (ft): **12.5**  
 Structural Grade: **0**  
 O&M Grade: **2**  
 Clock Start/From: **8**  
 Clock To: **9**  
 1st Value:  
 2nd Value:  
 Value Percent: **5.000**  
 Continuous Index:  
 Within 8" of Joint: **NO**  
 Remarks:

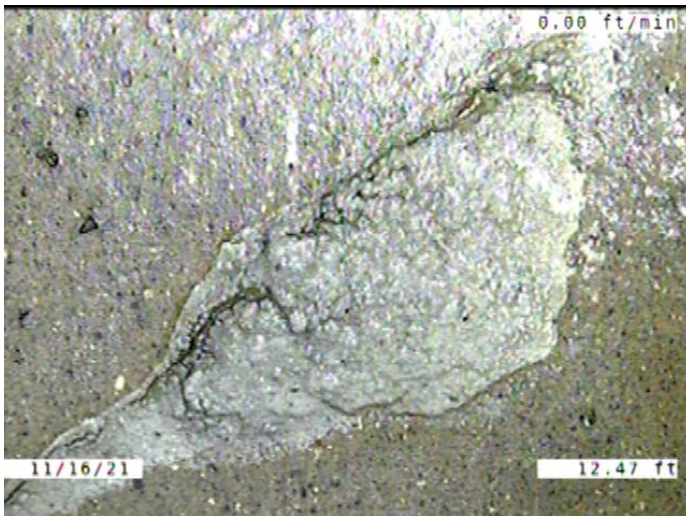
Code: **DAE**  
 Description: **Deposits Attached Encrustation**

Distance (ft): **12.5**  
 Structural Grade: **0**  
 O&M Grade: **2**  
 Clock Start/From: **3**  
 Clock To: **4**  
 1st Value:  
 2nd Value:  
 Value Percent: **5.000**  
 Continuous Index:  
 Within 8" of Joint: **YES**  
 Remarks:

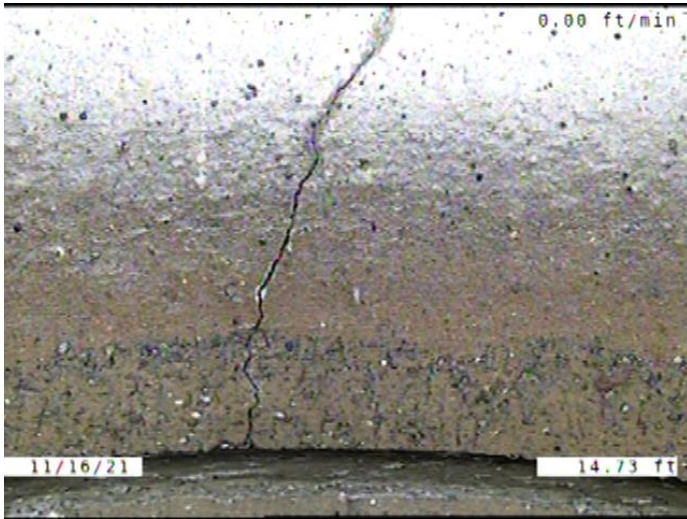
Code: **CM**  
Description: **Crack Multiple**

Distance (ft): **14.7**  
Structural Grade: **3**  
O&M Grade: **0**  
Clock Start/From: **12**  
Clock To: **2**  
1st Value:  
2nd Value:  
Value Percent:  
Continuous Index:  
Within 8" of Joint: **YES**  
Remarks:

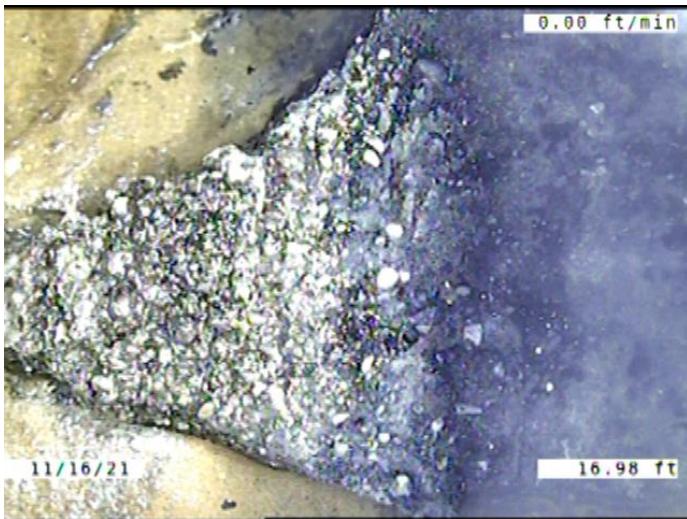
Code: **DAE**  
Description: **Deposits Attached Encrustation**

Distance (ft): **17.0**  
Structural Grade: **0**  
O&M Grade: **2**  
Clock Start/From: **3**  
Clock To: **9**  
1st Value:  
2nd Value:  
Value Percent: **5.000**  
Continuous Index:  
Within 8" of Joint: **YES**  
Remarks:

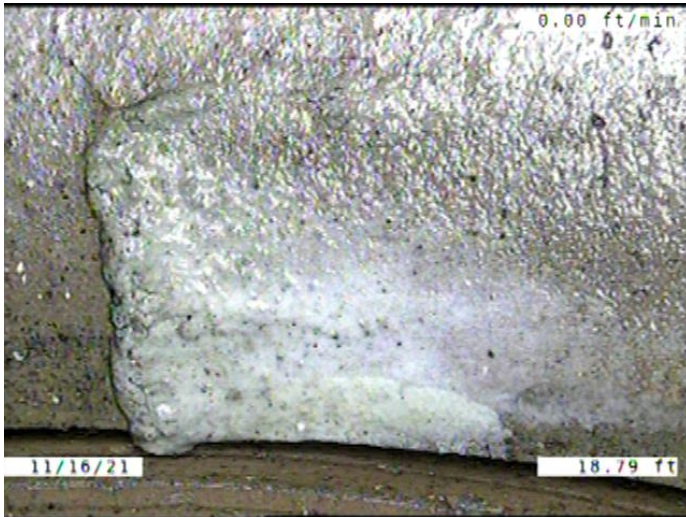
Code: **DAE**  
 Description: **Deposits Attached Encrustation**

Distance (ft): **18.8**  
 Structural Grade: **0**  
 O&M Grade: **2**  
 Clock Start/From: **1**  
 Clock To: **3**  
 1st Value:  
 2nd Value:  
 Value Percent: **5.000**  
 Continuous Index:  
 Within 8" of Joint: **YES**  
 Remarks:

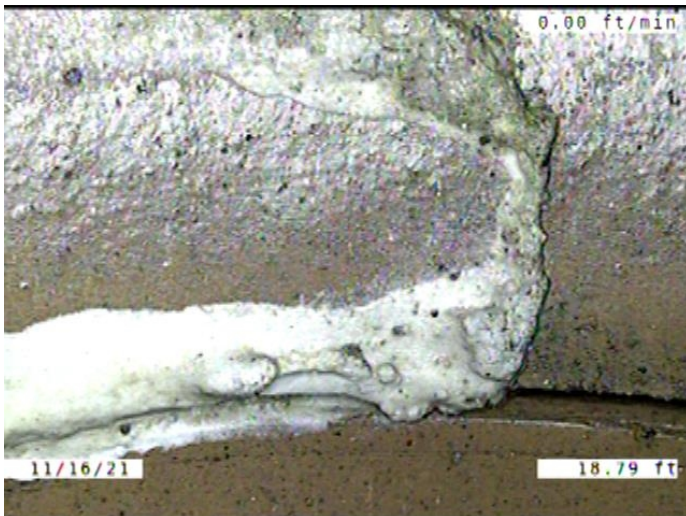
Code: **DAE**  
 Description: **Deposits Attached Encrustation**

Distance (ft): **18.8**  
 Structural Grade: **0**  
 O&M Grade: **2**  
 Clock Start/From: **9**  
 Clock To: **11**  
 1st Value:  
 2nd Value:  
 Value Percent: **5.000**  
 Continuous Index:  
 Within 8" of Joint: **YES**  
 Remarks:

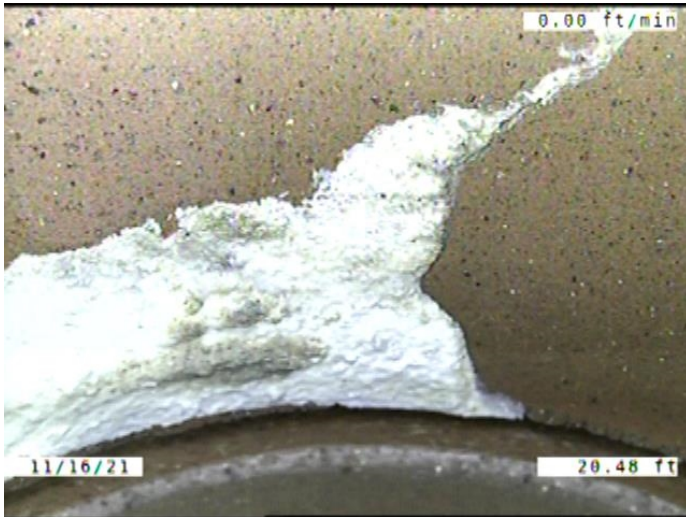
Code: **DAE**  
 Description: **Deposits Attached Encrustation**

Distance (ft): **20.5**  
 Structural Grade: **0**  
 O&M Grade: **2**  
 Clock Start/From: **8**  
 Clock To: **12**  
 1st Value:  
 2nd Value:  
 Value Percent: **5.000**  
 Continuous Index: **S02**  
 Within 8" of Joint: **YES**  
 Remarks:

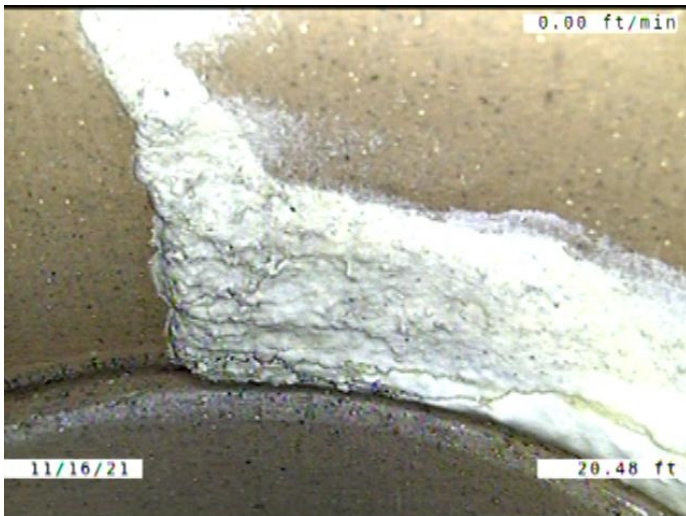
Code: **DAE**  
 Description: **Deposits Attached Encrustation**

Distance (ft): **20.5**  
 Structural Grade: **0**  
 O&M Grade: **2**  
 Clock Start/From: **1**  
 Clock To: **5**  
 1st Value:  
 2nd Value:  
 Value Percent: **5.000**  
 Continuous Index: **S01**  
 Within 8" of Joint: **YES**  
 Remarks:

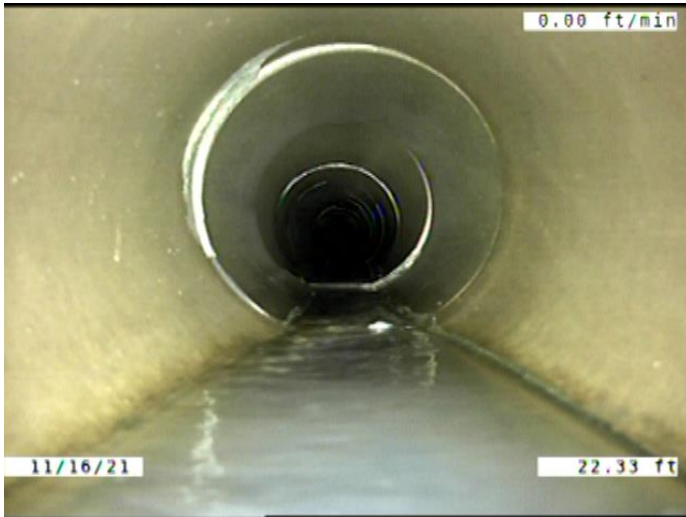
Code: **MWLS**  
 Description: **Miscellaneous Water Level Sag**

Distance (ft): **22.3**  
 Structural Grade: **2**  
 O&M Grade: **0**  
 Clock Start/From:  
 Clock To:  
 1st Value:  
 2nd Value:  
 Value Percent: **5.000**  
 Continuous Index:  
 Within 8" of Joint: **NO**  
 Remarks:

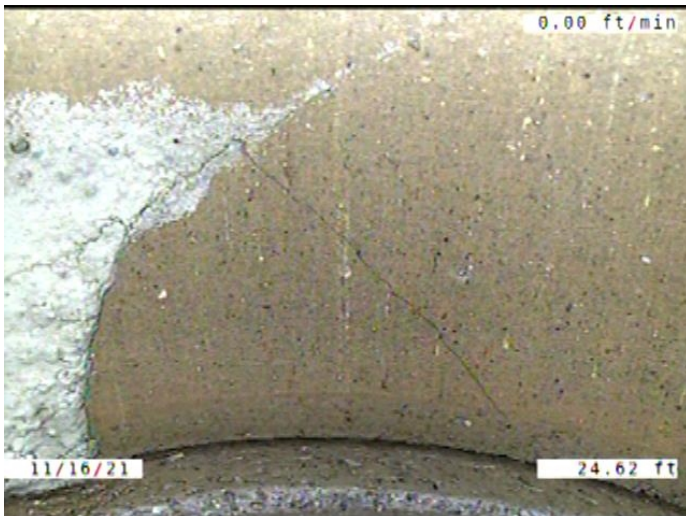
Code: **CM**  
 Description: **Crack Multiple**

Distance (ft): **24.6**  
 Structural Grade: **3**  
 O&M Grade: **0**  
 Clock Start/From: **11**  
 Clock To: **12**  
 1st Value:  
 2nd Value:  
 Value Percent:  
 Continuous Index:  
 Within 8" of Joint: **YES**  
 Remarks:

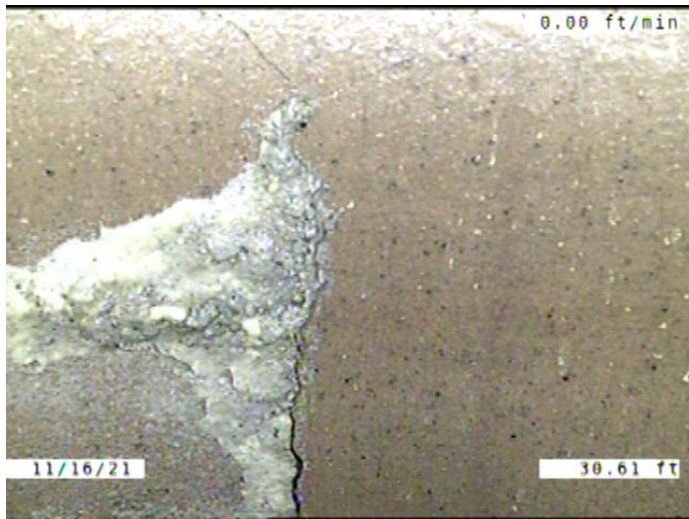
Code: **FM**  
 Description: **Fracture Multiple**

Distance (ft): **30.6**  
 Structural Grade: **4**  
 O&M Grade: **0**  
 Clock Start/From: **10**  
 Clock To: **2**  
 1st Value:  
 2nd Value:  
 Value Percent:  
 Continuous Index:  
 Within 8" of Joint: **YES**  
 Remarks:

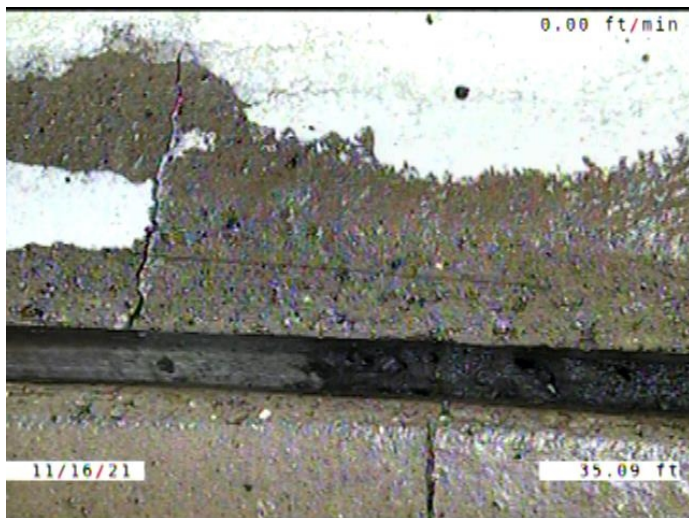
Code: **FM**  
 Description: **Fracture Multiple**

Distance (ft): **35.1**  
 Structural Grade: **4**  
 O&M Grade: **0**  
 Clock Start/From: **1**  
 Clock To: **4**  
 1st Value:  
 2nd Value:  
 Value Percent:  
 Continuous Index:  
 Within 8" of Joint: **YES**  
 Remarks:

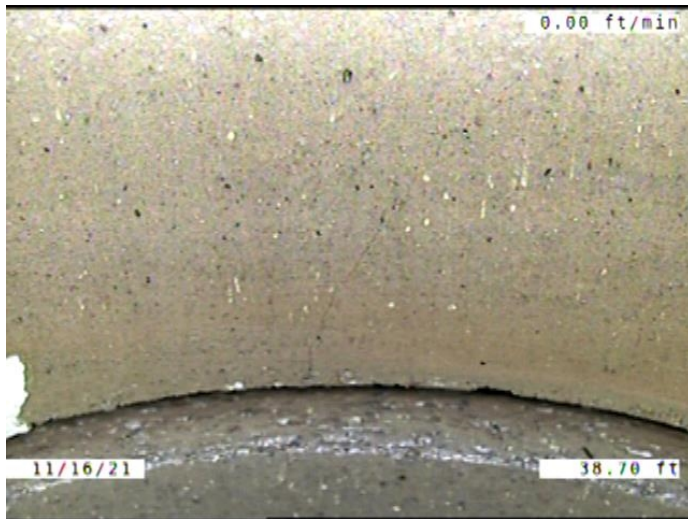
Code: **CL**  
 Description: **Crack Longitudinal**

Distance (ft): **38.7**  
 Structural Grade: **2**  
 O&M Grade: **0**  
 Clock Start/From: **12**  
 Clock To:  
 1st Value:  
 2nd Value:  
 Value Percent:  
 Continuous Index:  
 Within 8" of Joint: **YES**  
 Remarks:

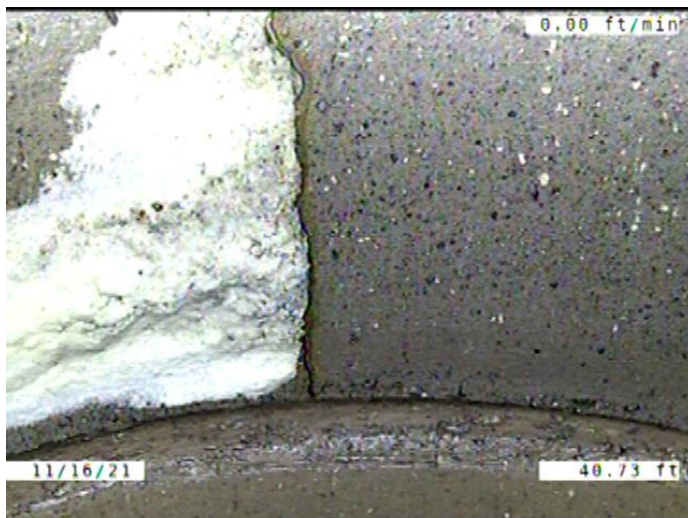
Code: **CL**  
 Description: **Crack Longitudinal**

Distance (ft): **40.7**  
 Structural Grade: **2**  
 O&M Grade: **0**  
 Clock Start/From: **11**  
 Clock To:  
 1st Value:  
 2nd Value:  
 Value Percent:  
 Continuous Index:  
 Within 8" of Joint: **NO**  
 Remarks:

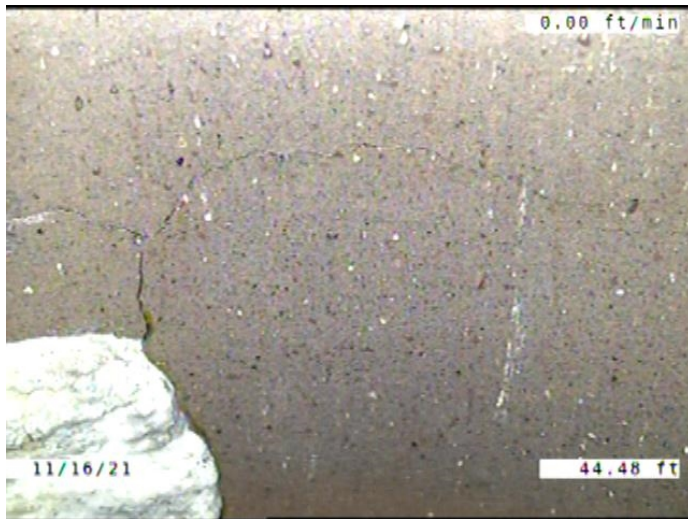
Code: **CM**  
 Description: **Crack Multiple**

Distance (ft): **44.5**  
 Structural Grade: **3**  
 O&M Grade: **0**  
 Clock Start/From: **11**  
 Clock To: **2**  
 1st Value:  
 2nd Value:  
 Value Percent:  
 Continuous Index:  
 Within 8" of Joint: **YES**  
 Remarks:

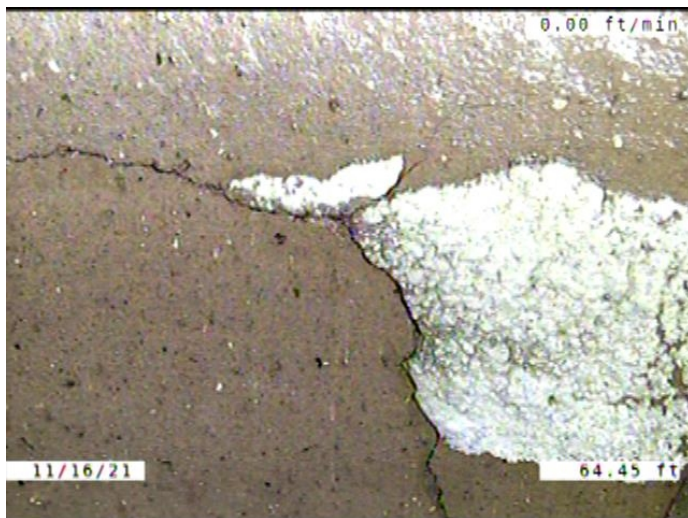
Code: **CM**  
 Description: **Crack Multiple**

Distance (ft): **64.5**  
 Structural Grade: **3**  
 O&M Grade: **0**  
 Clock Start/From: **11**  
 Clock To: **5**  
 1st Value:  
 2nd Value:  
 Value Percent:  
 Continuous Index:  
 Within 8" of Joint: **YES**  
 Remarks:

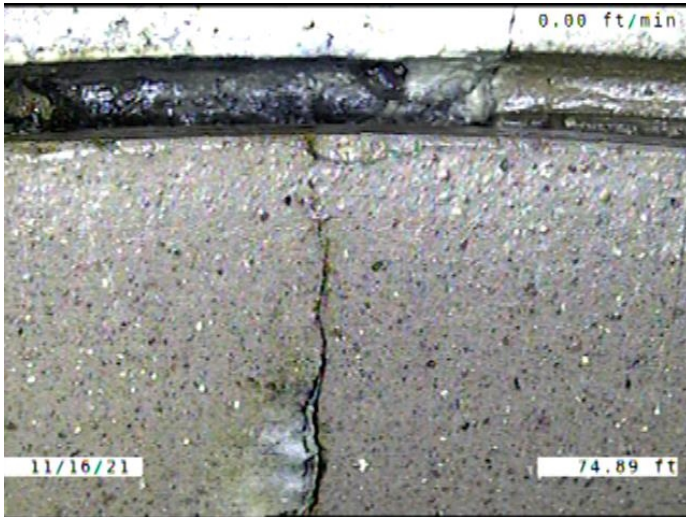
Code: **CM**  
Description: **Crack Multiple**

Distance (ft): **74.9**  
Structural Grade: **3**  
O&M Grade: **0**  
Clock Start/From: **10**  
Clock To: **11**  
1st Value:  
2nd Value:  
Value Percent:  
Continuous Index:  
Within 8" of Joint: **YES**  
Remarks:

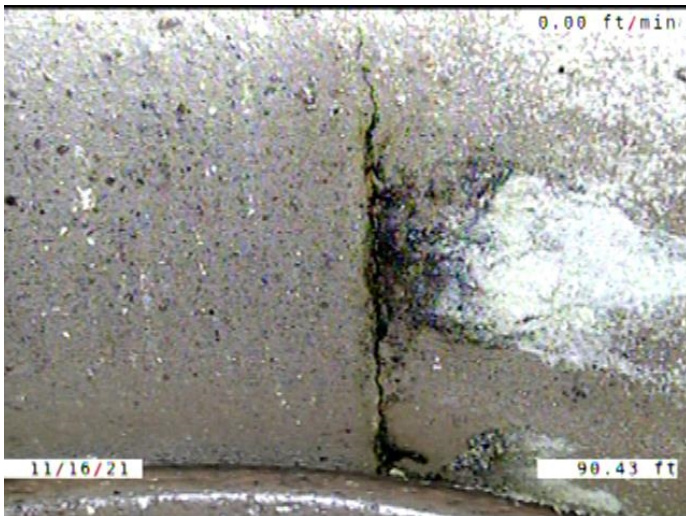
Code: **CL**  
Description: **Crack Longitudinal**

Distance (ft): **90.4**  
Structural Grade: **2**  
O&M Grade: **0**  
Clock Start/From: **1**  
Clock To:  
1st Value:  
2nd Value:  
Value Percent:  
Continuous Index:  
Within 8" of Joint: **YES**  
Remarks:

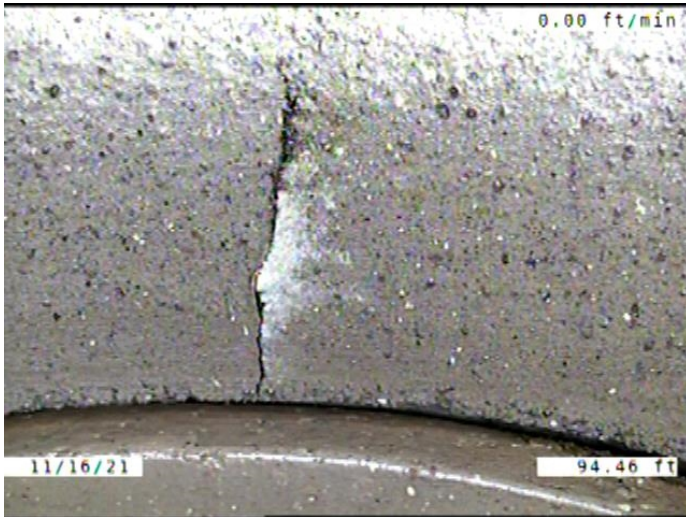
Code: **CL**  
 Description: **Crack Longitudinal**

Distance (ft): **94.5**  
 Structural Grade: **2**  
 O&M Grade: **0**  
 Clock Start/From: **1**  
 Clock To:  
 1st Value:  
 2nd Value:  
 Value Percent:  
 Continuous Index:  
 Within 8" of Joint: **YES**  
 Remarks:

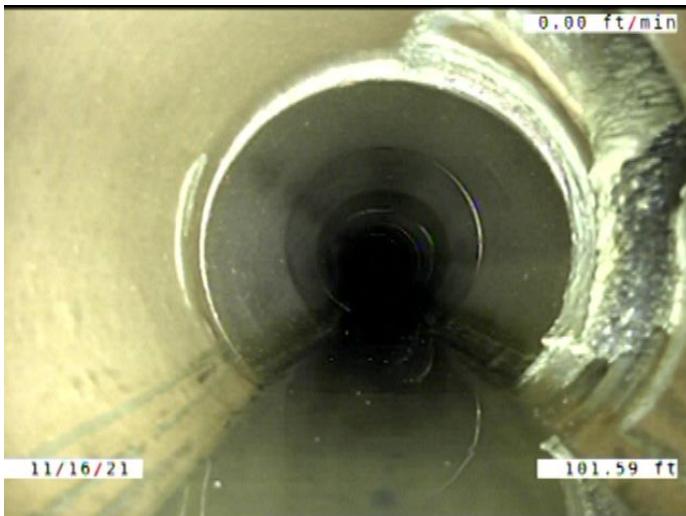
Code: **MWLS**  
 Description: **Miscellaneous Water Level Sag**

Distance (ft): **101.6**  
 Structural Grade: **2**  
 O&M Grade: **0**  
 Clock Start/From:  
 Clock To:  
 1st Value:  
 2nd Value:  
 Value Percent: **5.000**  
 Continuous Index:  
 Within 8" of Joint: **NO**  
 Remarks:

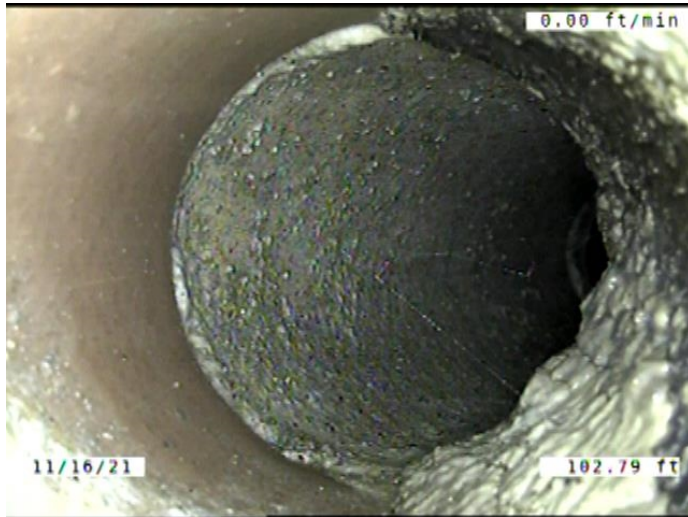
Code:	<b>TFD</b>
Description:	<b>Tap Factory Defective</b>
Distance (ft):	<b>102.8</b>
Structural Grade:	<b>0</b>
O&M Grade:	<b>3</b>
Clock Start/From:	<b>1</b>
Clock To:	
1st Value:	<b>4.000</b>
2nd Value:	
Value Percent:	
Continuous Index:	
Within 8" of Joint:	<b>YES</b>
Remarks:	<b>ENCRUSTATION IN THE TAP AND COMING INTO THE MAIN</b>

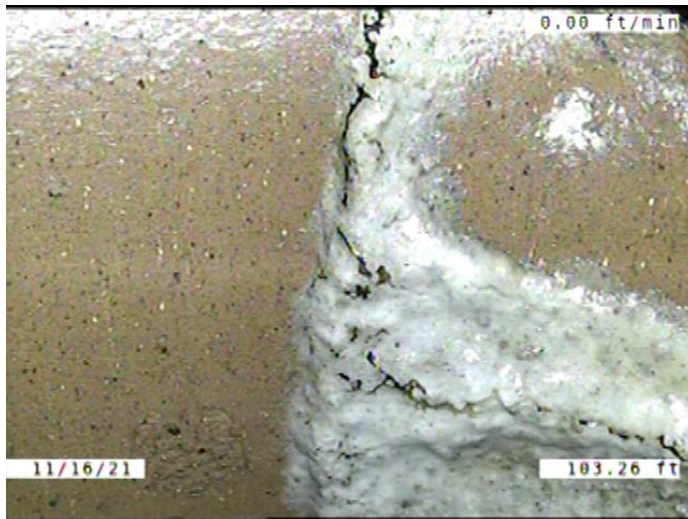
Code:	<b>CM</b>
Description:	<b>Crack Multiple</b>
Distance (ft):	<b>103.3</b>
Structural Grade:	<b>3</b>
O&M Grade:	<b>0</b>
Clock Start/From:	<b>12</b>
Clock To:	<b>3</b>
1st Value:	
2nd Value:	
Value Percent:	
Continuous Index:	
Within 8" of Joint:	<b>YES</b>
Remarks:

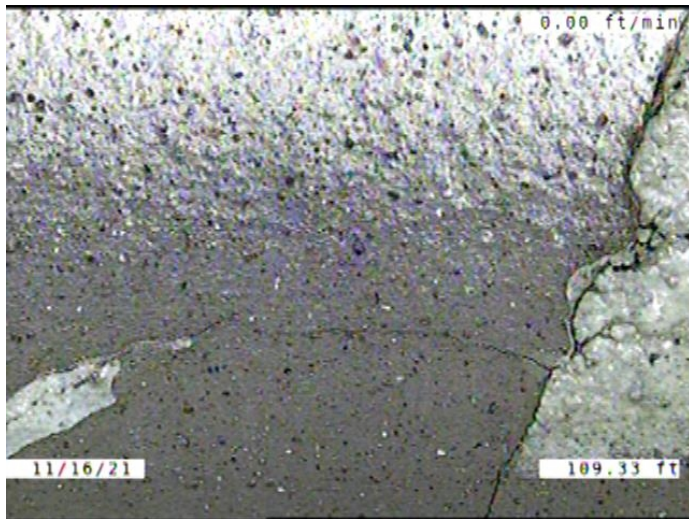
Code: **CM**  
 Description: **Crack Multiple**

Distance (ft): **109.3**  
 Structural Grade: **3**  
 O&M Grade: **0**  
 Clock Start/From: **11**  
 Clock To: **1**  
 1st Value:  
 2nd Value:  
 Value Percent:  
 Continuous Index:  
 Within 8" of Joint: **YES**  
 Remarks:

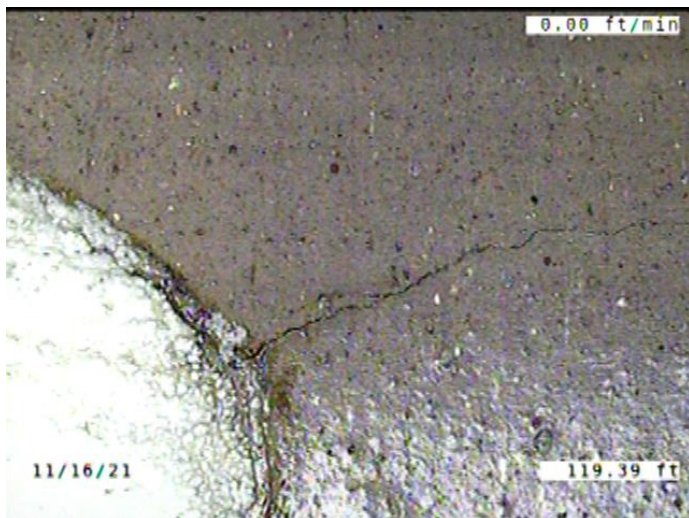
Code: **CM**  
 Description: **Crack Multiple**

Distance (ft): **119.4**  
 Structural Grade: **3**  
 O&M Grade: **0**  
 Clock Start/From: **10**  
 Clock To: **11**  
 1st Value:  
 2nd Value:  
 Value Percent:  
 Continuous Index:  
 Within 8" of Joint: **YES**  
 Remarks:

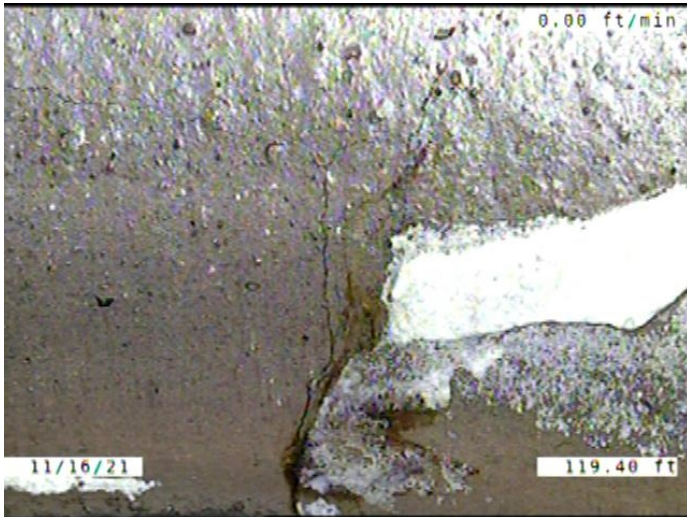
Code: **CM**  
Description: **Crack Multiple**

Distance (ft): **119.4**  
Structural Grade: **3**  
O&M Grade: **0**  
Clock Start/From: **1**  
Clock To: **3**  
1st Value:  
2nd Value:  
Value Percent:  
Continuous Index:  
Within 8" of Joint: **YES**  
Remarks:

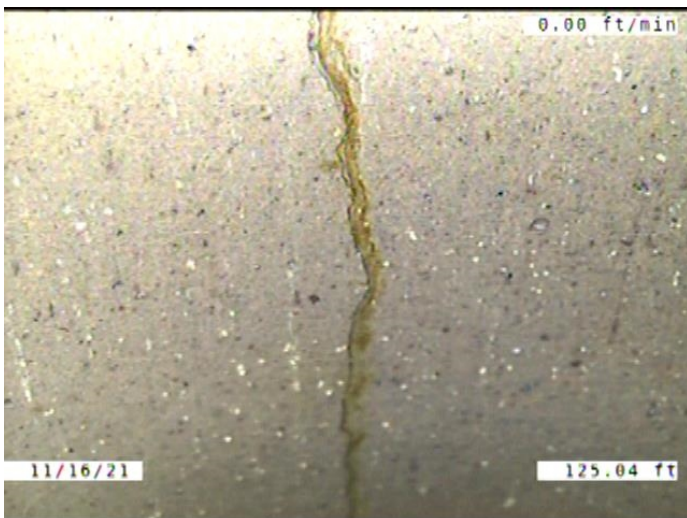
Code: **CL**  
Description: **Crack Longitudinal**

Distance (ft): **125.0**  
Structural Grade: **2**  
O&M Grade: **0**  
Clock Start/From: **9**  
Clock To:  
1st Value:  
2nd Value:  
Value Percent:  
Continuous Index:  
Within 8" of Joint: **YES**  
Remarks:

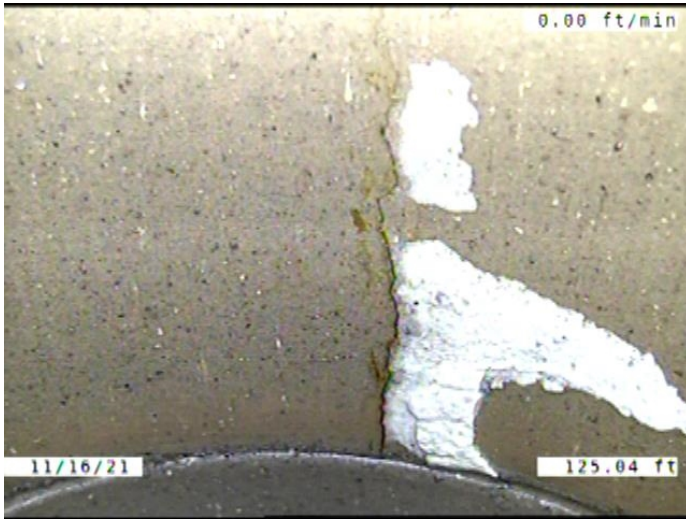
Code: **CL**  
Description: **Crack Longitudinal**

Distance (ft): **125.0**  
Structural Grade: **2**  
O&M Grade: **0**  
Clock Start/From: **1**  
Clock To:  
1st Value:  
2nd Value:  
Value Percent:  
Continuous Index:  
Within 8" of Joint: **YES**  
Remarks:

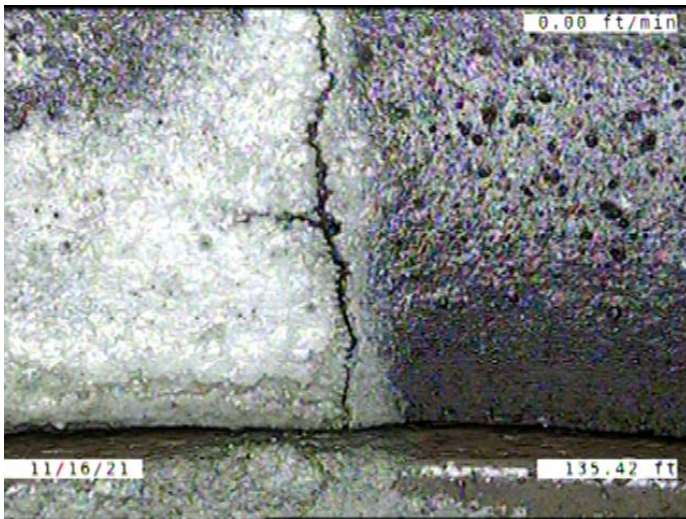
Code: **FL**  
Description: **Fracture Longitudinal**

Distance (ft): **135.4**  
Structural Grade: **3**  
O&M Grade: **0**  
Clock Start/From: **12**  
Clock To:  
1st Value:  
2nd Value:  
Value Percent:  
Continuous Index:  
Within 8" of Joint: **YES**  
Remarks:

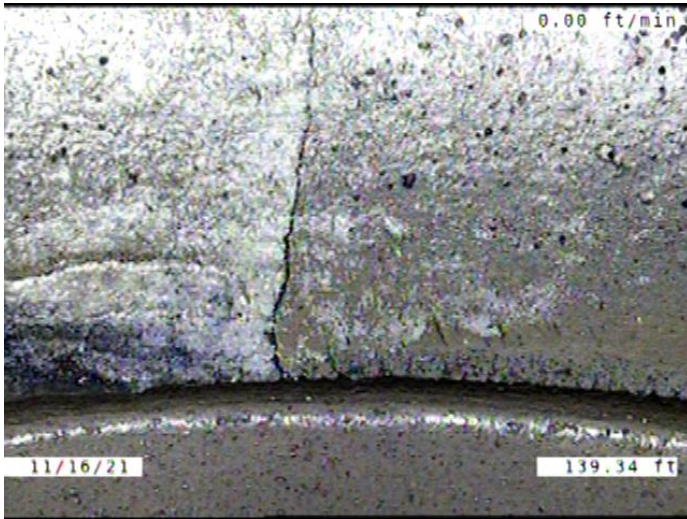
Code: **FM**  
Description: **Fracture Multiple**

Distance (ft): **139.3**  
Structural Grade: **4**  
O&M Grade: **0**  
Clock Start/From: **9**  
Clock To: **11**  
1st Value:  
2nd Value:  
Value Percent:  
Continuous Index:  
Within 8" of Joint: **YES**  
Remarks:

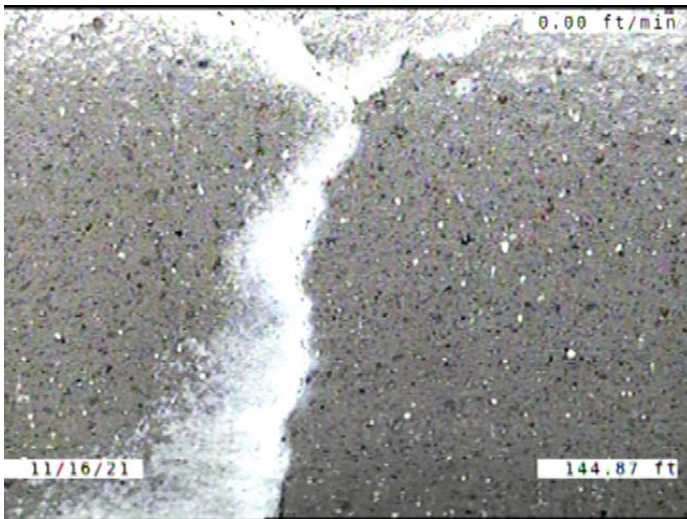
Code: **CM**  
Description: **Crack Multiple**

Distance (ft): **144.9**  
Structural Grade: **3**  
O&M Grade: **0**  
Clock Start/From: **10**  
Clock To: **12**  
1st Value:  
2nd Value:  
Value Percent:  
Continuous Index:  
Within 8" of Joint: **YES**  
Remarks:

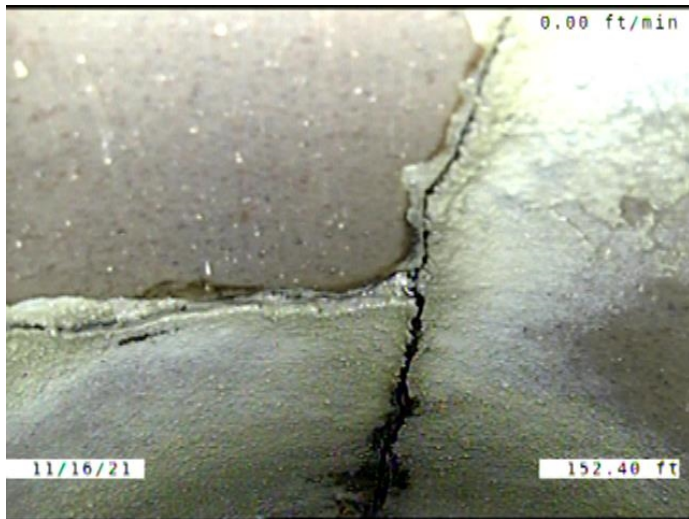
Code: **B**  
Description: **Broken**

Distance (ft): **152.4**  
Structural Grade: **4**  
O&M Grade: **0**  
Clock Start/From: **12**  
Clock To: **12**  
1st Value:  
2nd Value:  
Value Percent:  
Continuous Index:  
Within 8" of Joint: **YES**  
Remarks:

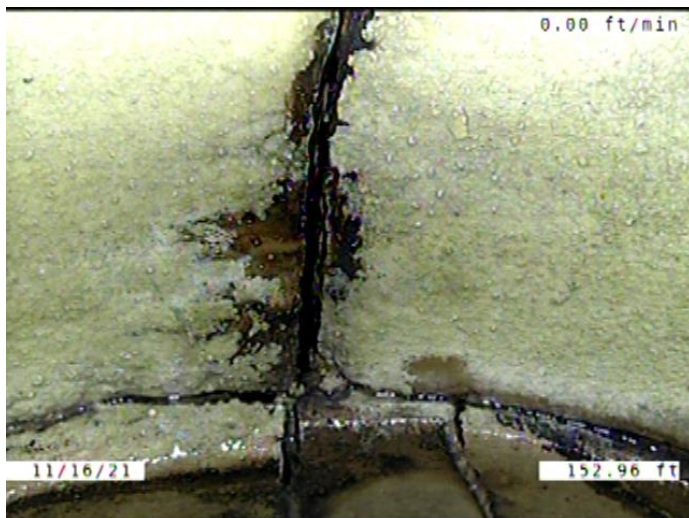
Code: **IDB**  
Description: **Infiltration Dripper Barrel**

Distance (ft): **153.0**  
Structural Grade: **0**  
O&M Grade: **3**  
Clock Start/From: **12**  
Clock To:  
1st Value:  
2nd Value:  
Value Percent:  
Continuous Index:  
Within 8" of Joint: **YES**  
Remarks:

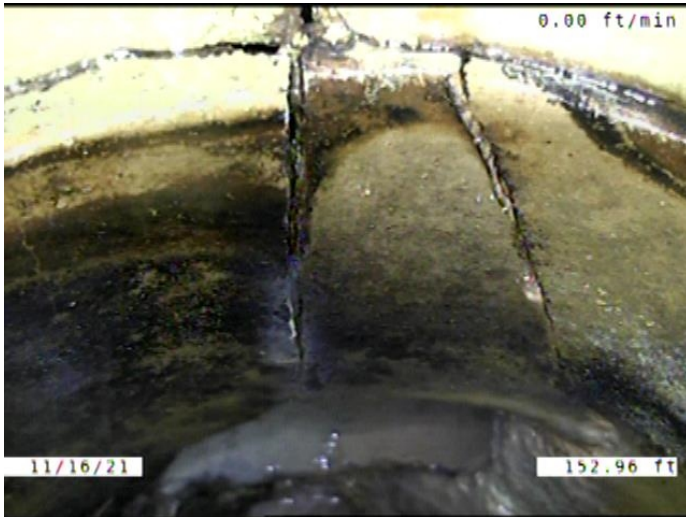
Code: **DR**  
 Description: **Deformed Rigid**

Distance (ft): **153.0**  
 Structural Grade: **4**  
 O&M Grade: **0**  
 Clock Start/From:  
 Clock To:  
 1st Value:  
 2nd Value:  
 Value Percent: **5.000**  
 Continuous Index:  
 Within 8" of Joint: **NO**  
 Remarks:

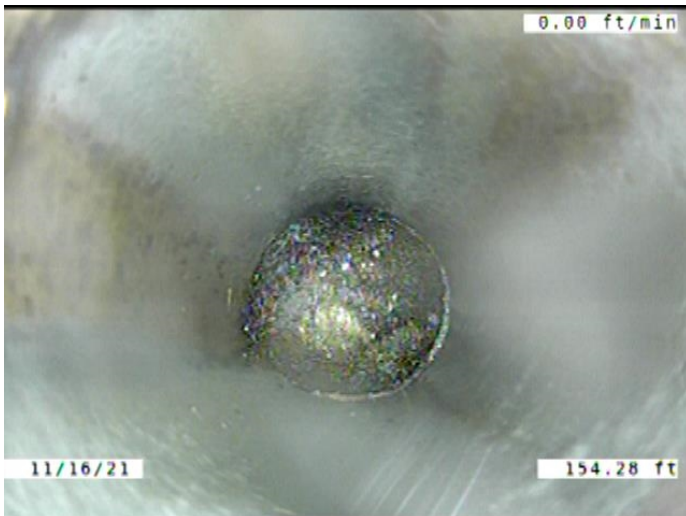
Code: **TBD**  
 Description: **Tap Break-in/Hammer Defective**

Distance (ft): **154.3**  
 Structural Grade: **0**  
 O&M Grade: **3**  
 Clock Start/From: **12**  
 Clock To:  
 1st Value: **4.000**  
 2nd Value:  
 Value Percent:  
 Continuous Index:  
 Within 8" of Joint: **YES**  
 Remarks: **CONSTANTLY RUNNING WATER.  
 LOOKS TO BE 95% PLUGGED WITH R**

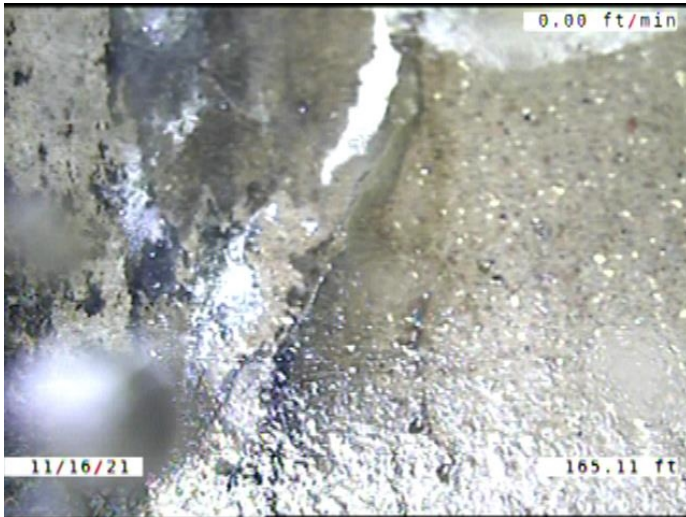
Code: **CM**  
 Description: **Crack Multiple**

Distance (ft): **165.1**  
 Structural Grade: **3**  
 O&M Grade: **0**  
 Clock Start/From: **4**  
 Clock To: **5**  
 1st Value:  
 2nd Value:  
 Value Percent:  
 Continuous Index:  
 Within 8" of Joint: **YES**  
 Remarks:

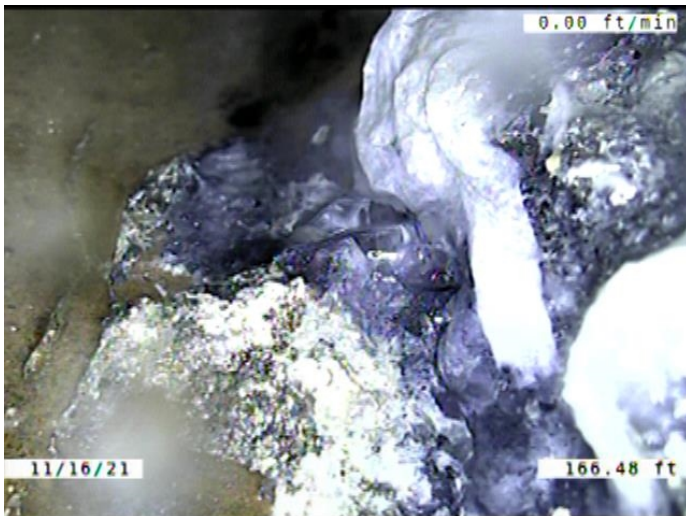
Code: **DSC**  
 Description: **Deposits Settled Hard/Compacted**

Distance (ft): **166.5**  
 Structural Grade: **0**  
 O&M Grade: **2**  
 Clock Start/From: **5**  
 Clock To: **7**  
 1st Value:  
 2nd Value:  
 Value Percent: **5.000**  
 Continuous Index:  
 Within 8" of Joint: **YES**  
 Remarks:

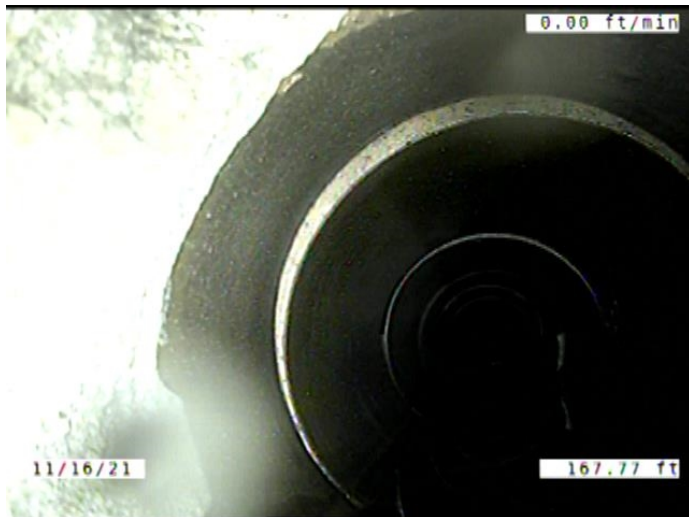
Code: **DAE**  
Description: **Deposits Attached Encrustation**

Distance (ft): **167.8**  
Structural Grade: **0**  
O&M Grade: **2**  
Clock Start/From: **8**  
Clock To: **12**  
1st Value:  
2nd Value:  
Value Percent: **5.000**  
Continuous Index: **F02**  
Within 8" of Joint: **YES**  
Remarks:

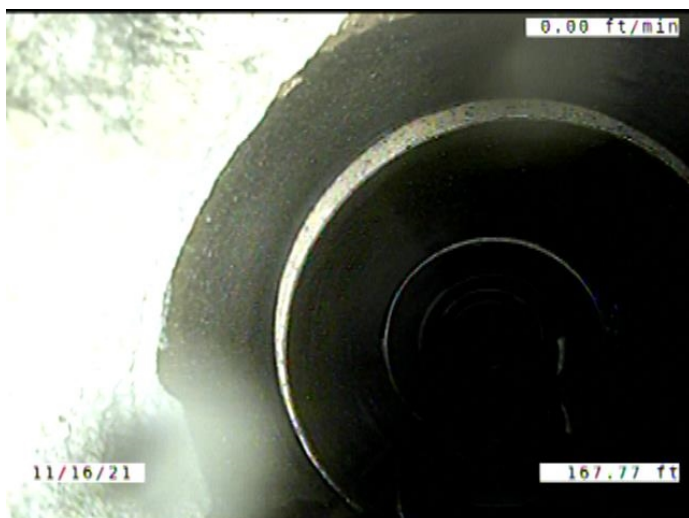
Code: **DAE**  
Description: **Deposits Attached Encrustation**

Distance (ft): **167.8**  
Structural Grade: **0**  
O&M Grade: **2**  
Clock Start/From: **1**  
Clock To: **5**  
1st Value:  
2nd Value:  
Value Percent: **5.000**  
Continuous Index: **F01**  
Within 8" of Joint: **YES**  
Remarks:
