Profile/Photo Observation Report

Street:	COURT ST & S ASH ST	Flow Control:	Not Controlled
City:	Hobart, IN	Year Renewed:	
Location:	Other	Tape/Media #:	
Purpose:	Not Known	Dia/Height:	12"
Use:	Sanitary	Material:	VCP
Drain Area:	NA	Lining:	
Category:	NA		
Comment:	Flow direction wrong. Debris at 2'.		
Location Details:		Direction of Survey:	Downstream
US MH:	M-605-072	DS MH:	M-605-025
		Total Length Surveyed (ft):	3.3

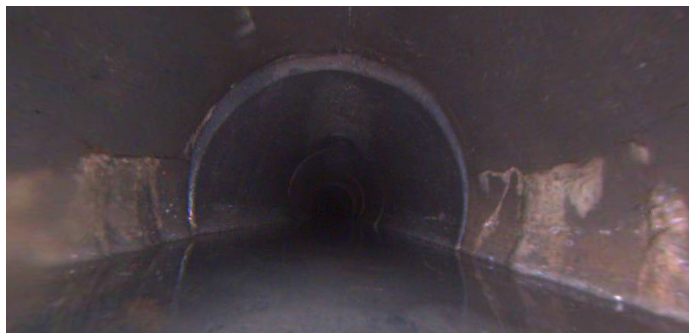
Code: **AMH**
Description: **Manhole**

Distance (ft): **.0**
Structural Grade: **0**
O&M Grade: **0**
Clock Start/From:
Clock To:
1st Value:
2nd Value:
Value Percent:
Continuous Index:
Within 8" of Joint: **NO**
Remarks: **M-605-072**

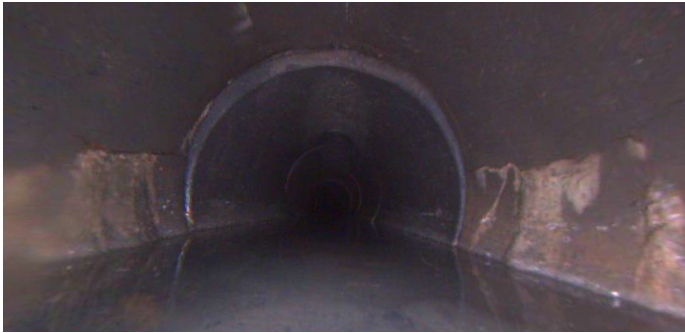
Code:	MWL
Description:	Water Level

Distance (ft):	.0
Structural Grade:	0
O&M Grade:	0
Clock Start/From:	
Clock To:	
1st Value:	
2nd Value:	
Value Percent:	40.000
Continuous Index:	
Within 8" of Joint:	NO
Remarks:

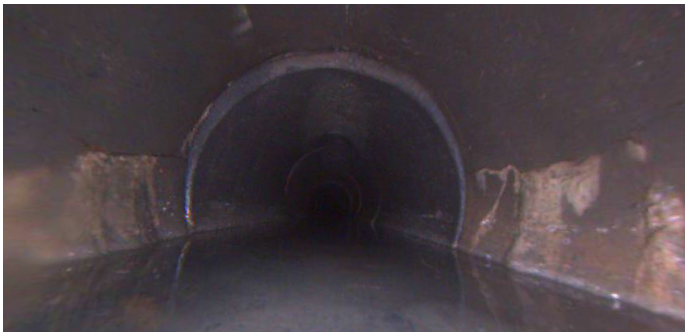
Code:	FM
Description:	Fracture Multiple

Distance (ft):	.0
Structural Grade:	4
O&M Grade:	0
Clock Start/From:	8
Clock To:	4
1st Value:	
2nd Value:	
Value Percent:	
Continuous Index:	
Within 8" of Joint:	YES
Remarks:

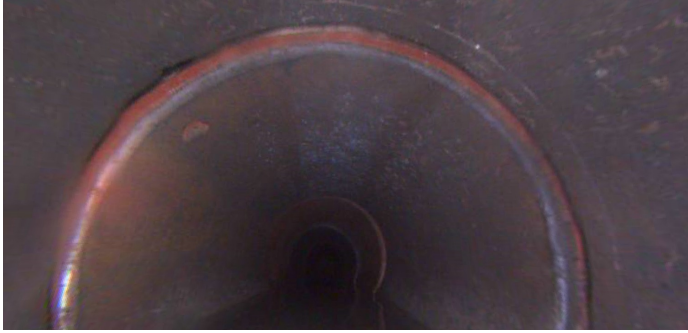
Code:	MSA
Description:	Abandoned Survey
Distance (ft):	3.3
Structural Grade:	0
O&M Grade:	0
Clock Start/From:	
Clock To:	
1st Value:	
2nd Value:	
Value Percent:	
Continuous Index:	
Within 8" of Joint:	NO
Remarks:	debris under water
