Profile/Photo Observation Report

Street:	Ash	Flow Control:	Not Controlled
City:	Hobart, IN	Year Renewed:	
Location:	Other	Tape/Media #:	
Purpose:	Not Known	Dia/Height:	12"
Use:	Sanitary	Material:	VCP
Drain Area:	NA	Lining:	
Category:	NA		
Comment:	Flow direction wrong. Debris at 2'.		
Location Details:		Direction of Survey:	Downstream
US MH:	M-605-072	DS MH:	M-605-025
		Total Length Surveyed (ft):	3.3

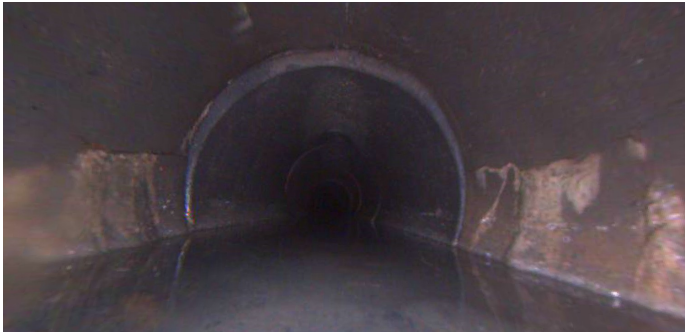
Code:	MWL
Description:	Water Level

Distance (ft):	.0
Structural Grade:	0
O&M Grade:	0
Clock Start/From:	
Clock To:	
1st Value:	
2nd Value:	
Value Percent:	40.000
Continuous Index:	
Within 8" of Joint:	NO
Remarks:

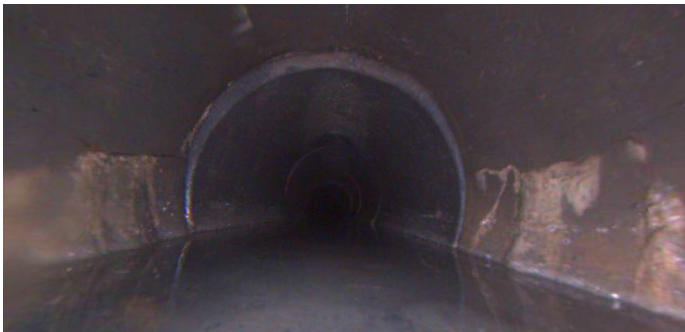
Code:	FM
Description:	Fracture Multiple

Distance (ft):	.0
Structural Grade:	4
O&M Grade:	0
Clock Start/From:	8
Clock To:	4
1st Value:	
2nd Value:	
Value Percent:	
Continuous Index:	
Within 8" of Joint:	YES
Remarks:

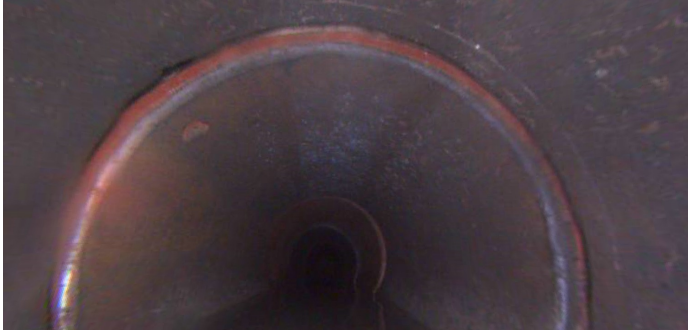
Code:	MSA
Description:	Abandoned Survey
Distance (ft):	3.3
Structural Grade:	0
O&M Grade:	0
Clock Start/From:	
Clock To:	
1st Value:	
2nd Value:	
Value Percent:	
Continuous Index:	
Within 8" of Joint:	NO
Remarks:	debris under water
