Profile/Photo Observation Report

Street:	COURT ST & S ASH ST	Flow Control:	Not Controlled
City:	Hobart, IN	Year Renewed:	
Location:	Other	Tape/Media #:	
Purpose:	Not Known	Dia/Height:	12"
Use:	Sanitary	Material:	VCP
Drain Area:	NA	Lining:	
Category:	NA		
Comment:	Flow direction wrong. Reverse setup.		
Location Details:		Direction of Survey:	Upstream
US MH:	M-605-072	DS MH:	M-605-025
		Total Length Surveyed (ft):	40.8

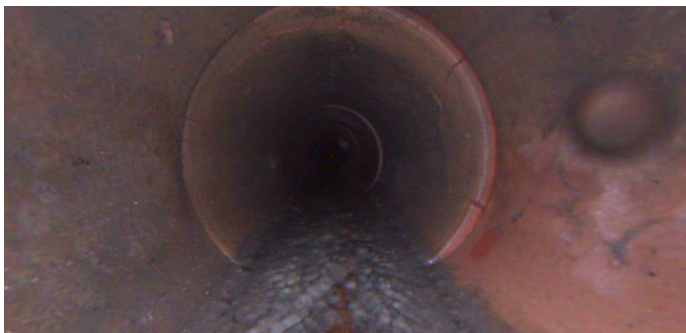
Code: **AMH**
Description: **Manhole**

Distance (ft): **.0**
Structural Grade: **0**
O&M Grade: **0**
Clock Start/From:
Clock To:
1st Value:
2nd Value:
Value Percent:
Continuous Index:
Within 8" of Joint: **NO**
Remarks: **M-605-025**

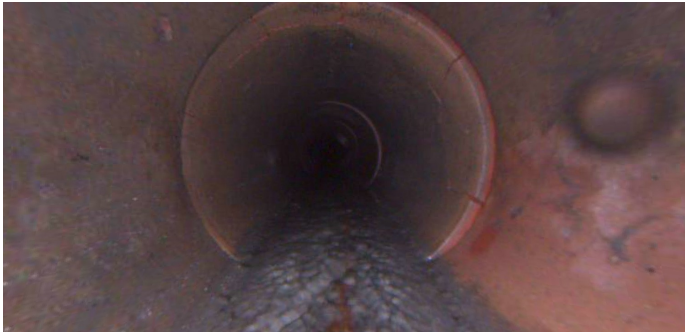
Code:	MWL
Description:	Water Level

Distance (ft):	.0
Structural Grade:	0
O&M Grade:	0
Clock Start/From:	
Clock To:	
1st Value:	
2nd Value:	
Value Percent:	5.000
Continuous Index:	
Within 8" of Joint:	NO
Remarks:

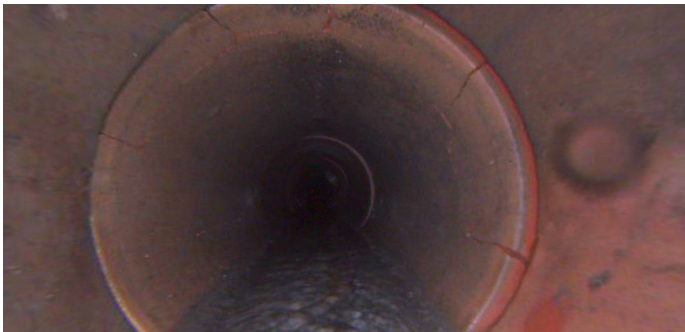
Code:	FM
Description:	Fracture Multiple

Distance (ft):	.5
Structural Grade:	4
O&M Grade:	0
Clock Start/From:	8
Clock To:	4
1st Value:	
2nd Value:	
Value Percent:	
Continuous Index:	
Within 8" of Joint:	YES
Remarks:

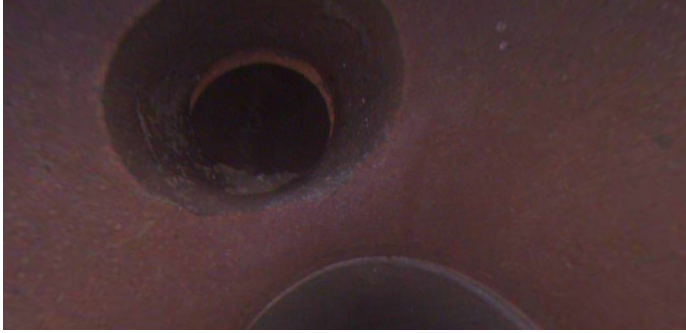
Code: **TF**
Description: **Tap Factory**

Distance (ft): **5.0**
Structural Grade: **0**
O&M Grade: **0**
Clock Start/From: **12**
Clock To:
1st Value: **4.000**
2nd Value:
Value Percent:
Continuous Index:
Within 8" of Joint:
Remarks:

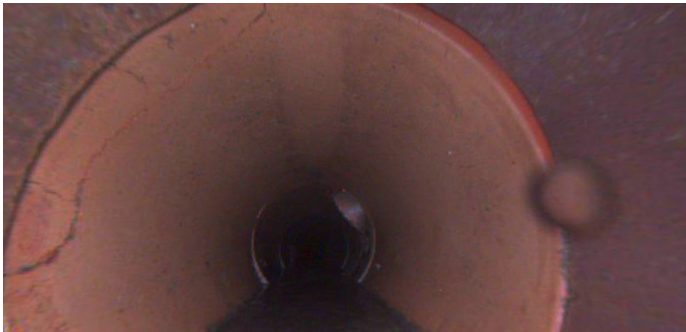
Code: **FM**
Description: **Fracture Multiple**

Distance (ft): **5.5**
Structural Grade: **4**
O&M Grade: **0**
Clock Start/From: **8**
Clock To: **4**
1st Value:
2nd Value:
Value Percent:
Continuous Index: **S01**
Within 8" of Joint: **YES**
Remarks:

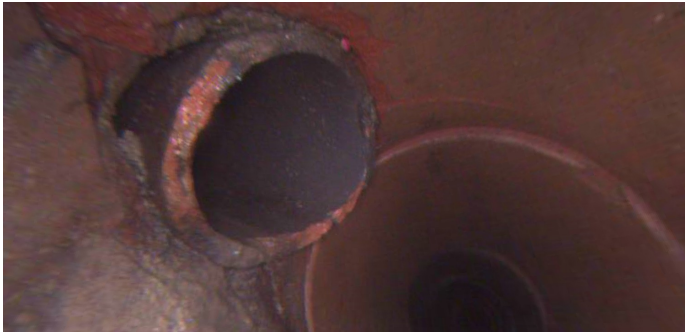
Code: **TBI**
Description: **Tap Break-in Intruding**

Distance (ft): **9.1**
Structural Grade: **0**
O&M Grade: **2**
Clock Start/From: **2**
Clock To:
1st Value: **4.000**
2nd Value: **1.000**
Value Percent:
Continuous Index:
Within 8" of Joint:
Remarks:

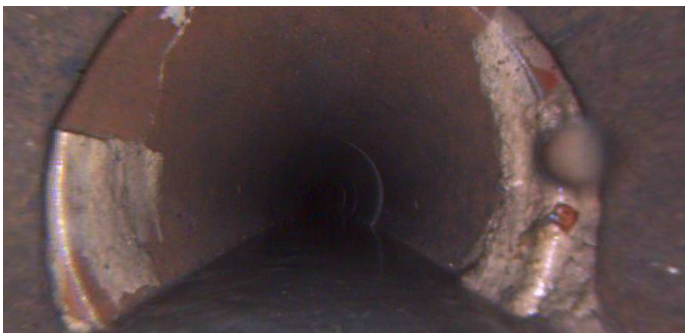
Code: **DAE**
Description: **Deposits Attached Encrustation**

Distance (ft): **15.6**
Structural Grade: **0**
O&M Grade: **2**
Clock Start/From: **8**
Clock To: **4**
1st Value:
2nd Value:
Value Percent: **5.000**
Continuous Index:
Within 8" of Joint: **YES**
Remarks:

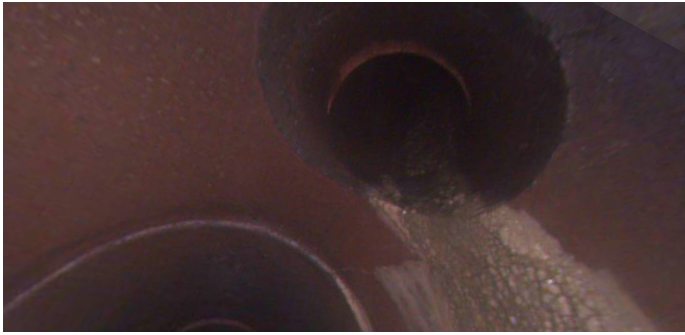
Code: **TF**
Description: **Tap Factory**

Distance (ft): **25.5**
Structural Grade: **0**
O&M Grade: **0**
Clock Start/From: **11**
Clock To:
1st Value: **4.000**
2nd Value:
Value Percent:
Continuous Index:
Within 8" of Joint:
Remarks:

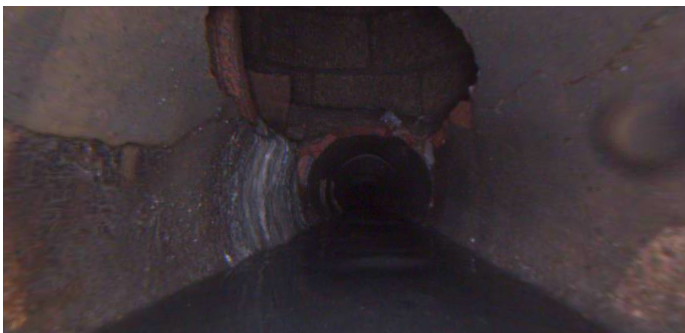
Code: **FM**
Description: **Fracture Multiple**

Distance (ft): **38.5**
Structural Grade: **4**
O&M Grade: **0**
Clock Start/From: **8**
Clock To: **4**
1st Value:
2nd Value:
Value Percent:
Continuous Index: **F01**
Within 8" of Joint: **YES**
Remarks:

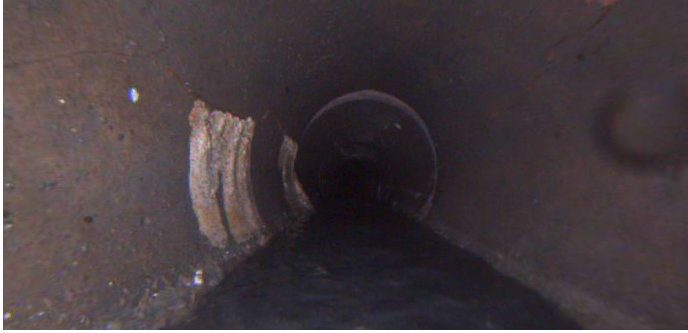
Code:	AMH
Description:	Manhole
Distance (ft):	40.8
Structural Grade:	0
O&M Grade:	0
Clock Start/From:	
Clock To:	
1st Value:	
2nd Value:	
Value Percent:	
Continuous Index:	
Within 8" of Joint:	NO
Remarks:	M-605-072
