## Profile/Photo Observation Report

Date:	<b>04/25/2018</b>	Weather:		Coding:	<b>PACP 6.0</b>
Pipe Length (ft):	<b>40.8</b>	Owner:	<b>NA</b>	Pre Clean:	<b>Not Known</b>
P.O.#:		Surveyor:	<b>Jen Costello</b>	PSR:	<b>P-605-025-072</b>
Customer:		Clean Date:	<b>01/01/1900</b>	Shape:	<b>C</b>

Street:	<b>Ash</b>	Flow Control:	<b>Not Controlled</b>
City:	<b>Hobart, IN</b>	Year Renewed:	
Location:	<b>Other</b>	Tape/Media #:	
Purpose:	<b>Not Known</b>	Dia/Height:	<b>12"</b>
Use:	<b>Sanitary</b>	Material:	<b>VCP</b>
Drain Area:	<b>NA</b>	Lining:	
Category:	<b>NA</b>		
Comment:	<b>Flow direction wrong. Reverse setup.</b>

Location Details:		Direction of Survey:	<b>Upstream</b>
US MH:	<b>M-605-072</b>	DS MH:	<b>M-605-025</b>
		Total Length Surveyed (ft):	<b>40.8</b>

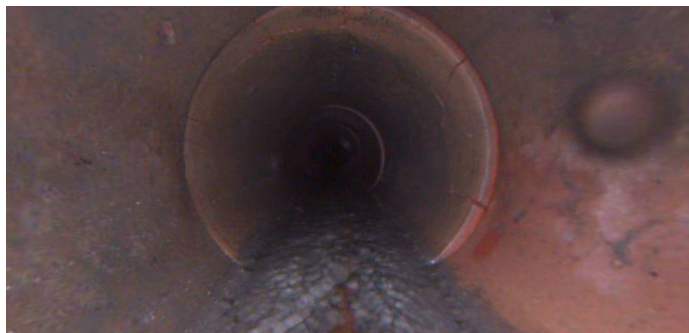
Code: **AMH**  
Description: **Manhole**

Distance (ft): **.0**  
Structural Grade: **0**  
O&M Grade: **0**  
Clock Start/From:  
Clock To:  
1st Value:  
2nd Value:  
Value Percent:  
Continuous Index:  
Within 8" of Joint: **NO**  
Remarks: **M-605-025**

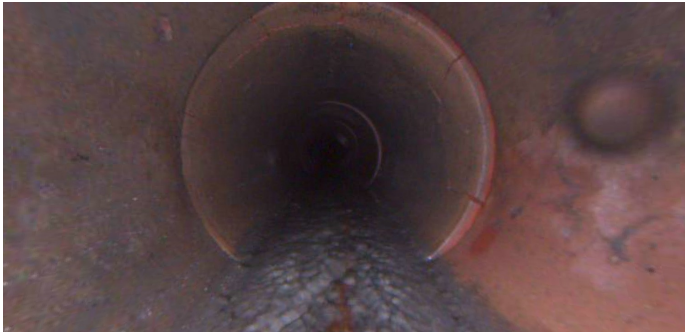
Code:	<b>MWL</b>
Description:	<b>Water Level</b>

Distance (ft):	<b>.0</b>
Structural Grade:	<b>0</b>
O&M Grade:	<b>0</b>
Clock Start/From:	
Clock To:	
1st Value:	
2nd Value:	
Value Percent:	<b>5.000</b>
Continuous Index:	
Within 8" of Joint:	<b>NO</b>
Remarks:

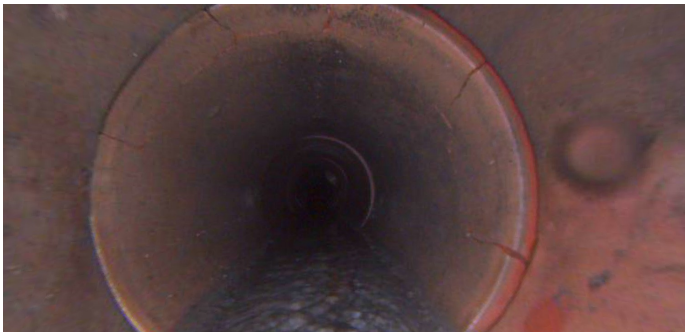
Code:	<b>FM</b>
Description:	<b>Fracture Multiple</b>

Distance (ft):	<b>.5</b>
Structural Grade:	<b>4</b>
O&M Grade:	<b>0</b>
Clock Start/From:	<b>8</b>
Clock To:	<b>4</b>
1st Value:	
2nd Value:	
Value Percent:	
Continuous Index:	
Within 8" of Joint:	<b>YES</b>
Remarks:

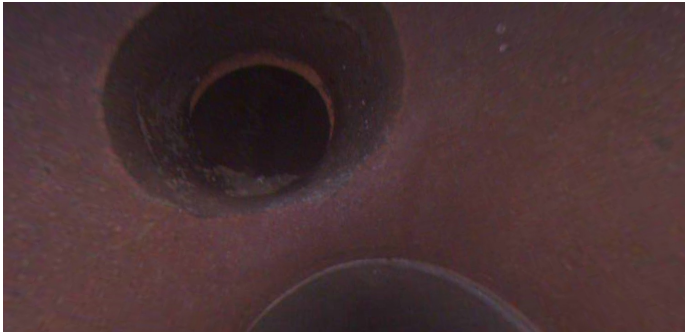
Code: **TF**  
Description: **Tap Factory**

Distance (ft): **5.0**  
Structural Grade: **0**  
O&M Grade: **0**  
Clock Start/From: **12**  
Clock To:  
1st Value: **4.000**  
2nd Value:  
Value Percent:  
Continuous Index:  
Within 8" of Joint:  
Remarks:

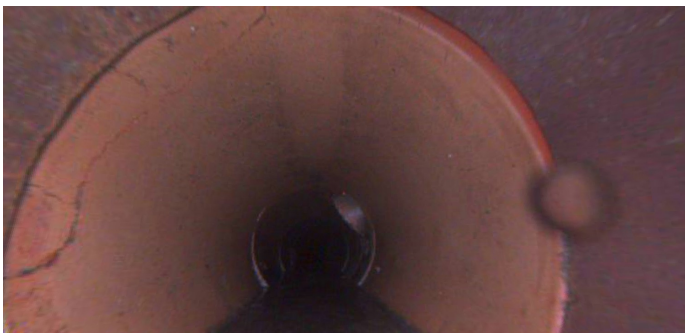
Code: **FM**  
Description: **Fracture Multiple**

Distance (ft): **5.5**  
Structural Grade: **4**  
O&M Grade: **0**  
Clock Start/From: **8**  
Clock To: **4**  
1st Value:  
2nd Value:  
Value Percent:  
Continuous Index: **S01**  
Within 8" of Joint: **YES**  
Remarks:

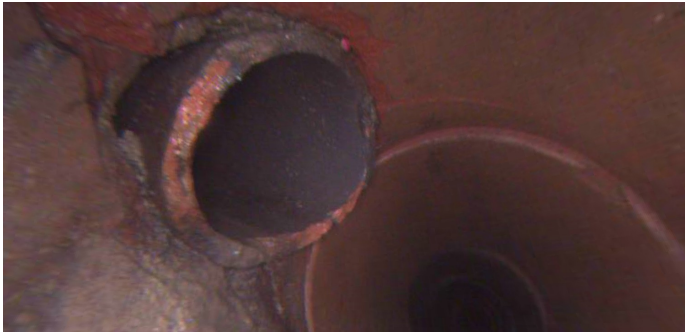
Code: **TBI**  
Description: **Tap Break-in Intruding**

Distance (ft): **9.1**  
Structural Grade: **0**  
O&M Grade: **2**  
Clock Start/From: **2**  
Clock To:  
1st Value: **4.000**  
2nd Value: **1.000**  
Value Percent:  
Continuous Index:  
Within 8" of Joint:  
Remarks:

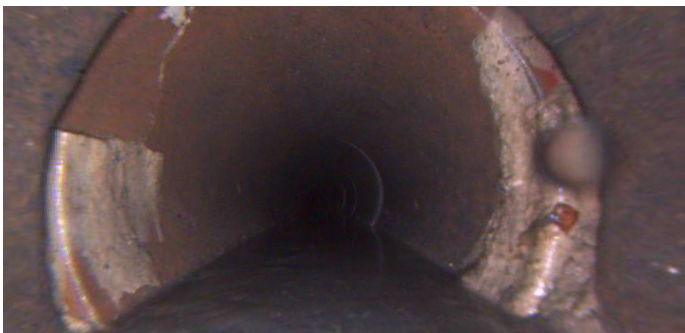
Code: **DAE**  
Description: **Deposits Attached Encrustation**

Distance (ft): **15.6**  
Structural Grade: **0**  
O&M Grade: **2**  
Clock Start/From: **8**  
Clock To: **4**  
1st Value:  
2nd Value:  
Value Percent: **5.000**  
Continuous Index:  
Within 8" of Joint: **YES**  
Remarks:

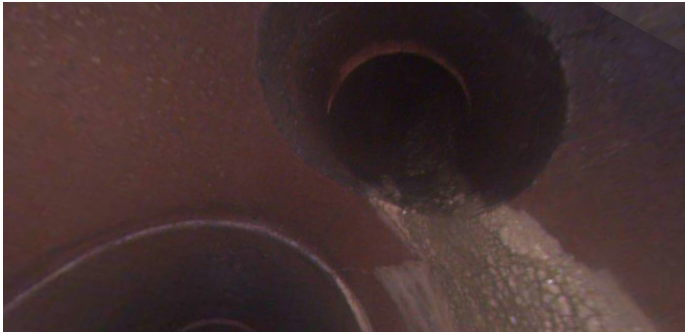
Code: **TF**  
Description: **Tap Factory**

Distance (ft): **25.5**  
Structural Grade: **0**  
O&M Grade: **0**  
Clock Start/From: **11**  
Clock To:  
1st Value: **4.000**  
2nd Value:  
Value Percent:  
Continuous Index:  
Within 8" of Joint:  
Remarks:

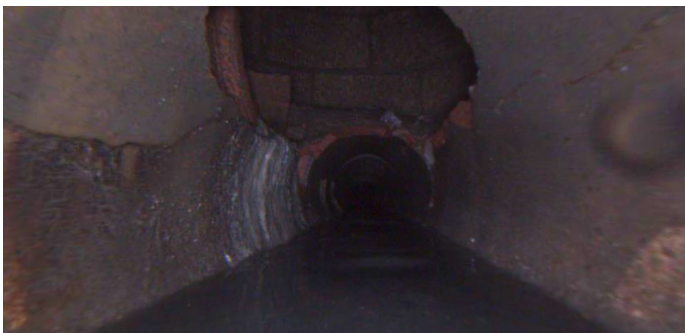
Code: **FM**  
Description: **Fracture Multiple**

Distance (ft): **38.5**  
Structural Grade: **4**  
O&M Grade: **0**  
Clock Start/From: **8**  
Clock To: **4**  
1st Value:  
2nd Value:  
Value Percent:  
Continuous Index: **F01**  
Within 8" of Joint: **YES**  
Remarks:

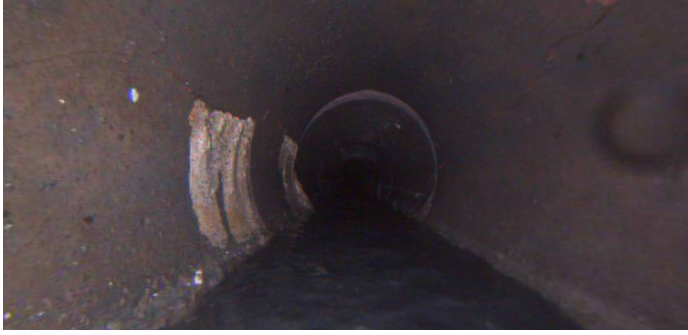
Code:	AMH
Description:	Manhole
Distance (ft):	40.8
Structural Grade:	0
O&M Grade:	0
Clock Start/From:	
Clock To:	
1st Value:	
2nd Value:	
Value Percent:	
Continuous Index:	
Within 8" of Joint:	NO
Remarks:	M-605-072
