Profile/Photo Observation Report

Date:	04/25/2018	Weather:		Coding:	PACP 6.0
Pipe Length (ft):	171.5	Owner:	NA	Pre Clean:	Not Known
P.O.#:		Surveyor:	Jen Costello	PSR:	P-605-073-074
Customer:		Clean Date:	01/01/1900	Shape:	C

Street:	MUNICIPAL DR & S ASH ST	Flow Control:	Not Controlled
City:	Hobart, IN	Year Renewed:	
Location:	Light Highway	Tape/Media #:	
Purpose:	Maintenance Related	Dia/Height:	12"
Use:	Sanitary	Material:	VCP
Drain Area:	NA	Lining:	Cured in Place
Category:	NA		
Comment:	Flow direction wrong. Debris at 5'.		
Location Details:		Direction of Survey:	Downstream
US MH:	M-605-074	DS MH:	M-605-073
		Total Length Surveyed (ft):	6.7

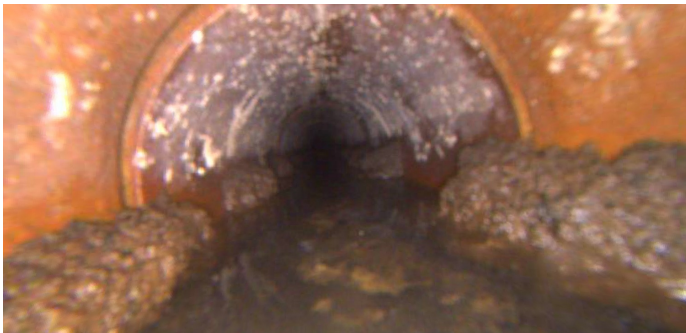
Code:	MWL
Description:	Water Level

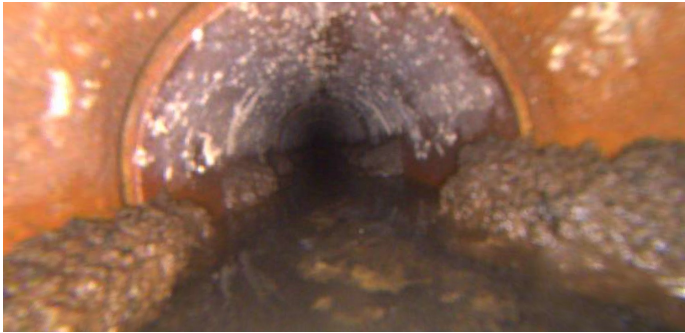
Code:	DAZ
Description:	Deposits Attached Other

Distance (ft):	.0
Structural Grade:	0
O&M Grade:	2
Clock Start/From:	8
Clock To:	4
1st Value:	
2nd Value:	
Value Percent:	10.000
Continuous Index:	S01
Within 8" of Joint:	NO
Remarks:

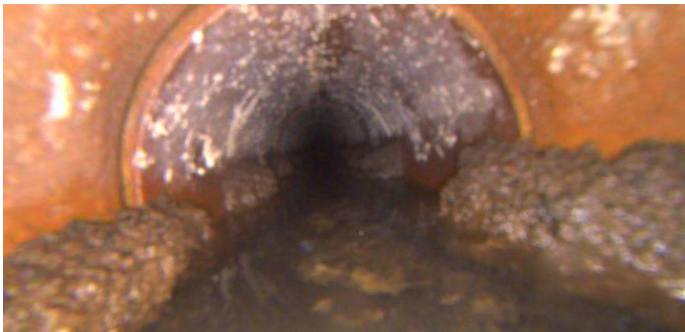
Code: **FS**
Description: **Fracture Spiral**

Distance (ft): **3.2**
Structural Grade: **3**
O&M Grade: **0**
Clock Start/From: **9**
Clock To: **10**
1st Value:
2nd Value:
Value Percent:
Continuous Index:
Within 8" of Joint: **YES**
Remarks:

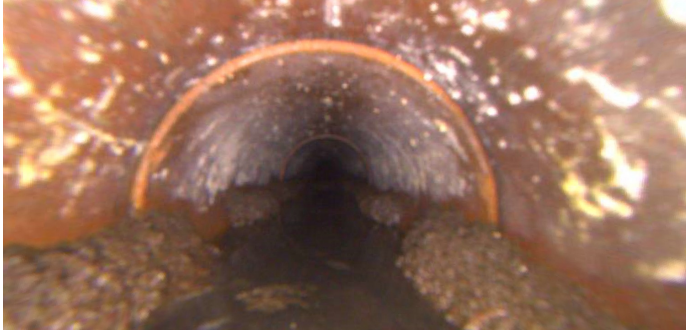
Code: **CL**
Description: **Crack Longitudinal**

Distance (ft): **6.7**
Structural Grade: **2**
O&M Grade: **0**
Clock Start/From: **2**
Clock To:
1st Value:
2nd Value:
Value Percent:
Continuous Index:
Within 8" of Joint:
Remarks:

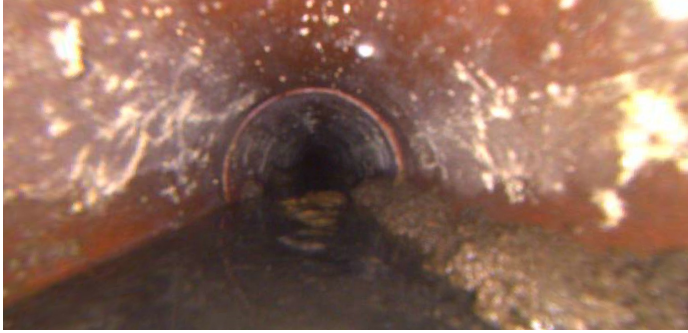
Code:	DAZ
Description:	Deposits Attached Other
Distance (ft):	6.7
Structural Grade:	0
O&M Grade:	2
Clock Start/From:	8
Clock To:	4
1st Value:	
2nd Value:	
Value Percent:	10.000
Continuous Index:	F01
Within 8" of Joint:	NO
Remarks:

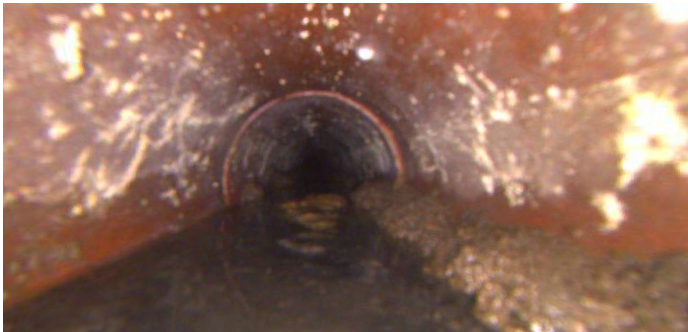
Code:	MSA
Description:	Abandoned Survey
Distance (ft):	6.7
Structural Grade:	0
O&M Grade:	0
Clock Start/From:	
Clock To:	
1st Value:	
2nd Value:	
Value Percent:	
Continuous Index:	
Within 8" of Joint:	NO
Remarks:	deposits
