Profile/Photo Observation Report

Date:	04/25/2018	Weather:		Coding:	PACP 6.0
Pipe Length (ft):	171.5	Owner:	NA	Pre Clean:	Not Known
P.O.#:		Surveyor:	Jen Costello	PSR:	P-605-073-074
Customer:		Clean Date:	01/01/1900	Shape:	C

Street:	Ash	Flow Control:	Not Controlled
City:	Hobart, IN	Year Renewed:	
Location:	Light Highway	Tape/Media #:	
Purpose:	Maintenance Related	Dia/Height:	12"
Use:	Sanitary	Material:	VCP
Drain Area:	NA	Lining:	Cured in Place
Category:	NA		
Comment:	Flow direction wrong. Debris at 5'.		
Location Details:		Direction of Survey:	Downstream
US MH:	M-605-074	DS MH:	M-605-073
		Total Length Surveyed (ft):	6.7

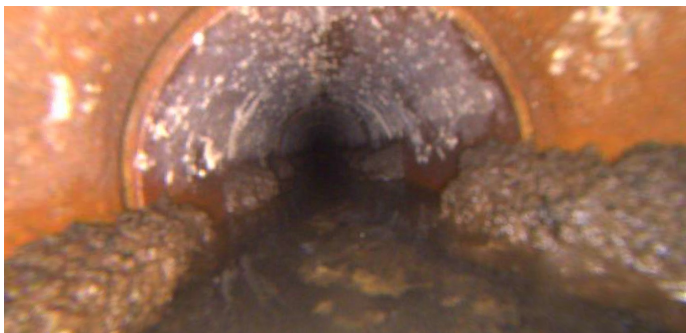
Code: **AMH**
Description: **Manhole**

Distance (ft): **.0**
Structural Grade: **0**
O&M Grade: **0**
Clock Start/From:
Clock To:
1st Value:
2nd Value:
Value Percent:
Continuous Index:
Within 8" of Joint: **NO**
Remarks: **M-605-074**

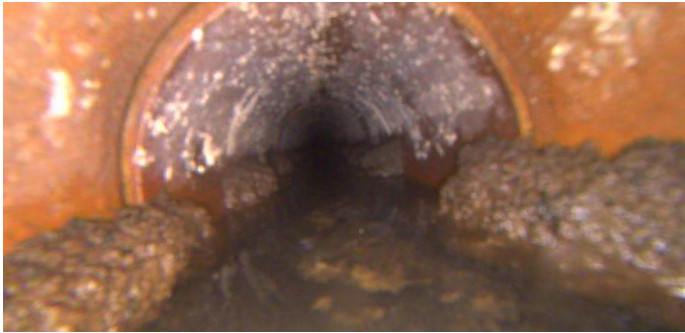
Code:	MWL
Description:	Water Level

Distance (ft):	.0
Structural Grade:	0
O&M Grade:	0
Clock Start/From:	
Clock To:	
1st Value:	
2nd Value:	
Value Percent:	20.000
Continuous Index:	
Within 8" of Joint:	NO
Remarks:

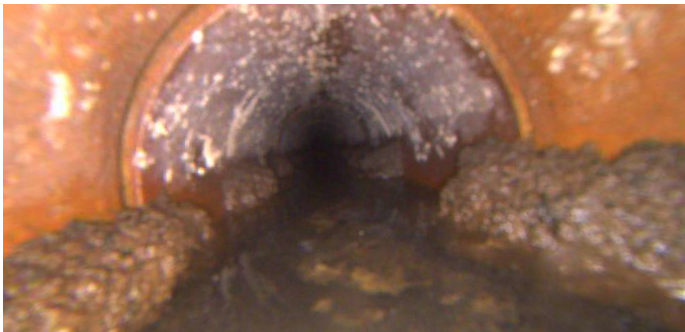
Code:	DAZ
Description:	Deposits Attached Other

Distance (ft):	.0
Structural Grade:	0
O&M Grade:	2
Clock Start/From:	8
Clock To:	4
1st Value:	
2nd Value:	
Value Percent:	10.000
Continuous Index:	S01
Within 8" of Joint:	NO
Remarks:

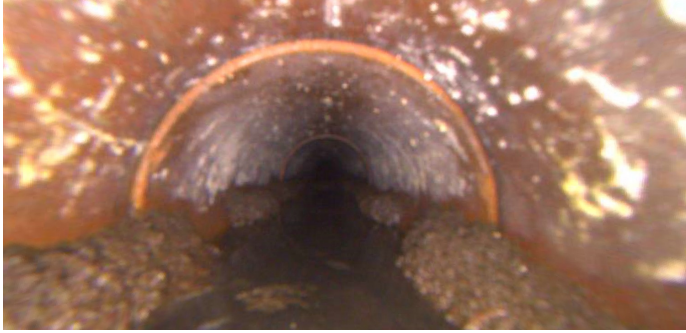
Code: **FS**
Description: **Fracture Spiral**

Distance (ft): **3.2**
Structural Grade: **3**
O&M Grade: **0**
Clock Start/From: **9**
Clock To: **10**
1st Value:
2nd Value:
Value Percent:
Continuous Index:
Within 8" of Joint: **YES**
Remarks:

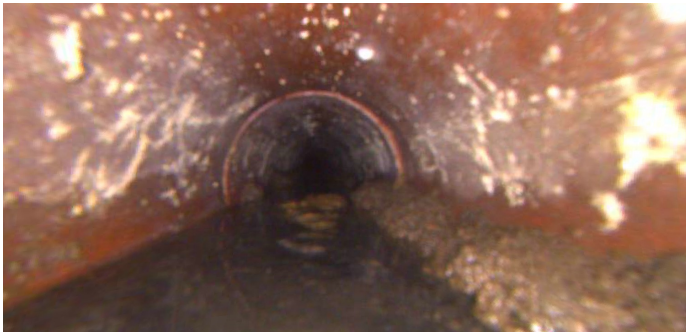
Code: **CL**
Description: **Crack Longitudinal**

Distance (ft): **6.7**
Structural Grade: **2**
O&M Grade: **0**
Clock Start/From: **2**
Clock To:
1st Value:
2nd Value:
Value Percent:
Continuous Index:
Within 8" of Joint:
Remarks:

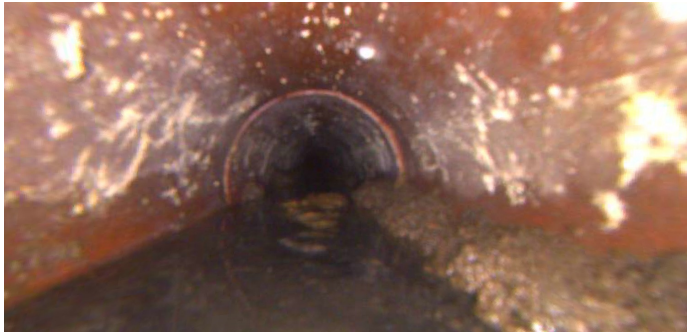
Code:	DAZ
Description:	Deposits Attached Other
Distance (ft):	6.7
Structural Grade:	0
O&M Grade:	2
Clock Start/From:	8
Clock To:	4
1st Value:	
2nd Value:	
Value Percent:	10.000
Continuous Index:	F01
Within 8" of Joint:	NO
Remarks:

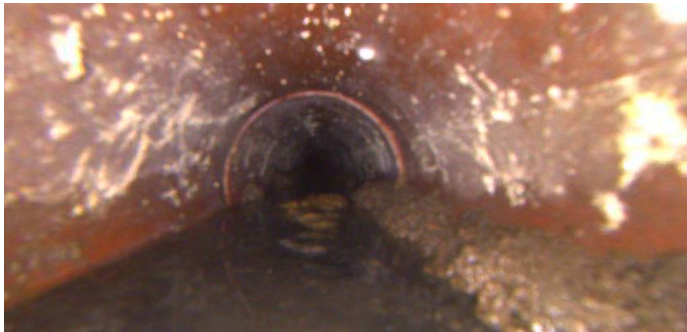
Code:	MSA
Description:	Abandoned Survey
Distance (ft):	6.7
Structural Grade:	0
O&M Grade:	0
Clock Start/From:	
Clock To:	
1st Value:	
2nd Value:	
Value Percent:	
Continuous Index:	
Within 8" of Joint:	NO
Remarks:	deposits
