## Profile/Photo Observation Report

Date:	<b>11/18/2021</b>	Weather:		Coding:	<b>PACP 7.0</b>
Pipe Length (ft):	<b>171.0</b>	Owner:	<b>City of Hobart</b>	Pre Clean:	<b>Heavy Cleaning</b>
P.O.#:	<b>YES502259</b>	Surveyor:	<b>S. Bucklin</b>	PSR:	<b>P-605-073-074</b>
Customer:	<b>City of Hobart</b>	Clean Date:	<b>11/18/2021</b>	Shape:	<b>C</b>

Street:	<b>South Ash Street</b>	Flow Control:	<b>Not Controlled</b>
City:	<b>Hobart, IN</b>	Year Renewed:	
Location:	<b>Local rural streets with light traffic, t</b>	Tape/Media #:	
Purpose:	<b>Routine Assessment</b>	Dia/Height:	<b>10"</b>
Use:	<b>Sanitary Sewage Pipe</b>	Material:	<b>VCP</b>
Drain Area:		Lining:	<b>None</b>
Category:	<b>NA</b>		
Comment:			
Location Details:		Direction of Survey:	<b>Upstream</b>
US MH:	<b>M-605-074</b>	DS MH:	<b>M-605-073</b>
		Total Length Surveyed (ft):	<b>75.6</b>

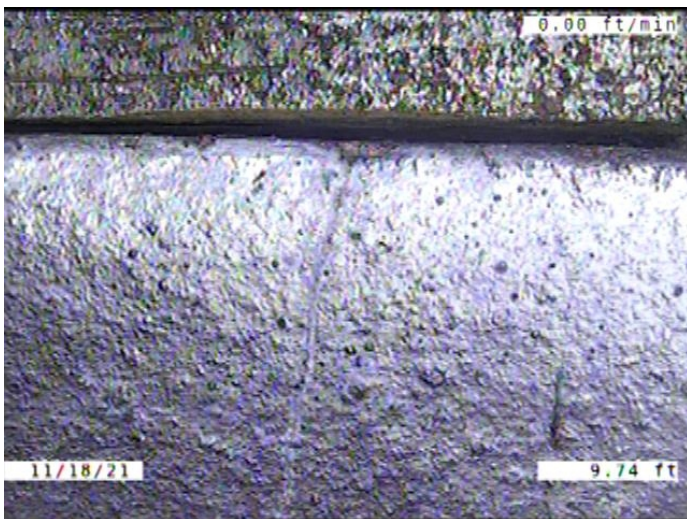
Code: **CL**  
Description: **Crack Longitudinal**

Distance (ft): **9.7**  
Structural Grade: **2**  
O&M Grade: **0**  
Clock Start/From: **2**  
Clock To:  
1st Value:  
2nd Value:  
Value Percent:  
Continuous Index:  
Within 8" of Joint: **YES**  
Remarks:

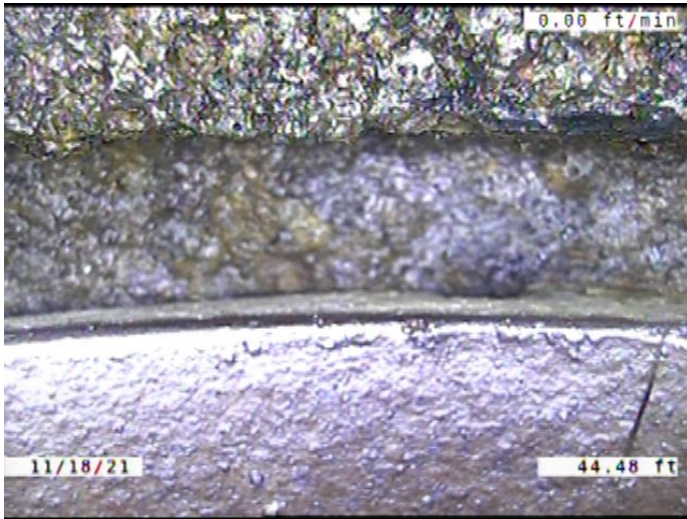
Code: **MMC**  
 Description: **Miscellaneous Material Change**

Distance (ft): **44.5**  
 Structural Grade: **0**  
 O&M Grade: **0**  
 Clock Start/From:  
 Clock To:  
 1st Value:  
 2nd Value:  
 Value Percent:  
 Continuous Index:  
 Within 8" of Joint: **NO**  
 Remarks: **DIP TO VCP**

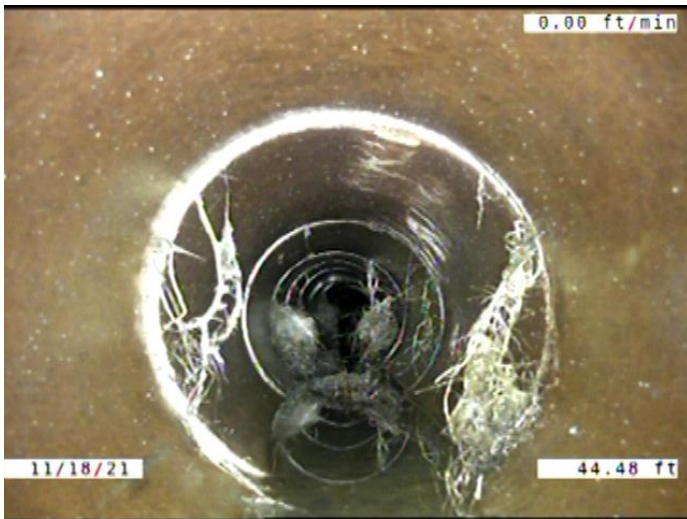
Code: **SSS**  
 Description: **Surface Damage Surface Spalling**

Distance (ft): **44.5**  
 Structural Grade: **2**  
 O&M Grade: **0**  
 Clock Start/From: **12**  
 Clock To: **12**  
 1st Value:  
 2nd Value:  
 Value Percent:  
 Continuous Index: **F01**  
 Within 8" of Joint: **YES**  
 Remarks:

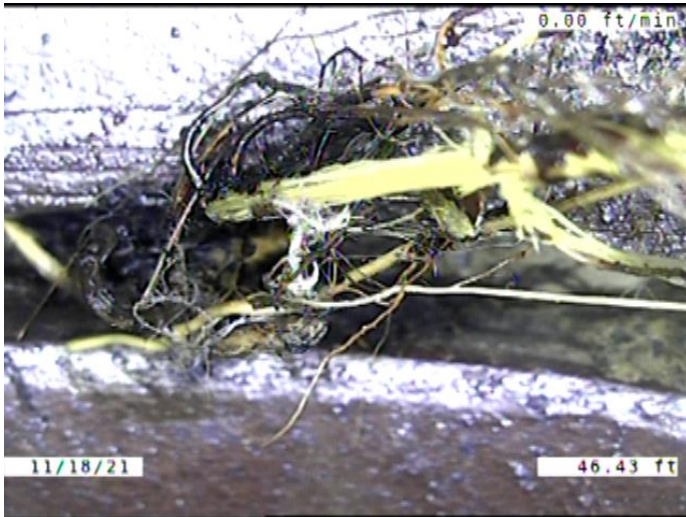
Code: **RMJ**  
 Description: **Roots Medium Joint**

Distance (ft): **46.4**  
 Structural Grade: **0**  
 O&M Grade: **3**  
 Clock Start/From: **8**  
 Clock To: **4**  
 1st Value:  
 2nd Value:  
 Value Percent: **10.000**  
 Continuous Index: **S02**  
 Within 8" of Joint: **YES**  
 Remarks:

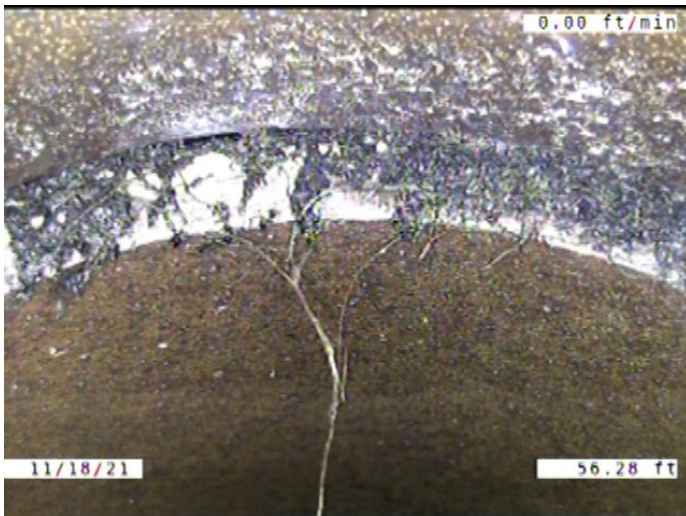
Code: **JOMD**  
 Description: **Joint Offset Medium Defective**

Distance (ft): **56.3**  
 Structural Grade: **3**  
 O&M Grade: **0**  
 Clock Start/From:  
 Clock To:  
 1st Value:  
 2nd Value:  
 Value Percent:  
 Continuous Index:  
 Within 8" of Joint: **NO**  
 Remarks:
