Profile/Photo Observation Report

Date:	11/18/2021	Weather:		Coding:	PACP 7.0
Pipe Length (ft):	171.0	Owner:	City of Hobart	Pre Clean:	Heavy Cleaning
P.O.#:	YES502259	Surveyor:	S. Bucklin	PSR:	P-605-073-074
Customer:	City of Hobart	Clean Date:	11/18/2021	Shape:	C

Street:	South Ash Street	Flow Control:	Not Controlled
City:	Hobart, IN	Year Renewed:	
Location:	Local rural streets with light traffic, t	Tape/Media #:	
Purpose:	Routine Assessment	Dia/Height:	10"
Use:	Sanitary Sewage Pipe	Material:	VCP
Drain Area:		Lining:	None
Category:	NA		
Comment:			
Location Details:		Direction of Survey:	Upstream
US MH:	M-605-074	DS MH:	M-605-073
		Total Length Surveyed (ft):	75.6

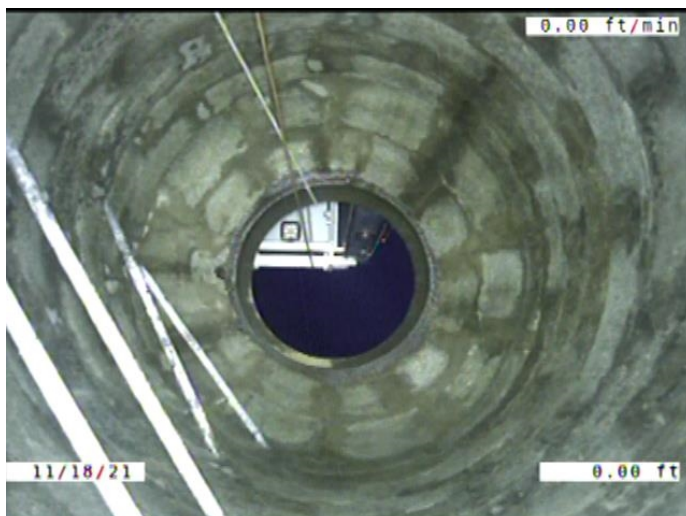
Code: **AMH**
 Description: **Manhole**

Distance (ft): **.0**
 Structural Grade: **0**
 O&M Grade: **0**
 Clock Start/From:
 Clock To:
 1st Value:
 2nd Value:
 Value Percent:
 Continuous Index:
 Within 8" of Joint: **NO**
 Remarks: **M-605-073**

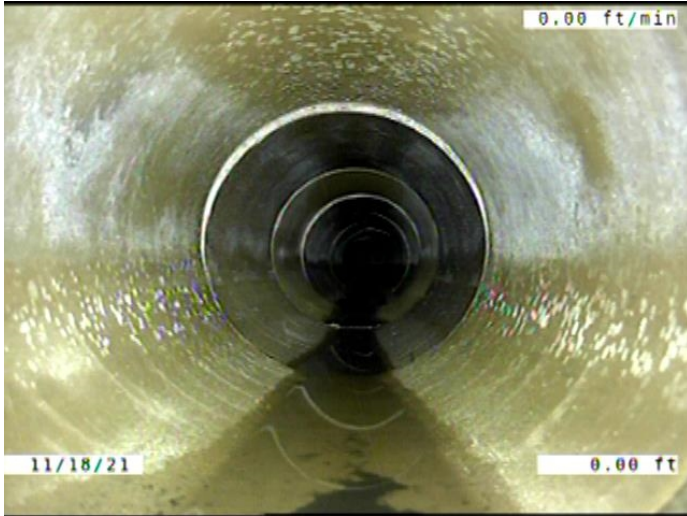
Code: **MWL**
Description: **Miscellaneous Water Level**

Distance (ft): **.0**
Structural Grade: **0**
O&M Grade: **0**
Clock Start/From:
Clock To:
1st Value:
2nd Value:
Value Percent: **5.000**
Continuous Index:
Within 8" of Joint: **NO**
Remarks:

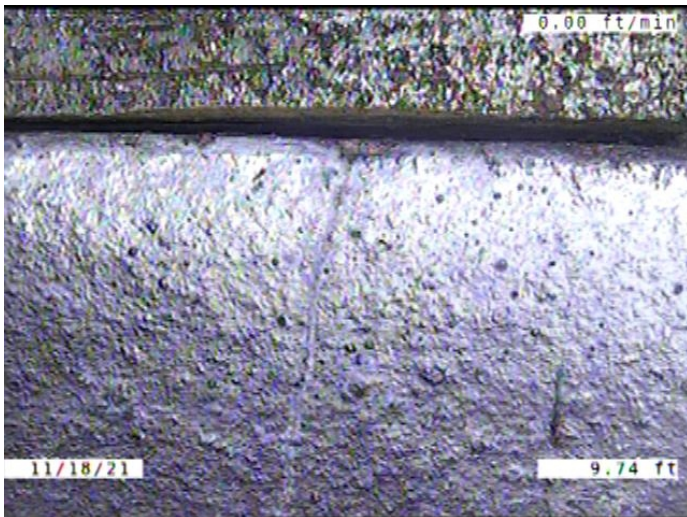
Code: **CL**
Description: **Crack Longitudinal**

Distance (ft): **9.7**
Structural Grade: **2**
O&M Grade: **0**
Clock Start/From: **2**
Clock To:
1st Value:
2nd Value:
Value Percent:
Continuous Index:
Within 8" of Joint: **YES**
Remarks:

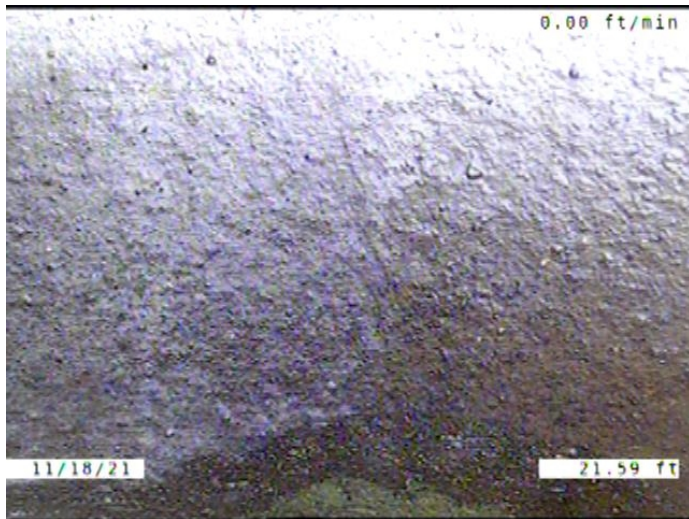
Code: **CS**
 Description: **Crack Spiral**

Distance (ft): **21.6**
 Structural Grade: **2**
 O&M Grade: **0**
 Clock Start/From: **1**
 Clock To: **3**
 1st Value:
 2nd Value:
 Value Percent:
 Continuous Index:
 Within 8" of Joint: **YES**
 Remarks:

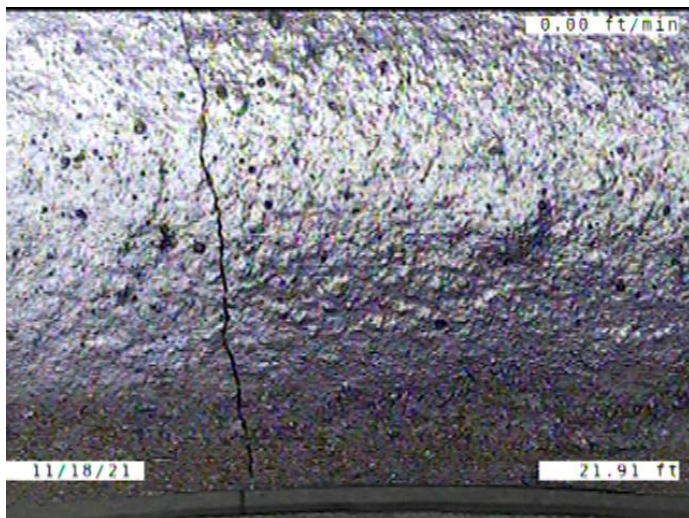
Code: **CL**
 Description: **Crack Longitudinal**

Distance (ft): **21.9**
 Structural Grade: **2**
 O&M Grade: **0**
 Clock Start/From: **11**
 Clock To:
 1st Value:
 2nd Value:
 Value Percent:
 Continuous Index:
 Within 8" of Joint: **YES**
 Remarks:

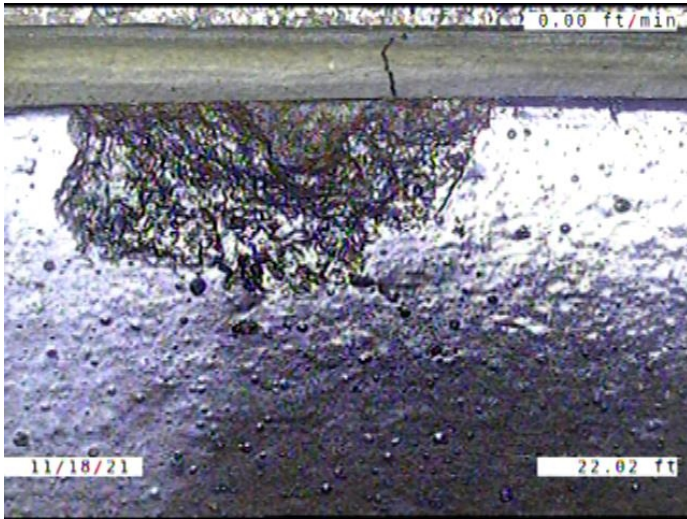
Code: **SZ**
 Description: **Surface Damage Other**

Distance (ft): **22.0**
 Structural Grade: **0**
 O&M Grade: **0**
 Clock Start/From: **11**
 Clock To:
 1st Value:
 2nd Value:
 Value Percent:
 Continuous Index:
 Within 8" of Joint: **YES**
 Remarks: **A PIECE CHIPPED AWAY FROM THE JOINT**

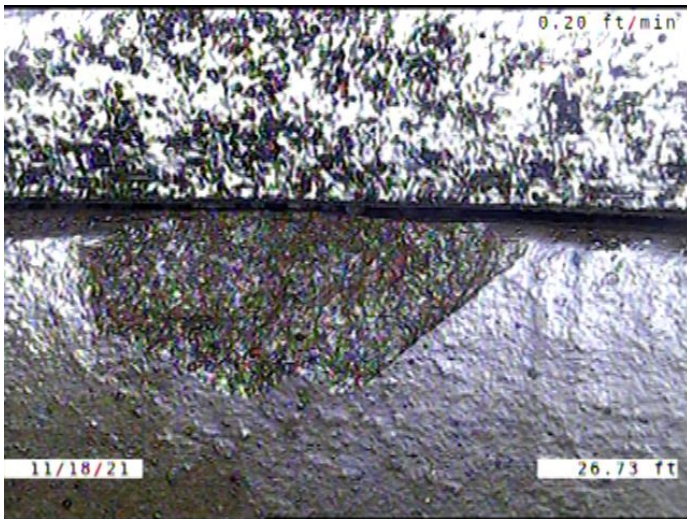
Code: **SZ**
 Description: **Surface Damage Other**

Distance (ft): **26.7**
 Structural Grade: **0**
 O&M Grade: **0**
 Clock Start/From: **1**
 Clock To: **2**
 1st Value:
 2nd Value:
 Value Percent:
 Continuous Index:
 Within 8" of Joint: **YES**
 Remarks: **A PIECE CHIPPED AWAY FROM THE JOINT**

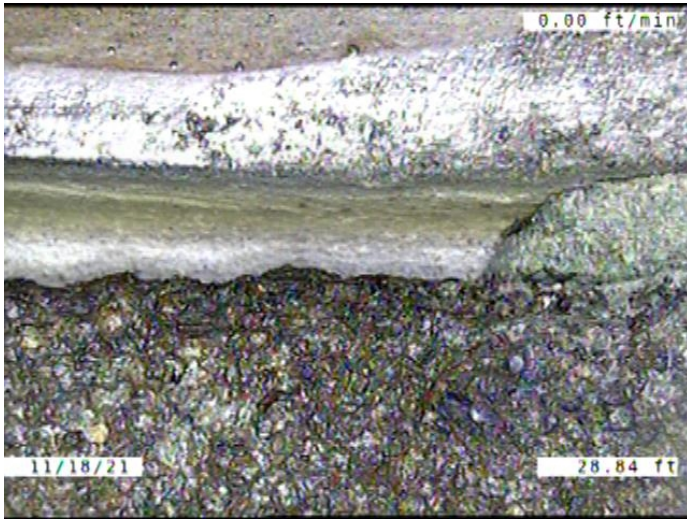
Code: **MMC**
 Description: **Miscellaneous Material Change**

Distance (ft): **28.8**
 Structural Grade: **0**
 O&M Grade: **0**
 Clock Start/From:
 Clock To:
 1st Value:
 2nd Value:
 Value Percent:
 Continuous Index:
 Within 8" of Joint: **NO**
 Remarks: **VCP TO DUCTILE IRON**

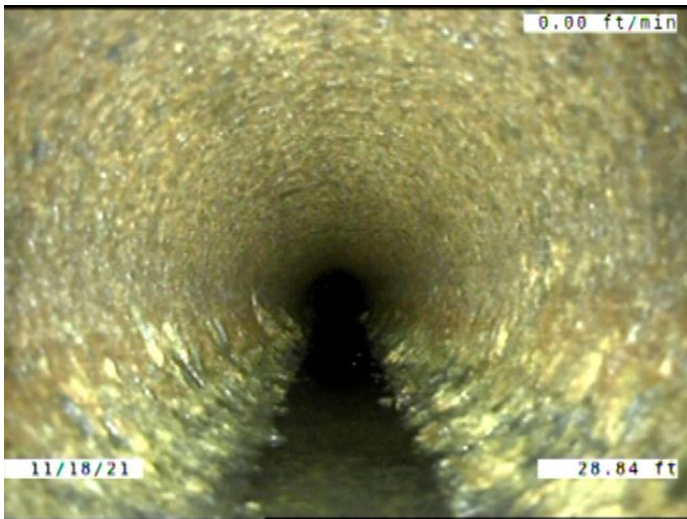
Code: **SSS**
 Description: **Surface Damage Surface Spalling**

Distance (ft): **28.8**
 Structural Grade: **2**
 O&M Grade: **0**
 Clock Start/From: **12**
 Clock To: **12**
 1st Value:
 2nd Value:
 Value Percent:
 Continuous Index: **S01**
 Within 8" of Joint: **YES**
 Remarks:

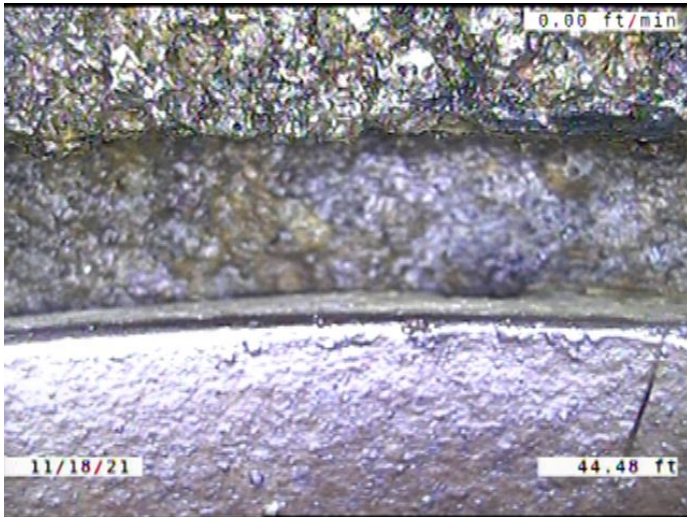
Code: **MMC**
 Description: **Miscellaneous Material Change**

Distance (ft): **44.5**
 Structural Grade: **0**
 O&M Grade: **0**
 Clock Start/From:
 Clock To:
 1st Value:
 2nd Value:
 Value Percent:
 Continuous Index:
 Within 8" of Joint: **NO**
 Remarks: **DIP TO VCP**

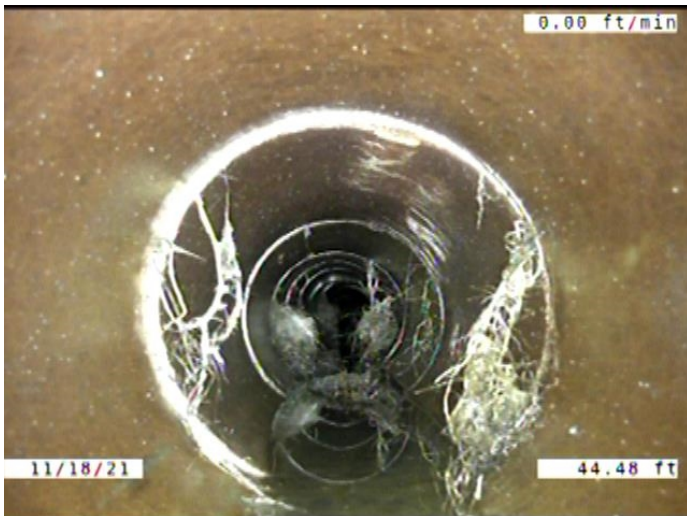
Code: **SSS**
 Description: **Surface Damage Surface Spalling**

Distance (ft): **44.5**
 Structural Grade: **2**
 O&M Grade: **0**
 Clock Start/From: **12**
 Clock To: **12**
 1st Value:
 2nd Value:
 Value Percent:
 Continuous Index: **F01**
 Within 8" of Joint: **YES**
 Remarks:

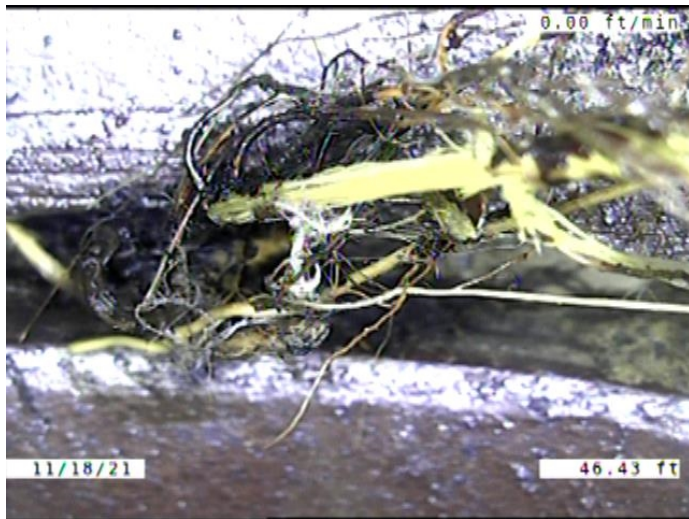
Code: **RMJ**
 Description: **Roots Medium Joint**

Distance (ft): **46.4**
 Structural Grade: **0**
 O&M Grade: **3**
 Clock Start/From: **8**
 Clock To: **4**
 1st Value:
 2nd Value:
 Value Percent: **10.000**
 Continuous Index: **S02**
 Within 8" of Joint: **YES**
 Remarks:

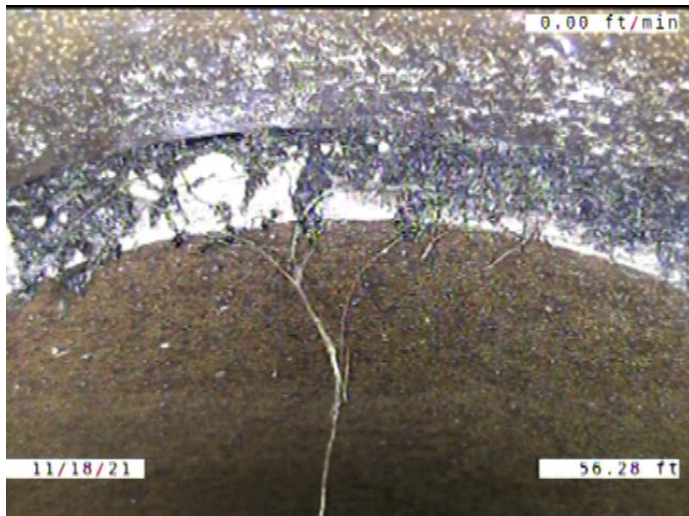
Code: **JOMD**
 Description: **Joint Offset Medium Defective**

Distance (ft): **56.3**
 Structural Grade: **3**
 O&M Grade: **0**
 Clock Start/From:
 Clock To:
 1st Value:
 2nd Value:
 Value Percent:
 Continuous Index:
 Within 8" of Joint: **NO**
 Remarks:

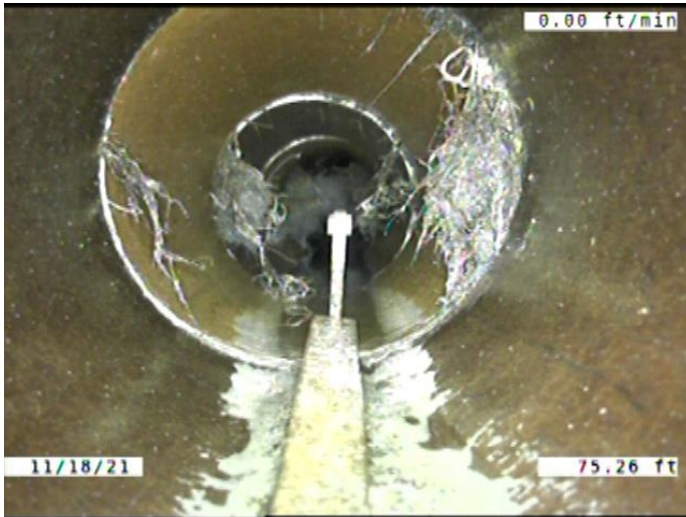
Code: **OBN**
 Description: **Obstruction Construction Debris**

Distance (ft): **75.3**
 Structural Grade: **0**
 O&M Grade: **2**
 Clock Start/From: **6**
 Clock To:
 1st Value:
 2nd Value:
 Value Percent: **5.000**
 Continuous Index:
 Within 8" of Joint: **YES**
 Remarks: **FLAT METAL PIECE WITH BOLT**

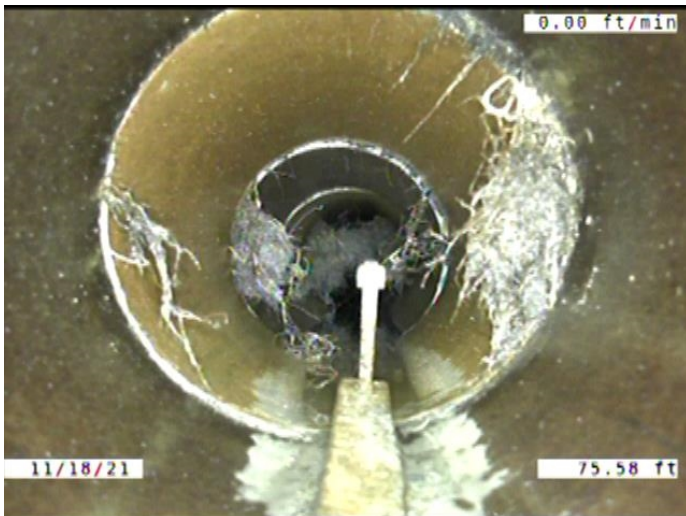
Code: **RMJ**
 Description: **Roots Medium Joint**

Distance (ft): **75.6**
 Structural Grade: **0**
 O&M Grade: **3**
 Clock Start/From: **8**
 Clock To: **4**
 1st Value:
 2nd Value:
 Value Percent: **10.000**
 Continuous Index: **F02**
 Within 8" of Joint: **YES**
 Remarks:

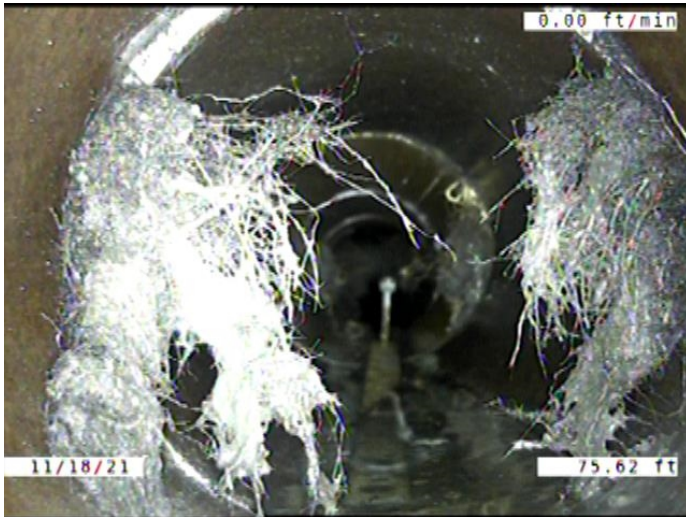
MSA

Miscellaneous Survey Abandoned

**CAMERA CANT MAKE IT PAST
ROOTS.**
