## Profile/Photo Observation Report

Date:	<b>11/19/2021</b>	Weather:		Coding:	<b>PACP 7.0</b>
Pipe Length (ft):	<b>171.0</b>	Owner:	<b>City of Hobart</b>	Pre Clean:	<b>Heavy Cleaning</b>
P.O.#:	<b>YES502259</b>	Surveyor:	<b>S. Bucklin</b>	PSR:	<b>P-605-073-074</b>
Customer:	<b>City of Hobart</b>	Clean Date:	<b>11/18/2021</b>	Shape:	<b>C</b>

Street:	<b>South Ash Street</b>	Flow Control:	<b>Not Controlled</b>
City:	<b>Hobart, IN</b>	Year Renewed:	
Location:	<b>Local rural streets with light traffic, t</b>	Tape/Media #:	
Purpose:	<b>Routine Assessment</b>	Dia/Height:	<b>10"</b>
Use:	<b>Sanitary Sewage Pipe</b>	Material:	<b>VCP</b>
Drain Area:		Lining:	<b>None</b>

US MH: **M-605-074** DS MH: **M-605-073** Total Length Surveyed (ft): **105.5**

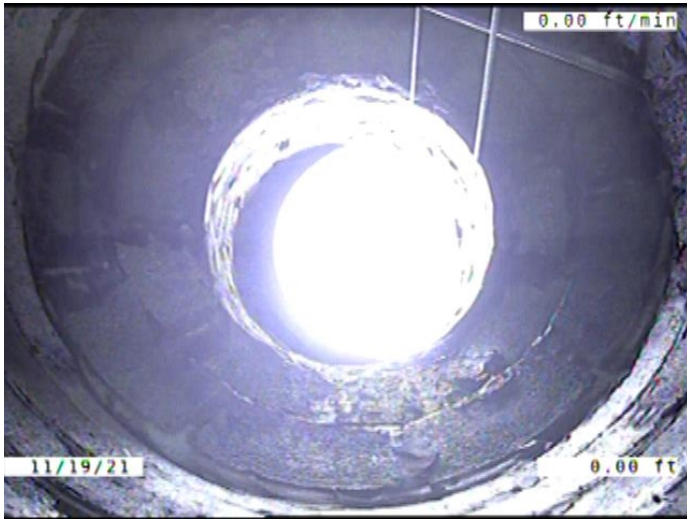
Code: **AMH**  
 Description: **Manhole**

Distance (ft): **.0**  
 Structural Grade: **0**  
 O&M Grade: **0**  
 Clock Start/From:  
 Clock To:  
 1st Value:  
 2nd Value:  
 Value Percent:  
 Continuous Index:  
 Within 8" of Joint: **NO**  
 Remarks: **M-605-074**

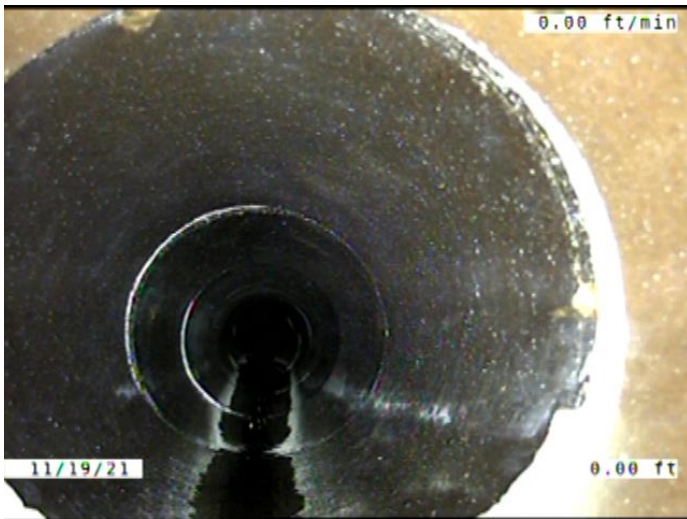
Code: **MWL**  
 Description: **Miscellaneous Water Level**

Distance (ft): **.0**  
 Structural Grade: **0**  
 O&M Grade: **0**  
 Clock Start/From:  
 Clock To:  
 1st Value:  
 2nd Value:  
 Value Percent: **5.000**  
 Continuous Index:  
 Within 8" of Joint: **NO**  
 Remarks:

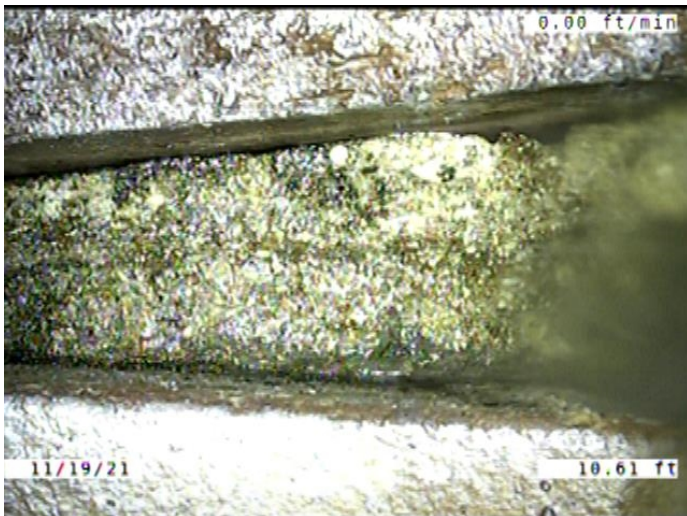
Code: **JAM**  
 Description: **Joint Angular Medium**

Distance (ft): **10.6**  
 Structural Grade: **3**  
 O&M Grade: **0**  
 Clock Start/From:  
 Clock To:  
 1st Value:  
 2nd Value:  
 Value Percent:  
 Continuous Index:  
 Within 8" of Joint: **NO**  
 Remarks:

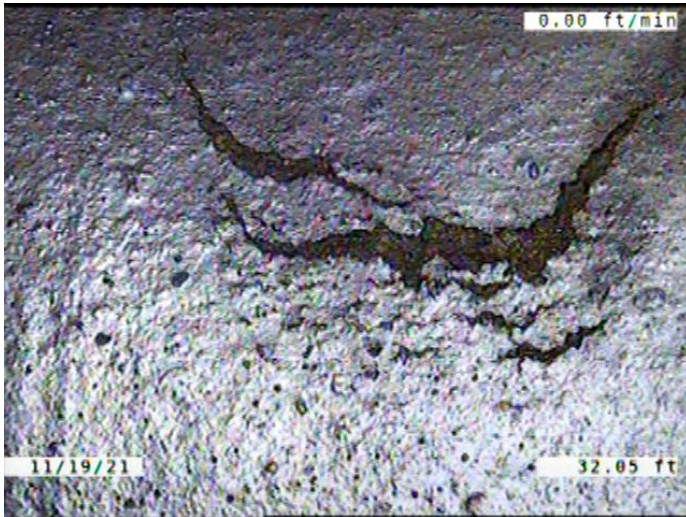
Code: **SSS**  
 Description: **Surface Damage Surface Spalling**

Distance (ft): **32.0**  
 Structural Grade: **2**  
 O&M Grade: **0**  
 Clock Start/From: **7**  
 Clock To: **9**  
 1st Value:  
 2nd Value:  
 Value Percent:  
 Continuous Index:  
 Within 8" of Joint: **NO**  
 Remarks:

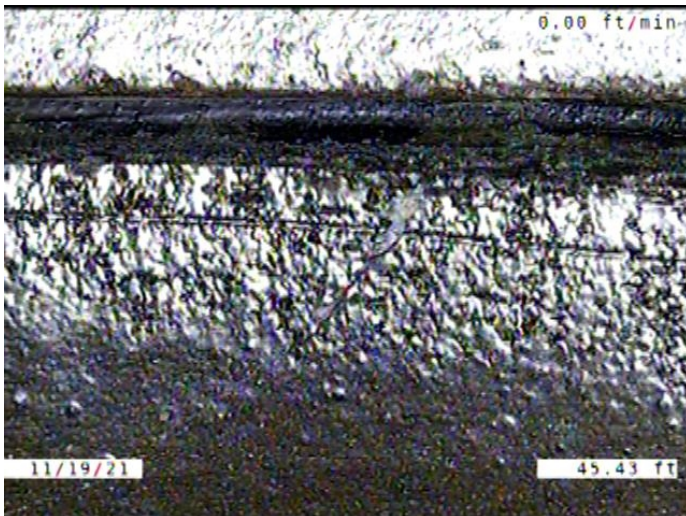
Code: **CS**  
 Description: **Crack Spiral**

Distance (ft): **45.4**  
 Structural Grade: **2**  
 O&M Grade: **0**  
 Clock Start/From: **12**  
 Clock To: **2**  
 1st Value:  
 2nd Value:  
 Value Percent:  
 Continuous Index:  
 Within 8" of Joint: **YES**  
 Remarks:

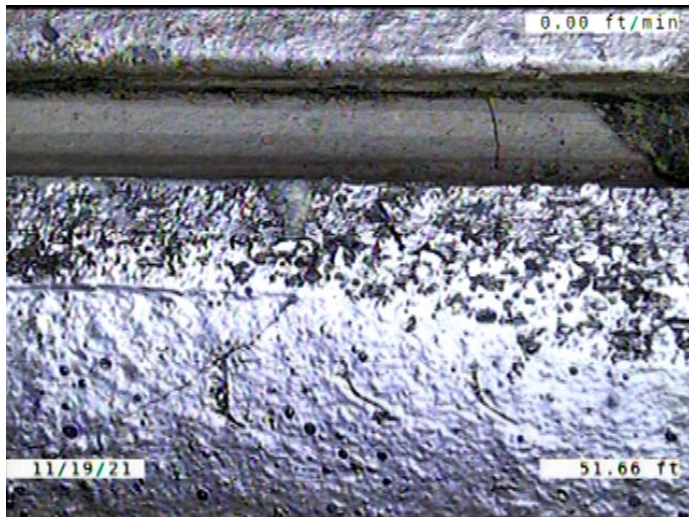
Code: **CM**  
 Description: **Crack Multiple**

Distance (ft): **51.7**  
 Structural Grade: **3**  
 O&M Grade: **0**  
 Clock Start/From: **8**  
 Clock To: **2**  
 1st Value:  
 2nd Value:  
 Value Percent:  
 Continuous Index:  
 Within 8" of Joint: **YES**  
 Remarks:

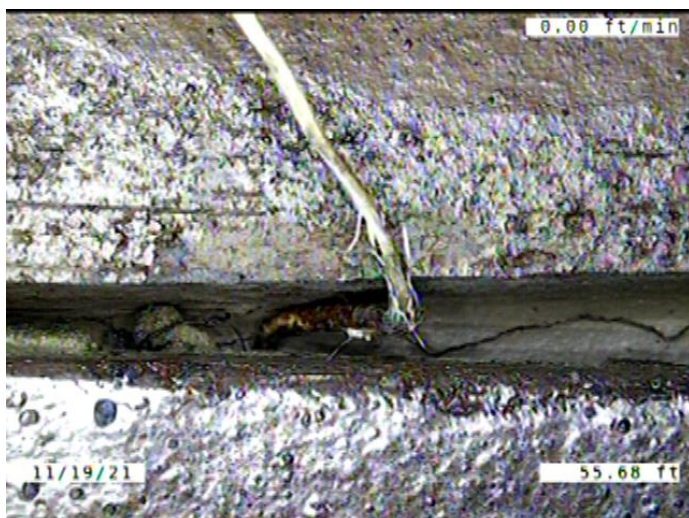
Code: **RFJ**  
 Description: **Roots Fine Joint**

Distance (ft): **55.7**  
 Structural Grade: **0**  
 O&M Grade: **1**  
 Clock Start/From: **3**  
 Clock To:  
 1st Value:  
 2nd Value:  
 Value Percent:  
 Continuous Index:  
 Within 8" of Joint: **YES**  
 Remarks:

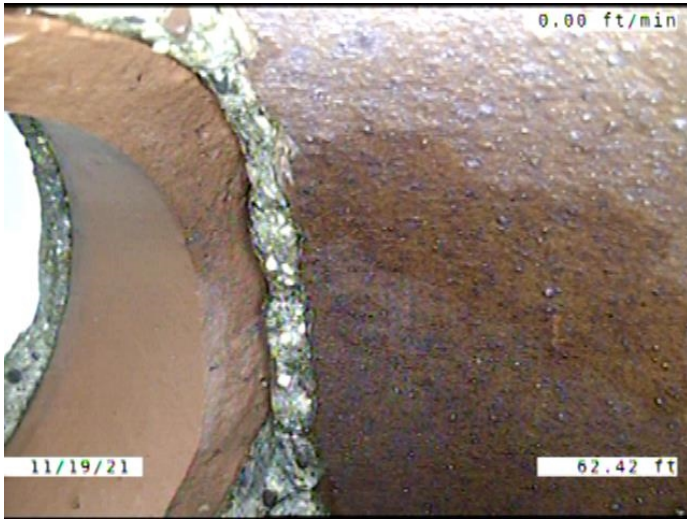
Code: **SSS**  
Description: **Surface Damage Surface Spalling**

Distance (ft): **62.4**  
Structural Grade: **2**  
O&M Grade: **0**  
Clock Start/From: **12**  
Clock To:  
1st Value:  
2nd Value:  
Value Percent:  
Continuous Index:  
Within 8" of Joint: **YES**  
Remarks:

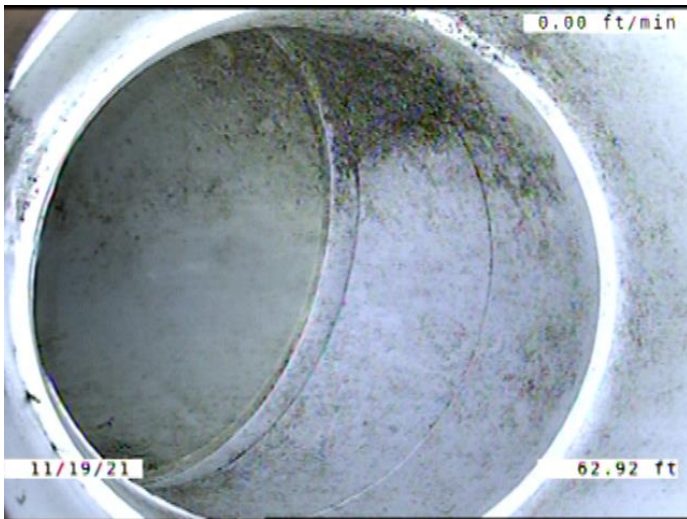
Code: **TBI**  
Description: **Tap Break-in Intruding**

Distance (ft): **62.9**  
Structural Grade: **0**  
O&M Grade: **2**  
Clock Start/From: **11**  
Clock To:  
1st Value: **6.000**  
2nd Value: **1.000**  
Value Percent:  
Continuous Index:  
Within 8" of Joint: **YES**  
Remarks: **CONSTANTLY RUNNING WATER**

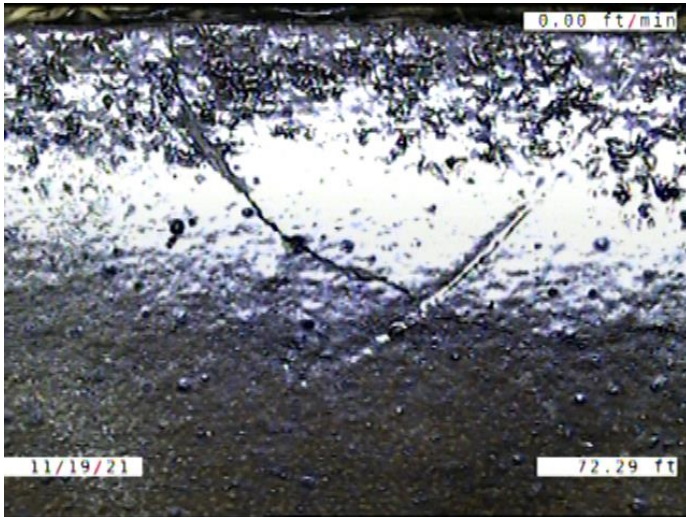
Code: **CM**  
 Description: **Crack Multiple**

Distance (ft): **72.3**  
 Structural Grade: **3**  
 O&M Grade: **0**  
 Clock Start/From: **12**  
 Clock To: **5**  
 1st Value:  
 2nd Value:  
 Value Percent:  
 Continuous Index:  
 Within 8" of Joint: **YES**  
 Remarks:

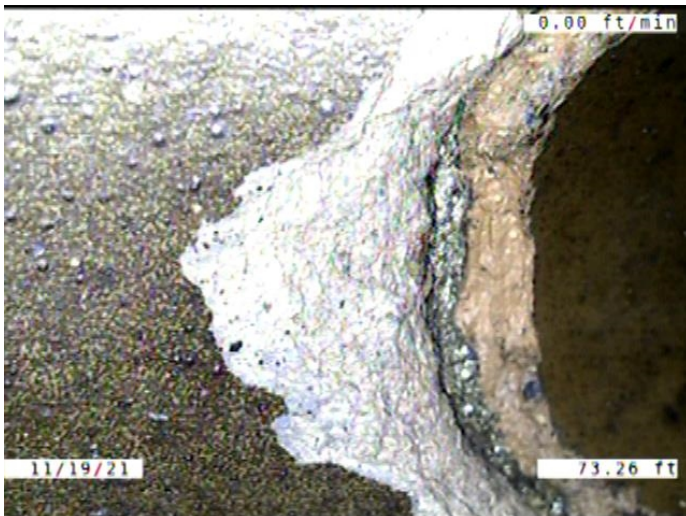
Code: **SSS**  
 Description: **Surface Damage Surface Spalling**

Distance (ft): **73.3**  
 Structural Grade: **2**  
 O&M Grade: **0**  
 Clock Start/From: **12**  
 Clock To: **2**  
 1st Value:  
 2nd Value:  
 Value Percent:  
 Continuous Index:  
 Within 8" of Joint: **YES**  
 Remarks:

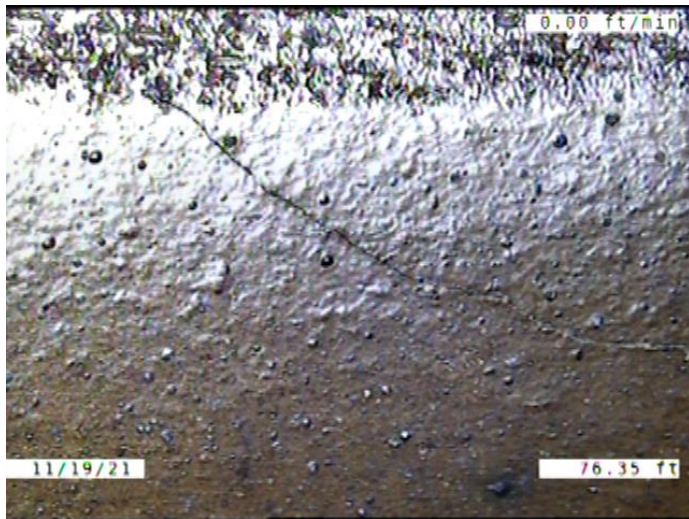
Code: **CM**  
 Description: **Crack Multiple**

Distance (ft): **76.4**  
 Structural Grade: **3**  
 O&M Grade: **0**  
 Clock Start/From: **8**  
 Clock To: **11**  
 1st Value:  
 2nd Value:  
 Value Percent:  
 Continuous Index:  
 Within 8" of Joint: **YES**  
 Remarks:

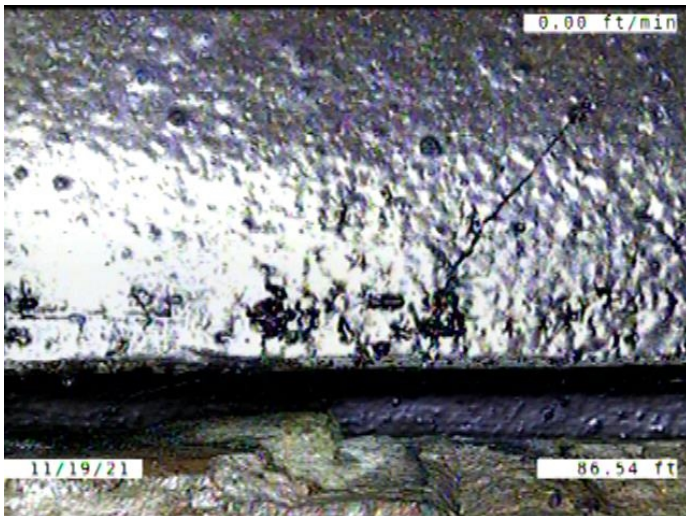
Code: **CS**  
 Description: **Crack Spiral**

Distance (ft): **86.5**  
 Structural Grade: **2**  
 O&M Grade: **0**  
 Clock Start/From: **2**  
 Clock To: **4**  
 1st Value:  
 2nd Value:  
 Value Percent:  
 Continuous Index:  
 Within 8" of Joint: **YES**  
 Remarks:

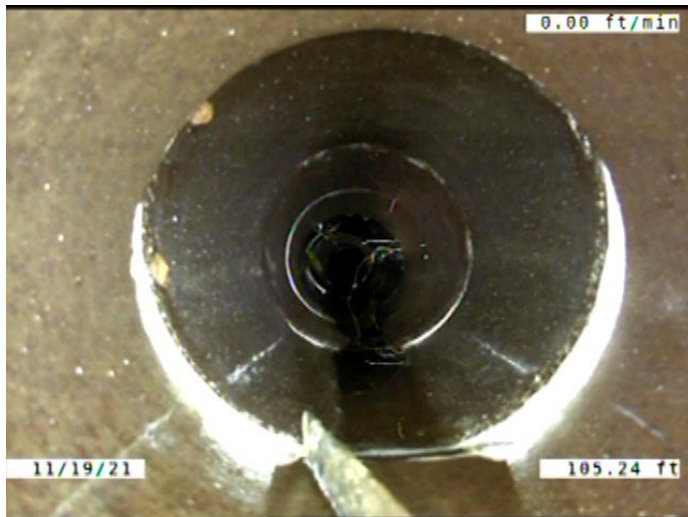
Code: **RFJ**  
 Description: **Roots Fine Joint**

Distance (ft): **105.2**  
 Structural Grade: **0**  
 O&M Grade: **1**  
 Clock Start/From: **8**  
 Clock To: **3**  
 1st Value:  
 2nd Value:  
 Value Percent:  
 Continuous Index: **F01**  
 Within 8" of Joint: **YES**  
 Remarks:

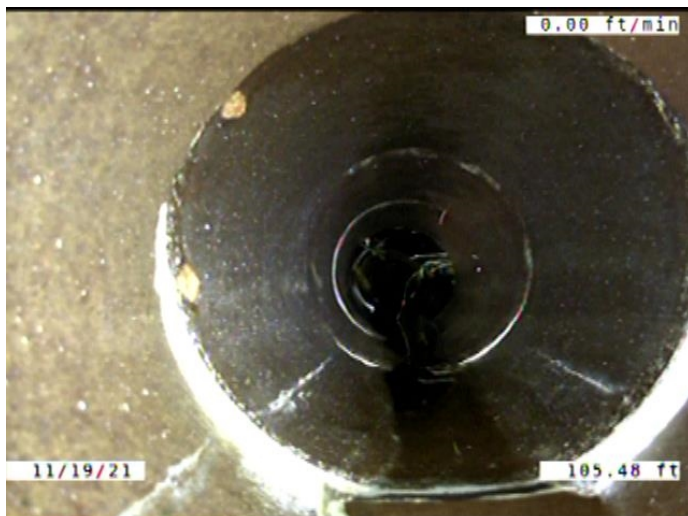
Code: **MSA**  
 Description: **Miscellaneous Survey Abandoned**

Distance (ft): **105.5**  
 Structural Grade: **0**  
 O&M Grade: **0**  
 Clock Start/From:  
 Clock To:  
 1st Value:  
 2nd Value:  
 Value Percent:  
 Continuous Index:  
 Within 8" of Joint: **NO**  
 Remarks: **MADE IT TO THE POINT OF OVERLAP.  
 REVERSAL COMPLETE.**
