Profile/Photo Observation Report

Date:	11/19/2021	Weather:		Coding:	PACP 7.0
Pipe Length (ft):	171.0	Owner:	City of Hobart	Pre Clean:	Heavy Cleaning
P.O.#:	YES502259	Surveyor:	S. Bucklin	PSR:	P-605-073-074
Customer:	City of Hobart	Clean Date:	11/18/2021	Shape:	C

Street:	South Ash Street	Flow Control:	Not Controlled
City:	Hobart, IN	Year Renewed:	
Location:	Local rural streets with light traffic, t	Tape/Media #:	
Purpose:	Routine Assessment	Dia/Height:	10"
Use:	Sanitary Sewage Pipe	Material:	VCP
Drain Area:		Lining:	None
Category:	NA		
Comment:			
Location Details:		Direction of Survey:	Downstream
US MH:	M-605-074	DS MH:	M-605-073
		Total Length Surveyed (ft):	105.5

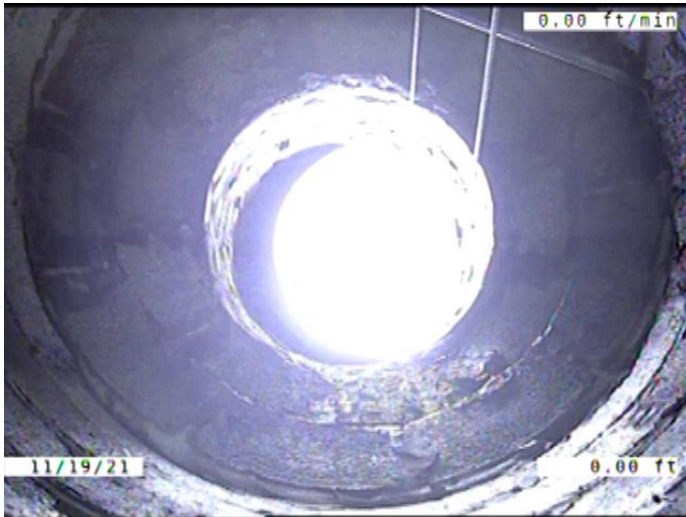
Code: **AMH**
 Description: **Manhole**

Distance (ft): **.0**
 Structural Grade: **0**
 O&M Grade: **0**
 Clock Start/From:
 Clock To:
 1st Value:
 2nd Value:
 Value Percent:
 Continuous Index:
 Within 8" of Joint: **NO**
 Remarks: **M-605-074**

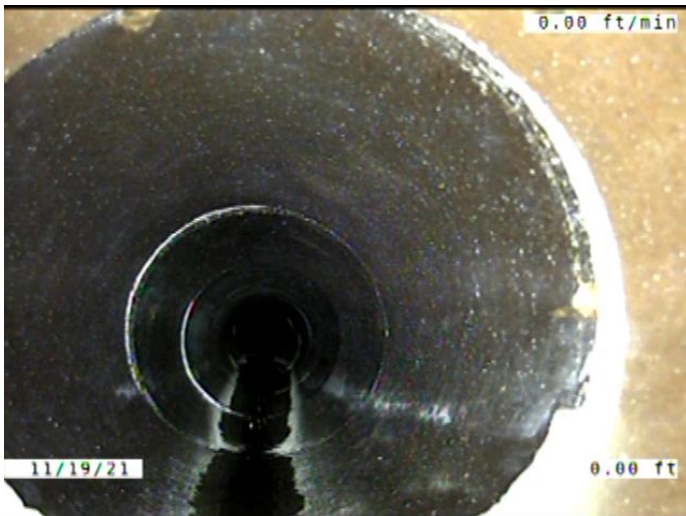
Code: **MWL**
 Description: **Miscellaneous Water Level**

Distance (ft): **.0**
 Structural Grade: **0**
 O&M Grade: **0**
 Clock Start/From:
 Clock To:
 1st Value:
 2nd Value:
 Value Percent: **5.000**
 Continuous Index:
 Within 8" of Joint: **NO**
 Remarks:

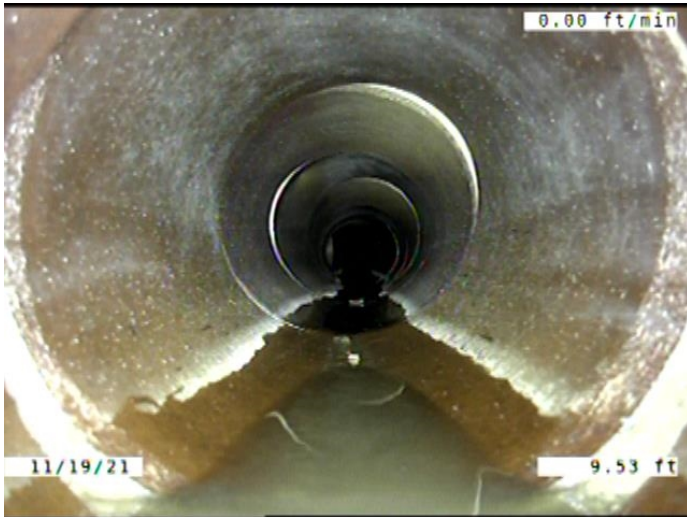
Code: **MWLS**
 Description: **Miscellaneous Water Level Sag**

Distance (ft): **9.5**
 Structural Grade: **2**
 O&M Grade: **0**
 Clock Start/From:
 Clock To:
 1st Value:
 2nd Value:
 Value Percent: **5.000**
 Continuous Index:
 Within 8" of Joint: **NO**
 Remarks:

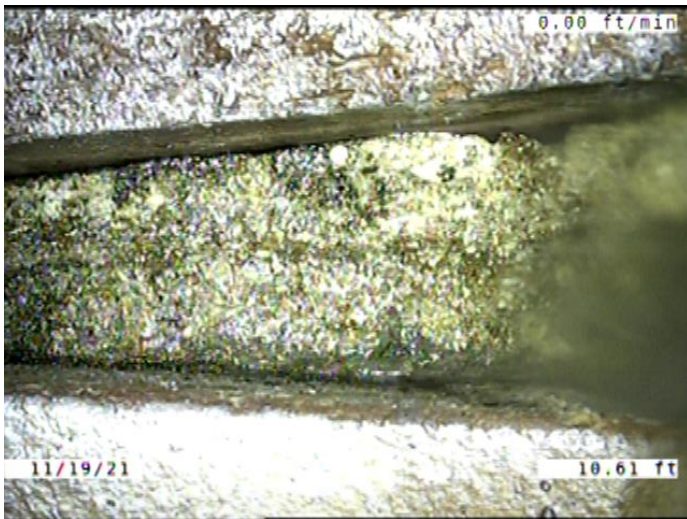
Code: **JAM**
 Description: **Joint Angular Medium**

Distance (ft): **10.6**
 Structural Grade: **3**
 O&M Grade: **0**
 Clock Start/From:
 Clock To:
 1st Value:
 2nd Value:
 Value Percent:
 Continuous Index:
 Within 8" of Joint: **NO**
 Remarks:

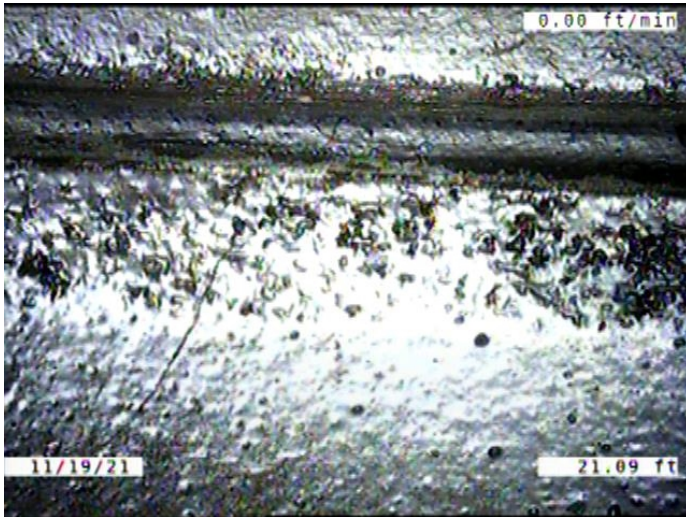
Code: **CS**
Description: **Crack Spiral**

Distance (ft): **21.1**
Structural Grade: **2**
O&M Grade: **0**
Clock Start/From: **9**
Clock To: **11**
1st Value:
2nd Value:
Value Percent:
Continuous Index:
Within 8" of Joint: **YES**
Remarks:

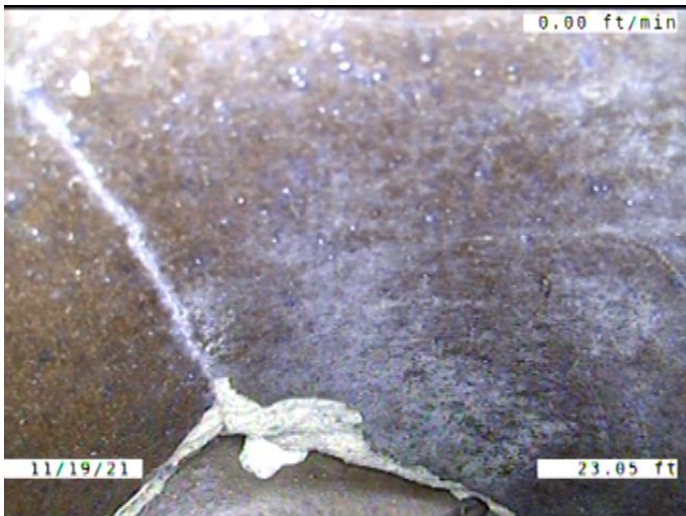
Code: **SSS**
Description: **Surface Damage Surface Spalling**

Distance (ft): **23.0**
Structural Grade: **2**
O&M Grade: **0**
Clock Start/From: **7**
Clock To: **1**
1st Value:
2nd Value:
Value Percent:
Continuous Index:
Within 8" of Joint: **YES**
Remarks:

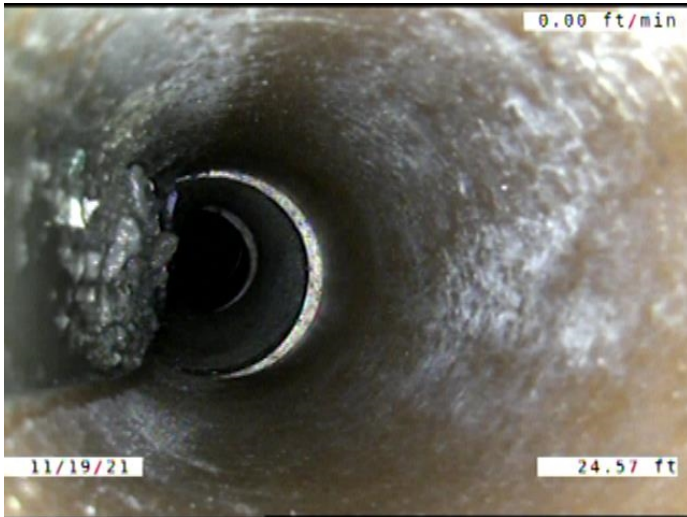
Code: **TBI**
 Description: **Tap Break-in Intruding**

Distance (ft): **24.6**
 Structural Grade: **0**
 O&M Grade: **2**
 Clock Start/From: **9**
 Clock To:
 1st Value: **6.000**
 2nd Value: **2.000**
 Value Percent:
 Continuous Index:
 Within 8" of Joint: **YES**
 Remarks:

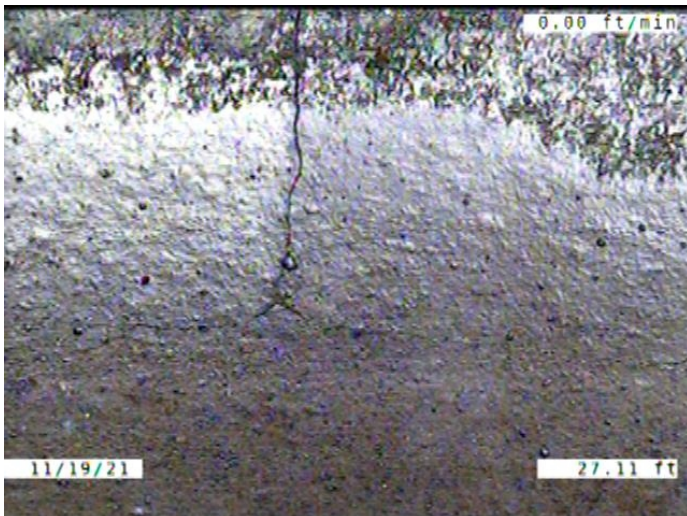
Code: **CM**
 Description: **Crack Multiple**

Distance (ft): **27.1**
 Structural Grade: **3**
 O&M Grade: **0**
 Clock Start/From: **11**
 Clock To: **3**
 1st Value:
 2nd Value:
 Value Percent:
 Continuous Index:
 Within 8" of Joint: **YES**
 Remarks:

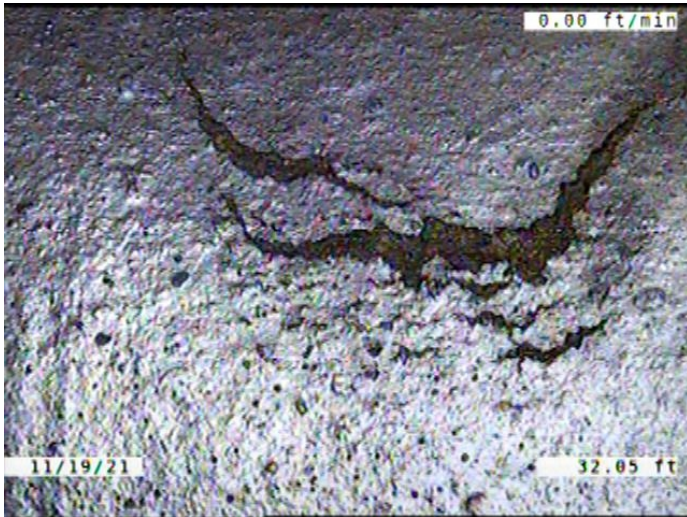
Code: **SSS**
 Description: **Surface Damage Surface Spalling**

Distance (ft): **32.0**
 Structural Grade: **2**
 O&M Grade: **0**
 Clock Start/From: **7**
 Clock To: **9**
 1st Value:
 2nd Value:
 Value Percent:
 Continuous Index:
 Within 8" of Joint: **NO**
 Remarks:

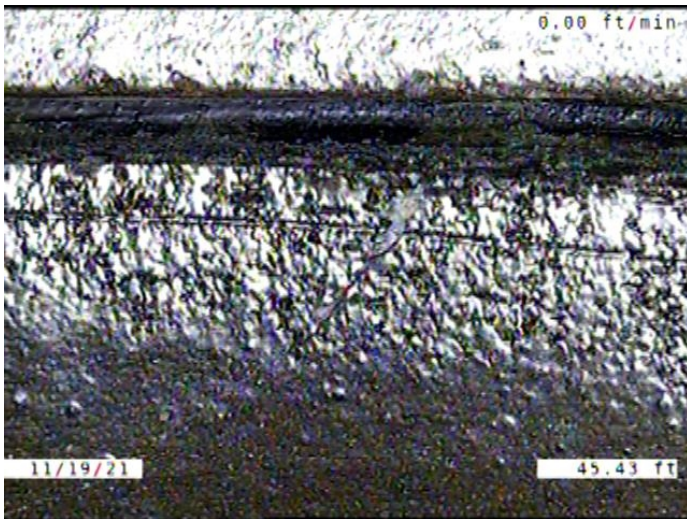
Code: **CS**
 Description: **Crack Spiral**

Distance (ft): **45.4**
 Structural Grade: **2**
 O&M Grade: **0**
 Clock Start/From: **12**
 Clock To: **2**
 1st Value:
 2nd Value:
 Value Percent:
 Continuous Index:
 Within 8" of Joint: **YES**
 Remarks:

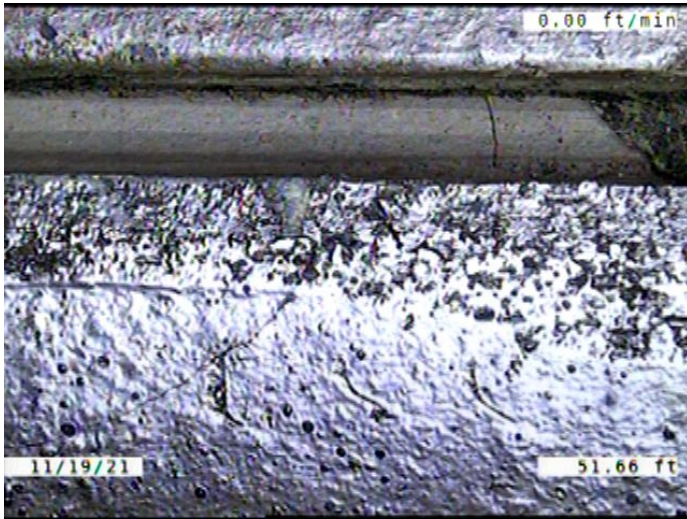
Code: **CM**
 Description: **Crack Multiple**

Distance (ft): **51.7**
 Structural Grade: **3**
 O&M Grade: **0**
 Clock Start/From: **8**
 Clock To: **2**
 1st Value:
 2nd Value:
 Value Percent:
 Continuous Index:
 Within 8" of Joint: **YES**
 Remarks:

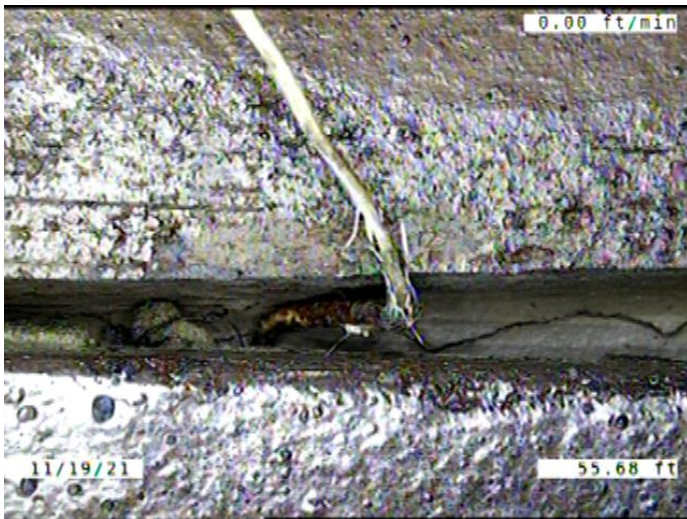
Code: **RFJ**
 Description: **Roots Fine Joint**

Distance (ft): **55.7**
 Structural Grade: **0**
 O&M Grade: **1**
 Clock Start/From: **3**
 Clock To:
 1st Value:
 2nd Value:
 Value Percent:
 Continuous Index:
 Within 8" of Joint: **YES**
 Remarks:

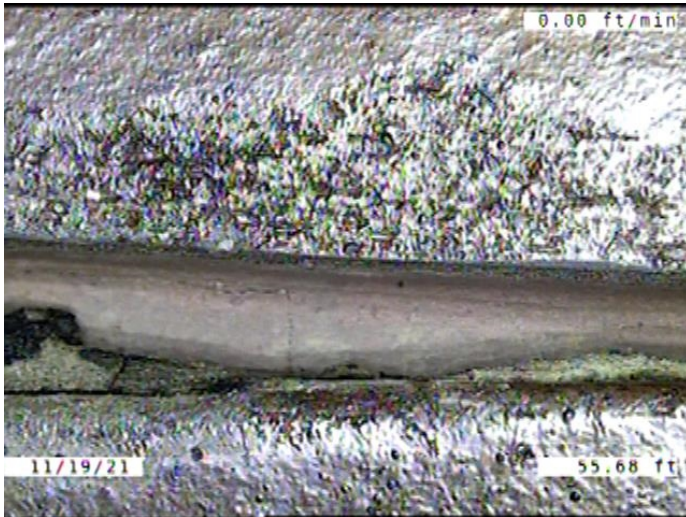
Code: **FM**
 Description: **Fracture Multiple**

Distance (ft): **55.7**
 Structural Grade: **4**
 O&M Grade: **0**
 Clock Start/From: **8**
 Clock To: **4**
 1st Value:
 2nd Value:
 Value Percent:
 Continuous Index:
 Within 8" of Joint: **YES**
 Remarks:

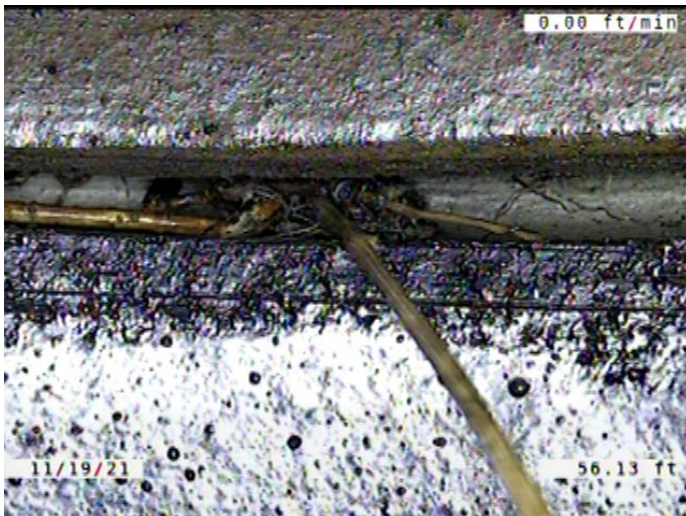
Code: **RFJ**
 Description: **Roots Fine Joint**

Distance (ft): **56.1**
 Structural Grade: **0**
 O&M Grade: **1**
 Clock Start/From: **8**
 Clock To: **3**
 1st Value:
 2nd Value:
 Value Percent:
 Continuous Index: **S01**
 Within 8" of Joint: **YES**
 Remarks:

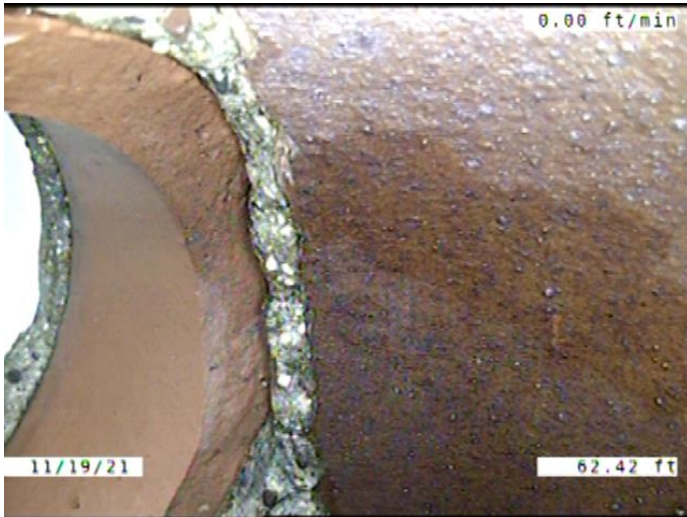
Code: **SSS**
 Description: **Surface Damage Surface Spalling**

Distance (ft): **62.4**
 Structural Grade: **2**
 O&M Grade: **0**
 Clock Start/From: **12**
 Clock To:
 1st Value:
 2nd Value:
 Value Percent:
 Continuous Index:
 Within 8" of Joint: **YES**
 Remarks:

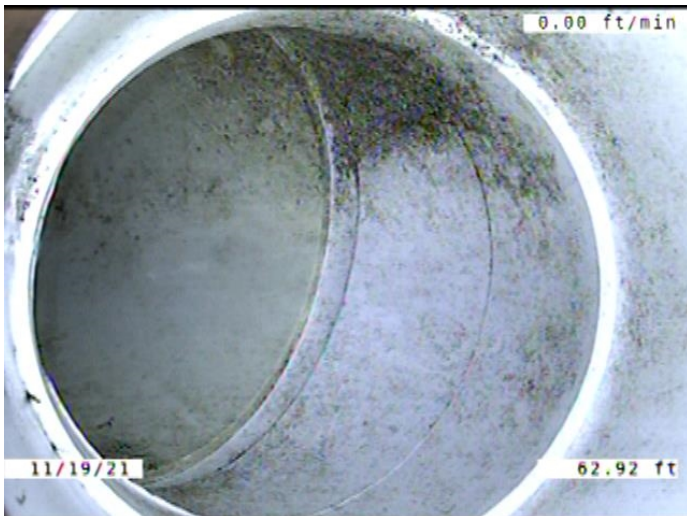
Code: **TBI**
 Description: **Tap Break-in Intruding**

Distance (ft): **62.9**
 Structural Grade: **0**
 O&M Grade: **2**
 Clock Start/From: **11**
 Clock To:
 1st Value: **6.000**
 2nd Value: **1.000**
 Value Percent:
 Continuous Index:
 Within 8" of Joint: **YES**
 Remarks: **CONSTANTLY RUNNING WATER**

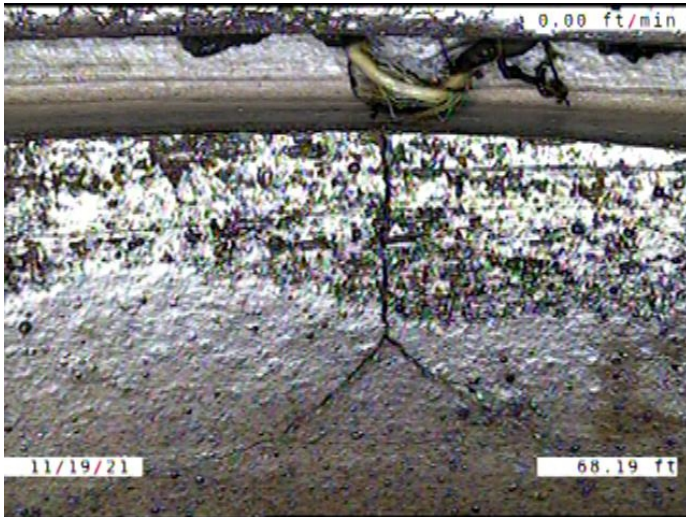
Code: **CM**
Description: **Crack Multiple**

Distance (ft): **68.2**
Structural Grade: **3**
O&M Grade: **0**
Clock Start/From: **8**
Clock To: **1**
1st Value:
2nd Value:
Value Percent:
Continuous Index:
Within 8" of Joint: **YES**
Remarks:

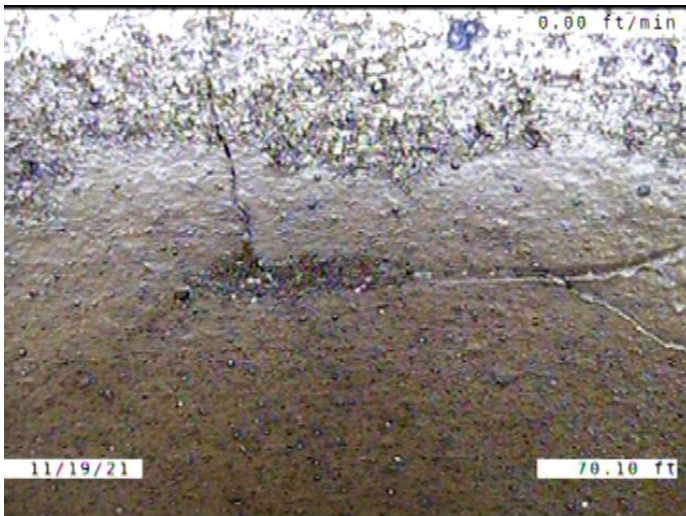
Code: **CM**
Description: **Crack Multiple**

Distance (ft): **70.1**
Structural Grade: **3**
O&M Grade: **0**
Clock Start/From: **11**
Clock To: **4**
1st Value:
2nd Value:
Value Percent:
Continuous Index:
Within 8" of Joint: **YES**
Remarks:

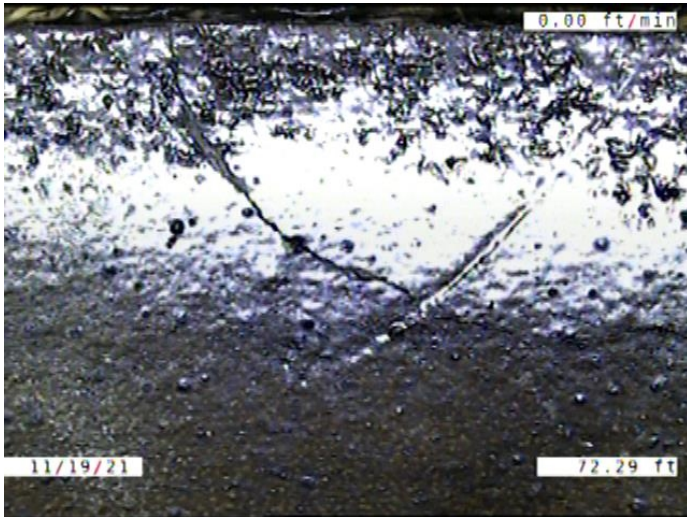
Code: **CM**
 Description: **Crack Multiple**

Distance (ft): **72.3**
 Structural Grade: **3**
 O&M Grade: **0**
 Clock Start/From: **12**
 Clock To: **5**
 1st Value:
 2nd Value:
 Value Percent:
 Continuous Index:
 Within 8" of Joint: **YES**
 Remarks:

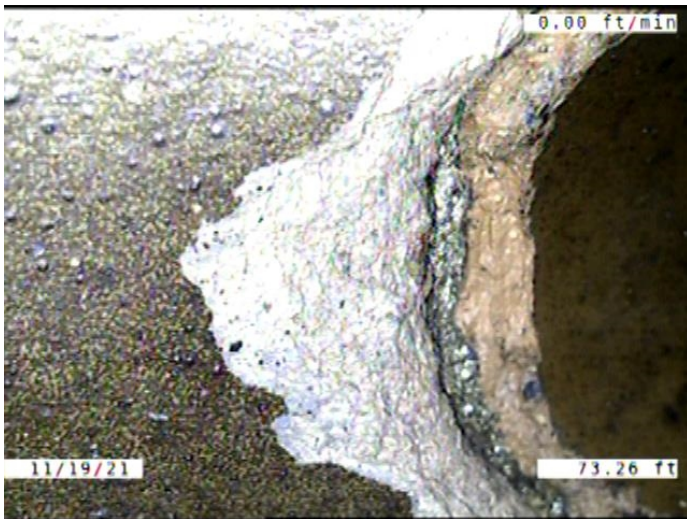
Code: **SSS**
 Description: **Surface Damage Surface Spalling**

Distance (ft): **73.3**
 Structural Grade: **2**
 O&M Grade: **0**
 Clock Start/From: **12**
 Clock To: **2**
 1st Value:
 2nd Value:
 Value Percent:
 Continuous Index:
 Within 8" of Joint: **YES**
 Remarks:

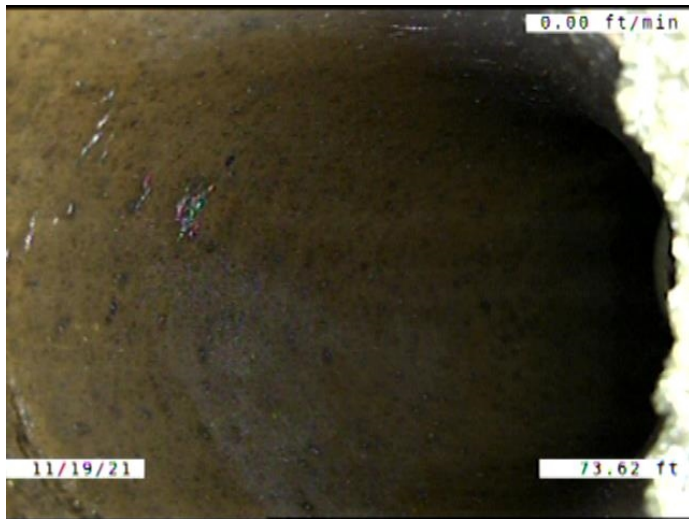
Code: **TB**
 Description: **Tap Break-in/Hammer**

Distance (ft): **73.6**
 Structural Grade: **0**
 O&M Grade: **0**
 Clock Start/From: **1**
 Clock To:
 1st Value: **4.000**
 2nd Value:
 Value Percent:
 Continuous Index:
 Within 8" of Joint: **YES**
 Remarks:

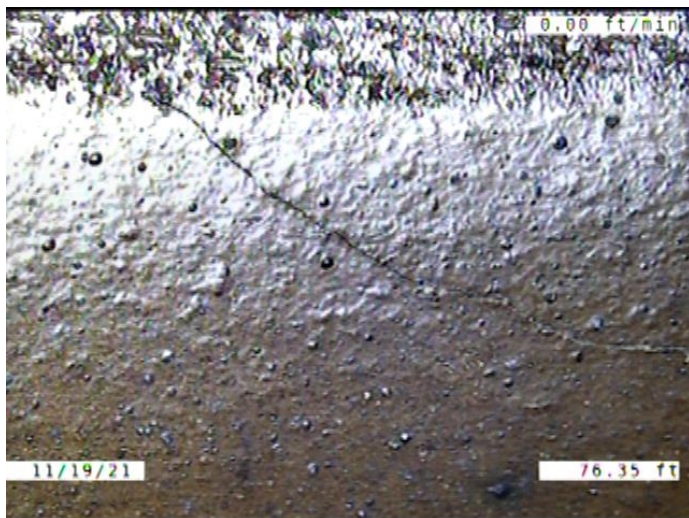
Code: **CM**
 Description: **Crack Multiple**

Distance (ft): **76.4**
 Structural Grade: **3**
 O&M Grade: **0**
 Clock Start/From: **8**
 Clock To: **11**
 1st Value:
 2nd Value:
 Value Percent:
 Continuous Index:
 Within 8" of Joint: **YES**
 Remarks:

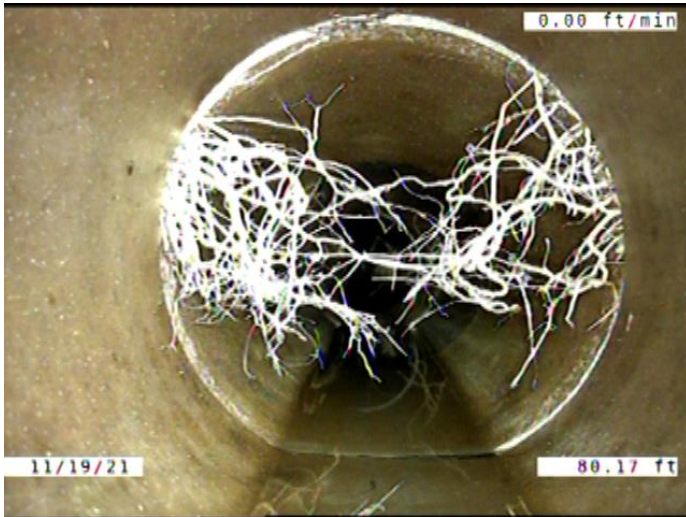
Code: **RMJ**
 Description: **Roots Medium Joint**

Distance (ft): **80.2**
 Structural Grade: **0**
 O&M Grade: **3**
 Clock Start/From: **8**
 Clock To: **4**
 1st Value:
 2nd Value:
 Value Percent: **5.000**
 Continuous Index:
 Within 8" of Joint: **YES**
 Remarks:

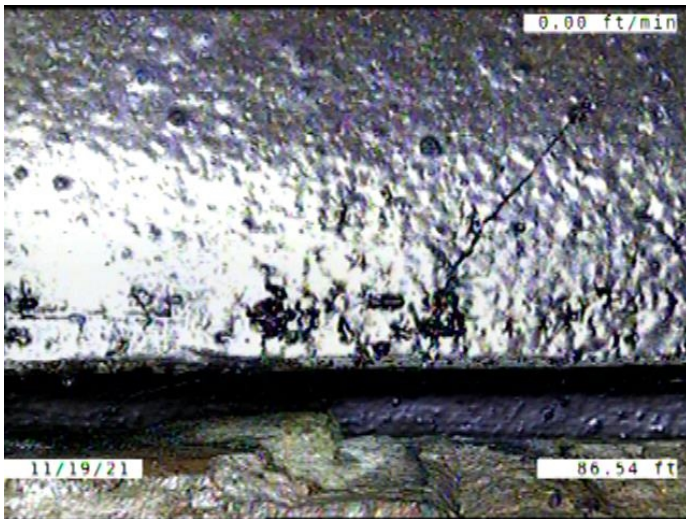
Code: **CS**
 Description: **Crack Spiral**

Distance (ft): **86.5**
 Structural Grade: **2**
 O&M Grade: **0**
 Clock Start/From: **2**
 Clock To: **4**
 1st Value:
 2nd Value:
 Value Percent:
 Continuous Index:
 Within 8" of Joint: **YES**
 Remarks:

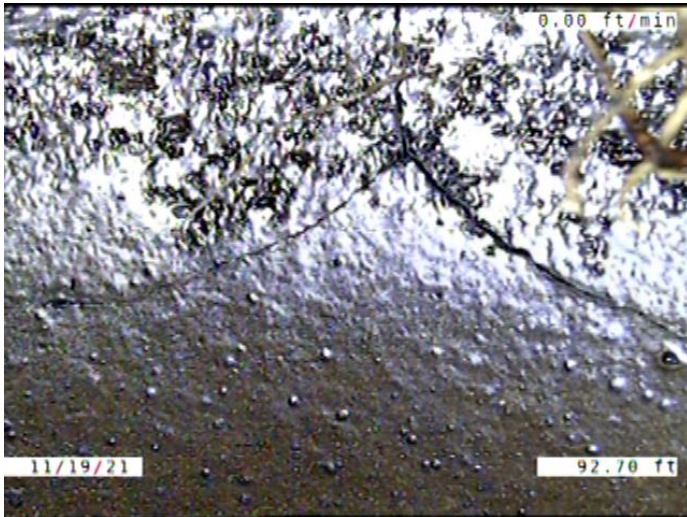
Code: **FM**
 Description: **Fracture Multiple**

Distance (ft): **92.7**
 Structural Grade: **4**
 O&M Grade: **0**
 Clock Start/From: **11**
 Clock To: **8**
 1st Value:
 2nd Value:
 Value Percent:
 Continuous Index:
 Within 8" of Joint: **YES**
 Remarks:

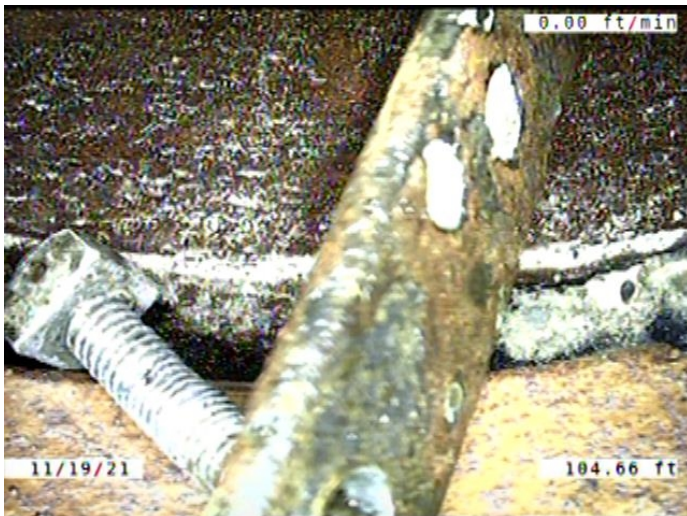
Code: **OBN**
 Description: **Obstruction Construction Debris**

Distance (ft): **104.7**
 Structural Grade: **0**
 O&M Grade: **2**
 Clock Start/From: **5**
 Clock To: **7**
 1st Value:
 2nd Value:
 Value Percent: **5.000**
 Continuous Index:
 Within 8" of Joint: **YES**
 Remarks:

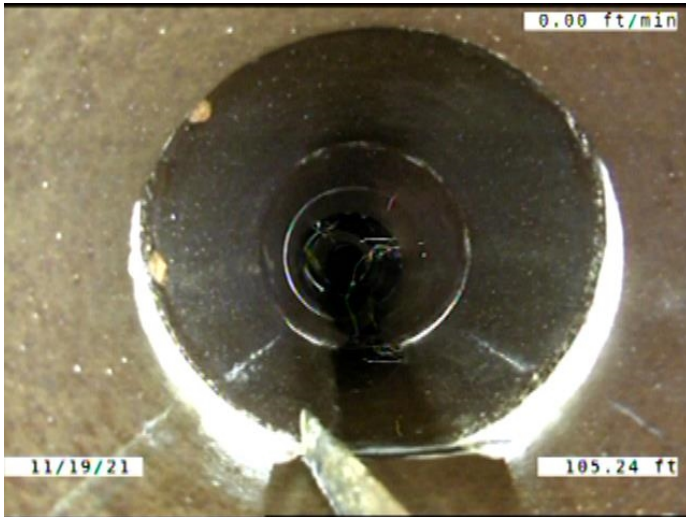
Code: **RFJ**
 Description: **Roots Fine Joint**

Distance (ft): **105.2**
 Structural Grade: **0**
 O&M Grade: **1**
 Clock Start/From: **8**
 Clock To: **3**
 1st Value:
 2nd Value:
 Value Percent:
 Continuous Index: **F01**
 Within 8" of Joint: **YES**
 Remarks:

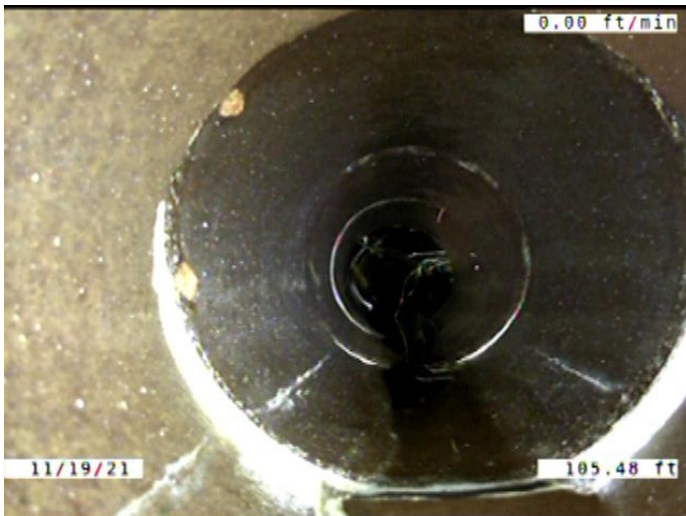
Code: **MSA**
 Description: **Miscellaneous Survey Abandoned**

Distance (ft): **105.5**
 Structural Grade: **0**
 O&M Grade: **0**
 Clock Start/From:
 Clock To:
 1st Value:
 2nd Value:
 Value Percent:
 Continuous Index:
 Within 8" of Joint: **NO**
 Remarks: **MADE IT TO THE POINT OF OVERLAP.
 REVERSAL COMPLETE.**
