Profile/Photo Observation Report

Street:	MUNICIPAL DR & S ASH ST	Flow Control:	Not Controlled
City:	Hobart, IN	Year Renewed:	
Location:	Light Highway	Tape/Media #:	
Purpose:	Maintenance Related	Dia/Height:	12"
Use:	Sanitary	Material:	VCP
Drain Area:	NA	Lining:	Cured in Place
Category:	NA		
Comment:	Underwater at 115'.

Location Details:		Direction of Survey:	Upstream
US MH:	M-605-075	DS MH:	M-605-074
		Total Length Surveyed (ft):	116.8

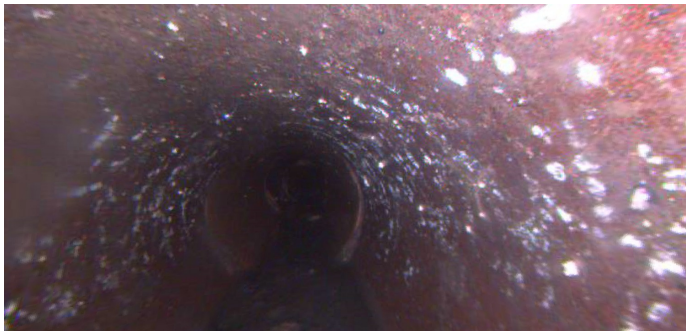
Code: **AMH**
Description: **Manhole**

Distance (ft): **.0**
Structural Grade: **0**
O&M Grade: **0**
Clock Start/From:
Clock To:
1st Value:
2nd Value:
Value Percent:
Continuous Index:
Within 8" of Joint: **NO**
Remarks: **M-605-074**

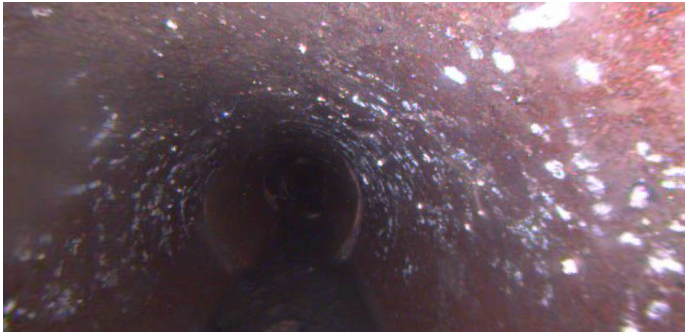
Code:	MWL
Description:	Water Level

Distance (ft):	.0
Structural Grade:	0
O&M Grade:	0
Clock Start/From:	
Clock To:	
1st Value:	
2nd Value:	
Value Percent:	5.000
Continuous Index:	
Within 8" of Joint:	NO
Remarks:

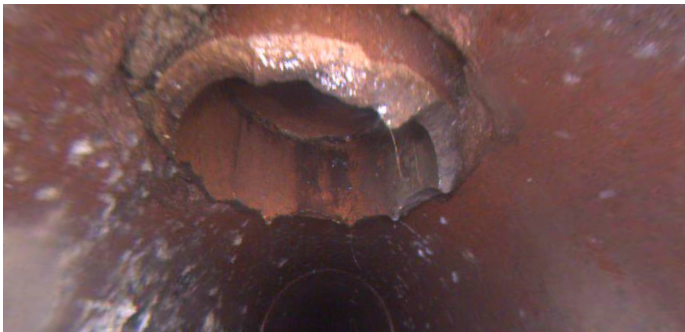
Code:	TBI
Description:	Tap Break-in Intruding

Distance (ft):	6.7
Structural Grade:	0
O&M Grade:	2
Clock Start/From:	12
Clock To:	
1st Value:	4.000
2nd Value:	1.000
Value Percent:	
Continuous Index:	
Within 8" of Joint:	
Remarks:

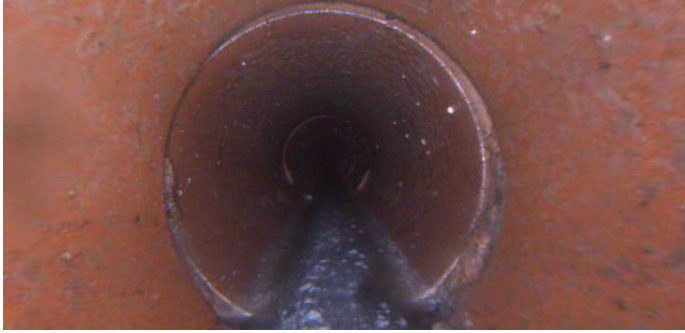
Code: **DAE**
Description: **Deposits Attached Encrustation**

Distance (ft): **10.2**
Structural Grade: **0**
O&M Grade: **2**
Clock Start/From: **8**
Clock To: **4**
1st Value:
2nd Value:
Value Percent: **5.000**
Continuous Index: **S01**
Within 8" of Joint: **YES**
Remarks:

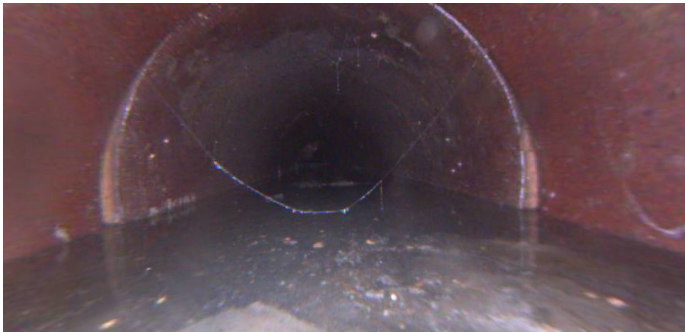
Code: **MWL**
Description: **Water Level**

Distance (ft): **53.8**
Structural Grade: **0**
O&M Grade: **0**
Clock Start/From:
Clock To:
1st Value:
2nd Value:
Value Percent: **40.000**
Continuous Index:
Within 8" of Joint: **NO**
Remarks:

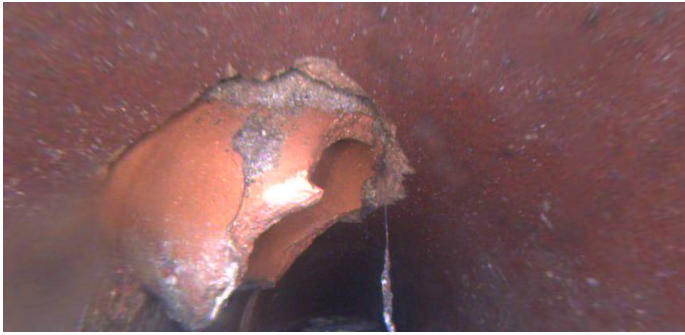
Code: **TBI**
Description: **Tap Break-in Intruding**

Distance (ft): **59.0**
Structural Grade: **0**
O&M Grade: **2**
Clock Start/From: **10**
Clock To:
1st Value: **4.000**
2nd Value: **2.000**
Value Percent:
Continuous Index:
Within 8" of Joint:
Remarks:

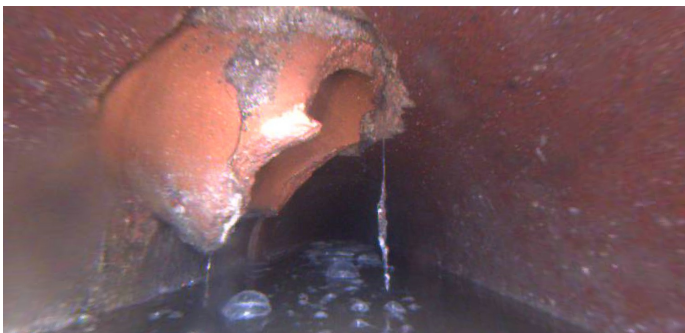
Code: **RFB**
Description: **Roots Fine Barrel**

Distance (ft): **59.0**
Structural Grade: **0**
O&M Grade: **2**
Clock Start/From: **12**
Clock To:
1st Value:
2nd Value:
Value Percent:
Continuous Index:
Within 8" of Joint: **NO**
Remarks:

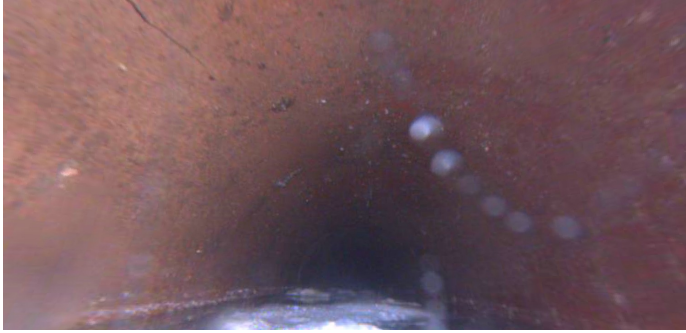
Code: **FL**
Description: **Fracture Longitudinal**

Distance (ft): **60.4**
Structural Grade: **3**
O&M Grade: **0**
Clock Start/From: **11**
Clock To:
1st Value:
2nd Value:
Value Percent:
Continuous Index:
Within 8" of Joint: **YES**
Remarks:

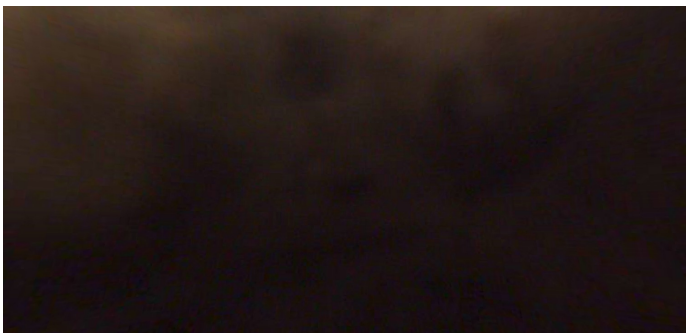
Code: **MWL**
Description: **Water Level**

Distance (ft): **111.4**
Structural Grade: **0**
O&M Grade: **0**
Clock Start/From:
Clock To:
1st Value:
2nd Value:
Value Percent: **100.000**
Continuous Index:
Within 8" of Joint: **NO**
Remarks:

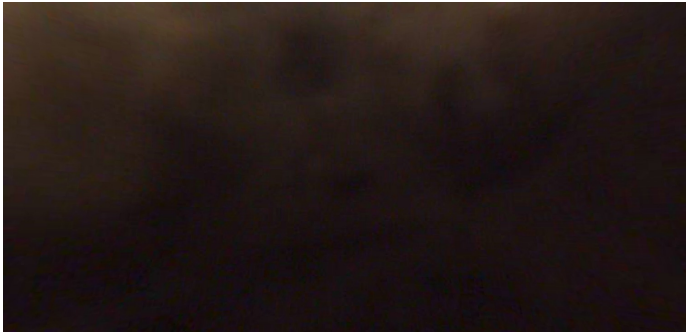
Code: **MCU**
Description: **Camera Underwater**

Distance (ft): **111.4**
Structural Grade: **0**
O&M Grade: **4**
Clock Start/From:
Clock To:
1st Value:
2nd Value:
Value Percent:
Continuous Index:
Within 8" of Joint: **NO**
Remarks:
