Profile/Photo Observation Report

Date:	04/25/2018	Weather:		Coding:	PACP 6.0
Pipe Length (ft):	163.6	Owner:	NA	Pre Clean:	Not Known
P.O.#:		Surveyor:	Jen Costello	PSR:	P-605-074-075
Customer:		Clean Date:	01/01/1900	Shape:	C

Street:	Ash	Flow Control:	Not Controlled
City:	Hobart, IN	Year Renewed:	
Location:	Light Highway	Tape/Media #:	
Purpose:	Maintenance Related	Dia/Height:	12"
Use:	Sanitary	Material:	VCP
Drain Area:	NA	Lining:	Cured in Place
Category:	NA		
Comment:	Underwater at 115'.

Location Details:		Direction of Survey:	Upstream
US MH:	M-605-075	DS MH:	M-605-074
		Total Length Surveyed (ft):	116.8

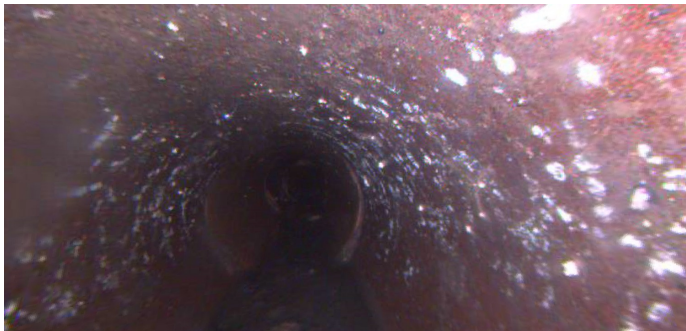
Code: **AMH**
Description: **Manhole**

Distance (ft): **.0**
Structural Grade: **0**
O&M Grade: **0**
Clock Start/From:
Clock To:
1st Value:
2nd Value:
Value Percent:
Continuous Index:
Within 8" of Joint: **NO**
Remarks: **M-605-074**

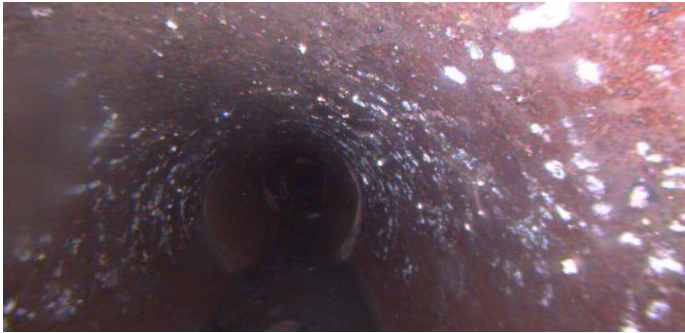
Code:	MWL
Description:	Water Level

Distance (ft):	.0
Structural Grade:	0
O&M Grade:	0
Clock Start/From:	
Clock To:	
1st Value:	
2nd Value:	
Value Percent:	5.000
Continuous Index:	
Within 8" of Joint:	NO
Remarks:

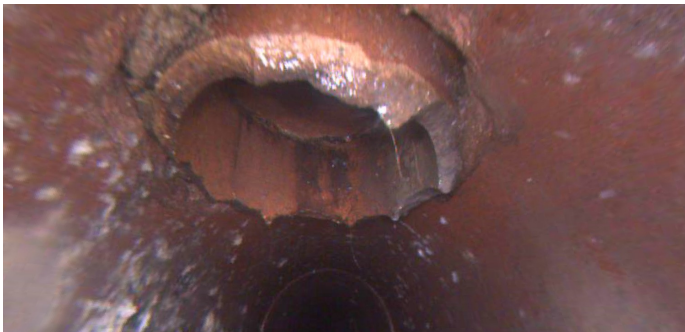
Code:	TBI
Description:	Tap Break-in Intruding

Distance (ft):	6.7
Structural Grade:	0
O&M Grade:	2
Clock Start/From:	12
Clock To:	
1st Value:	4.000
2nd Value:	1.000
Value Percent:	
Continuous Index:	
Within 8" of Joint:	
Remarks:

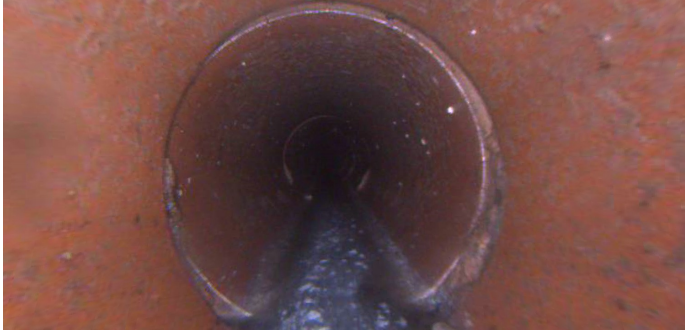
Code: **DAE**
Description: **Deposits Attached Encrustation**

Distance (ft): **10.2**
Structural Grade: **0**
O&M Grade: **2**
Clock Start/From: **8**
Clock To: **4**
1st Value:
2nd Value:
Value Percent: **5.000**
Continuous Index: **S01**
Within 8" of Joint: **YES**
Remarks:

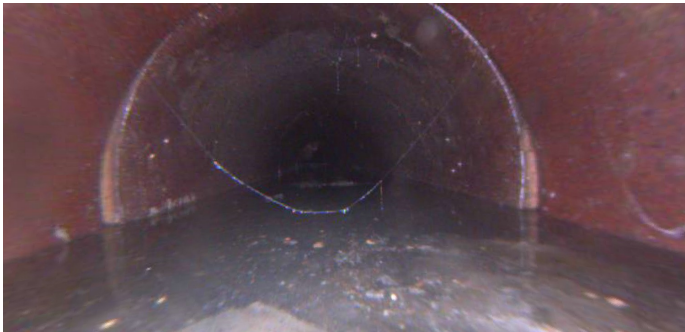
Code: **MWL**
Description: **Water Level**

Distance (ft): **53.8**
Structural Grade: **0**
O&M Grade: **0**
Clock Start/From:
Clock To:
1st Value:
2nd Value:
Value Percent: **40.000**
Continuous Index:
Within 8" of Joint: **NO**
Remarks:

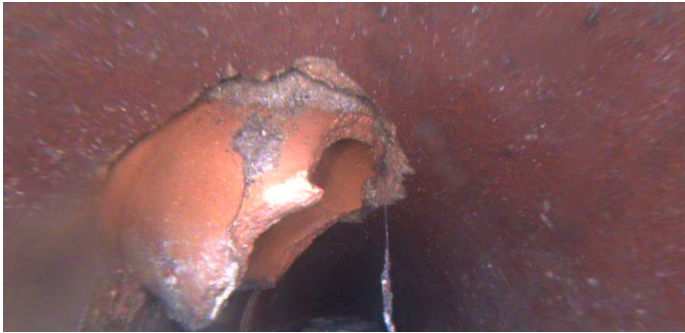
Code: **TBI**
Description: **Tap Break-in Intruding**

Distance (ft): **59.0**
Structural Grade: **0**
O&M Grade: **2**
Clock Start/From: **10**
Clock To:
1st Value: **4.000**
2nd Value: **2.000**
Value Percent:
Continuous Index:
Within 8" of Joint:
Remarks:

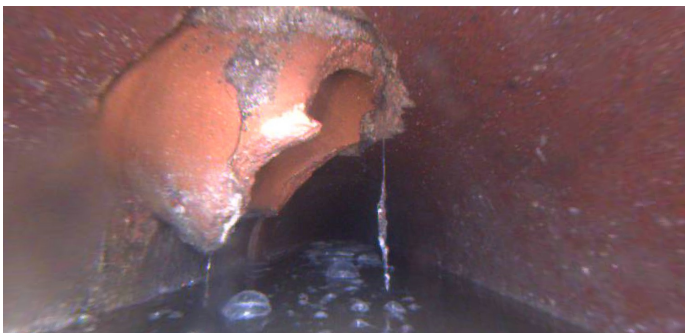
Code: **RFB**
Description: **Roots Fine Barrel**

Distance (ft): **59.0**
Structural Grade: **0**
O&M Grade: **2**
Clock Start/From: **12**
Clock To:
1st Value:
2nd Value:
Value Percent:
Continuous Index:
Within 8" of Joint: **NO**
Remarks:

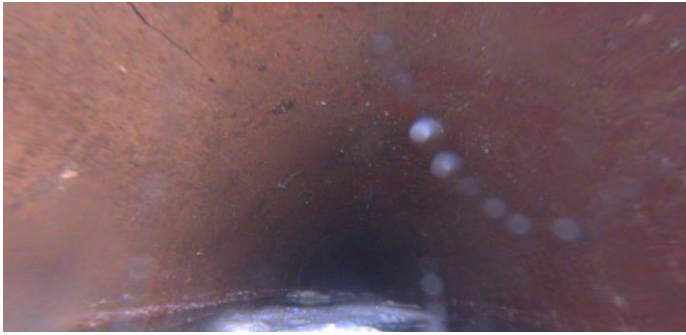
Code: **FL**
Description: **Fracture Longitudinal**

Distance (ft): **60.4**
Structural Grade: **3**
O&M Grade: **0**
Clock Start/From: **11**
Clock To:
1st Value:
2nd Value:
Value Percent:
Continuous Index:
Within 8" of Joint: **YES**
Remarks:
