## Profile/Photo Observation Report

Date:	<b>04/25/2018</b>	Weather:		Coding:	<b>PACP 6.0</b>
Pipe Length (ft):	<b>163.6</b>	Owner:	<b>NA</b>	Pre Clean:	<b>Not Known</b>
P.O.#:		Surveyor:	<b>Jen Costello</b>	PSR:	<b>P-605-074-075</b>
Customer:		Clean Date:	<b>01/01/1900</b>	Shape:	<b>C</b>

Street:	<b>Ash</b>	Flow Control:	<b>Not Controlled</b>
City:	<b>Hobart, IN</b>	Year Renewed:	
Location:	<b>Light Highway</b>	Tape/Media #:	
Purpose:	<b>Maintenance Related</b>	Dia/Height:	<b>12"</b>
Use:	<b>Sanitary</b>	Material:	<b>VCP</b>
Drain Area:	<b>NA</b>	Lining:	<b>Cured in Place</b>
Category:	<b>NA</b>		
Comment:	<b>Flow direction wrong. Root ball in pipe entrance.</b>		
Location Details:		Direction of Survey:	<b>Downstream</b>
US MH:	<b>M-605-075</b>	DS MH:	<b>M-605-074</b>
		Total Length Surveyed (ft):	<b>.4</b>

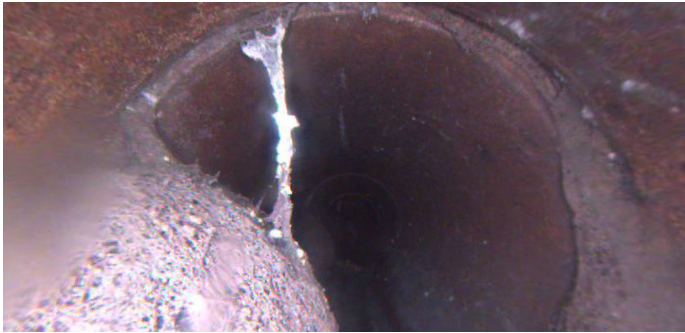
Code:	<b>MWL</b>
Description:	<b>Water Level</b>

Distance (ft):	<b>.0</b>
Structural Grade:	<b>0</b>
O&M Grade:	<b>0</b>
Clock Start/From:	
Clock To:	
1st Value:	
2nd Value:	
Value Percent:	<b>5.000</b>
Continuous Index:	
Within 8" of Joint:	<b>NO</b>
Remarks:

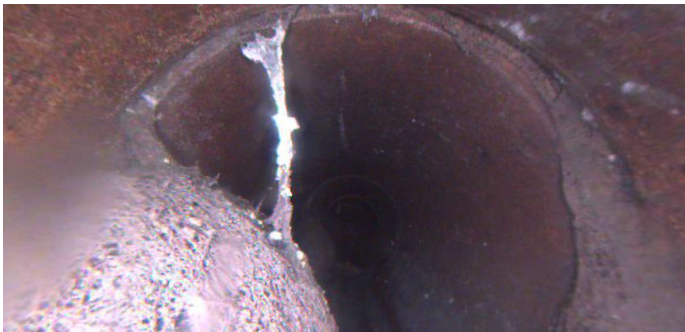
Code:	<b>RMJ</b>
Description:	<b>Roots Medium Joint</b>

Distance (ft):	<b>.0</b>
Structural Grade:	<b>0</b>
O&M Grade:	<b>3</b>
Clock Start/From:	<b>6</b>
Clock To:	<b>9</b>
1st Value:	
2nd Value:	
Value Percent:	<b>30.000</b>
Continuous Index:	
Within 8" of Joint:	<b>YES</b>
Remarks:

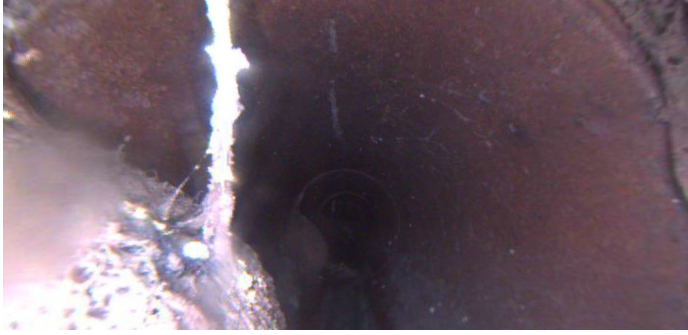
Code:	<b>MSA</b>
Description:	<b>Abandoned Survey</b>
Distance (ft):	<b>.4</b>
Structural Grade:	<b>0</b>
O&M Grade:	<b>0</b>
Clock Start/From:	
Clock To:	
1st Value:	
2nd Value:	
Value Percent:	
Continuous Index:	
Within 8" of Joint:	<b>NO</b>
Remarks:	<b>roots</b>
