Profile/Photo Observation Report

Date:	11/18/2021	Weather:		Coding:	PACP 7.0
Pipe Length (ft):	160.4	Owner:	City of Hobart	Pre Clean:	Heavy Cleaning
P.O.#:	YES502259	Surveyor:	S. Bucklin	PSR:	P-605-074-075
Customer:	City of Hobart	Clean Date:	11/18/2021	Shape:	C

Street:	South Ash Street	Flow Control:	Not Controlled
City:	Hobart, IN	Year Renewed:	
Location:	Local rural streets with light traffic, t	Tape/Media #:	
Purpose:	Routine Assessment	Dia/Height:	10"
Use:	Sanitary Sewage Pipe	Material:	VCP
Drain Area:		Lining:	None
Category:	NA		
Comment:			
Location Details:		Direction of Survey:	Downstream
US MH:	M-605-075	DS MH:	M-605-074
		Total Length Surveyed (ft):	160.4

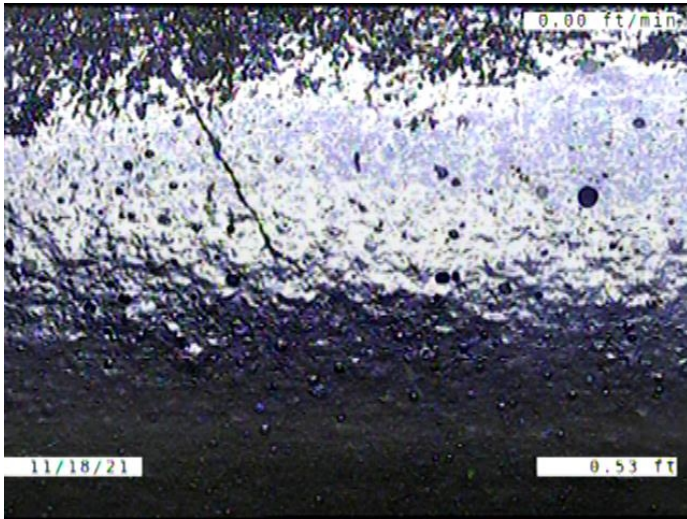
Code: **CM**
 Description: **Crack Multiple**

Distance (ft): **.5**
 Structural Grade: **3**
 O&M Grade: **0**
 Clock Start/From: **12**
 Clock To: **1**
 1st Value:
 2nd Value:
 Value Percent:
 Continuous Index:
 Within 8" of Joint: **YES**
 Remarks:

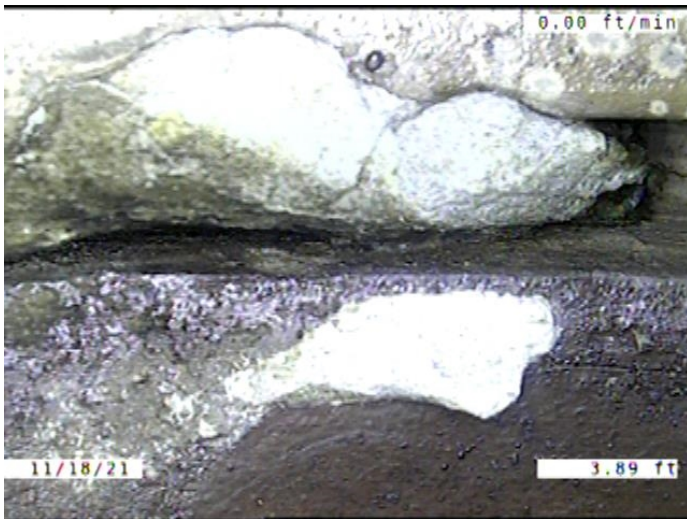
Code: **ISGT**
 Description: **Intruding Sealing Material Grout**

Distance (ft): **3.9**
 Structural Grade: **0**
 O&M Grade: **2**
 Clock Start/From: **12**
 Clock To: **12**
 1st Value:
 2nd Value:
 Value Percent: **5.000**
 Continuous Index: **S01**
 Within 8" of Joint: **NO**
 Remarks:

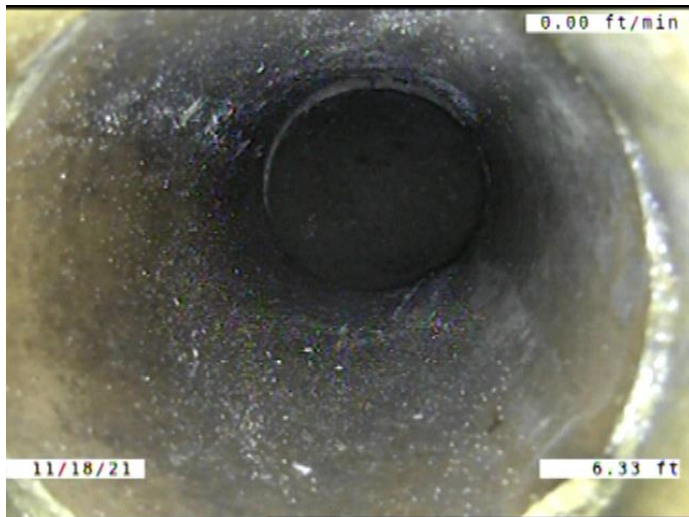
Code: **TBI**
 Description: **Tap Break-in Intruding**

Distance (ft): **6.3**
 Structural Grade: **0**
 O&M Grade: **2**
 Clock Start/From: **12**
 Clock To:
 1st Value: **6.000**
 2nd Value: **1.000**
 Value Percent:
 Continuous Index:
 Within 8" of Joint: **YES**
 Remarks:

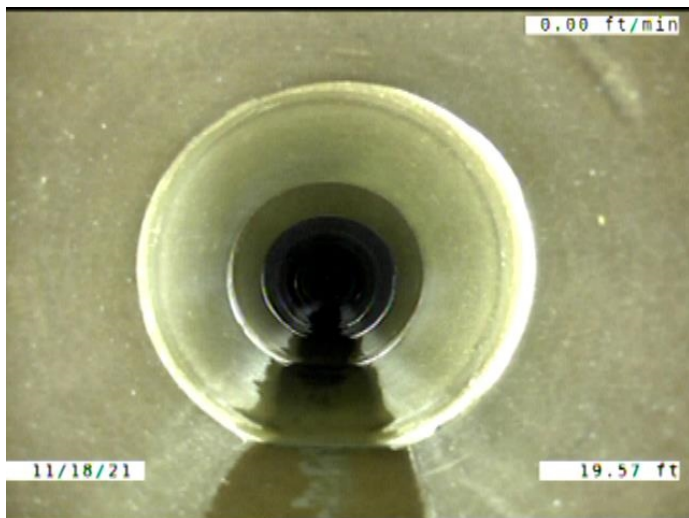
Code: **ISGT**
 Description: **Intruding Sealing Material Grout**

Distance (ft): **19.6**
 Structural Grade: **0**
 O&M Grade: **2**
 Clock Start/From: **12**
 Clock To: **12**
 1st Value:
 2nd Value:
 Value Percent: **5.000**
 Continuous Index: **F01**
 Within 8" of Joint: **NO**
 Remarks:

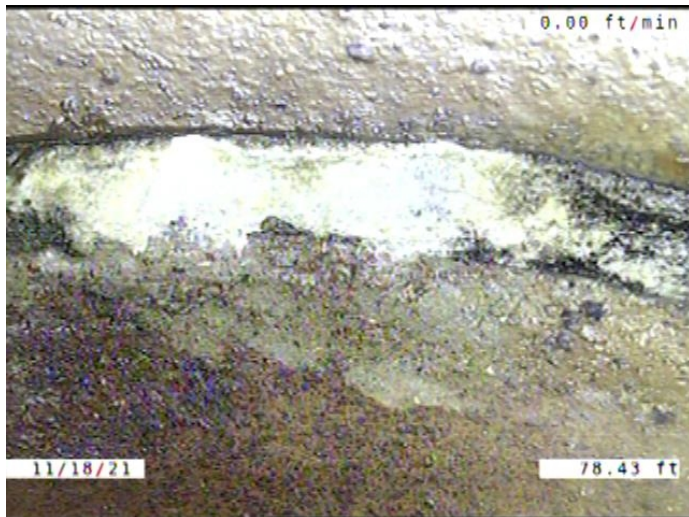
Code: **ISGT**
 Description: **Intruding Sealing Material Grout**

Distance (ft): **78.4**
 Structural Grade: **0**
 O&M Grade: **2**
 Clock Start/From: **3**
 Clock To: **10**
 1st Value:
 2nd Value:
 Value Percent: **5.000**
 Continuous Index:
 Within 8" of Joint: **NO**
 Remarks:

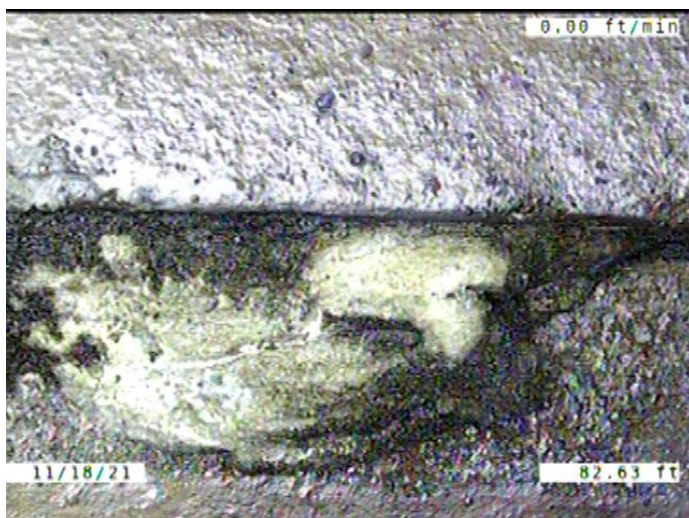
Code: **ISGT**
 Description: **Intruding Sealing Material Grout**

Distance (ft): **82.6**
 Structural Grade: **0**
 O&M Grade: **2**
 Clock Start/From: **2**
 Clock To: **10**
 1st Value:
 2nd Value:
 Value Percent: **5.000**
 Continuous Index:
 Within 8" of Joint: **NO**
 Remarks:

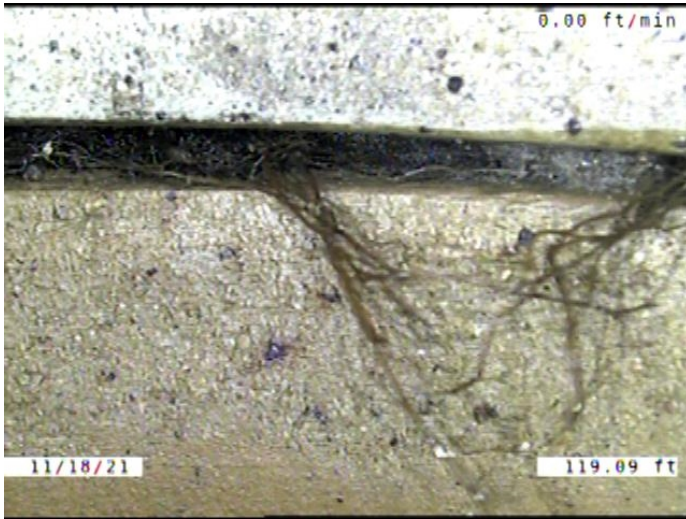
Code: **RFJ**
Description: **Roots Fine Joint**

Distance (ft): **119.1**
Structural Grade: **0**
O&M Grade: **1**
Clock Start/From: **10**
Clock To: **3**
1st Value:
2nd Value:
Value Percent:
Continuous Index:
Within 8" of Joint: **YES**
Remarks:

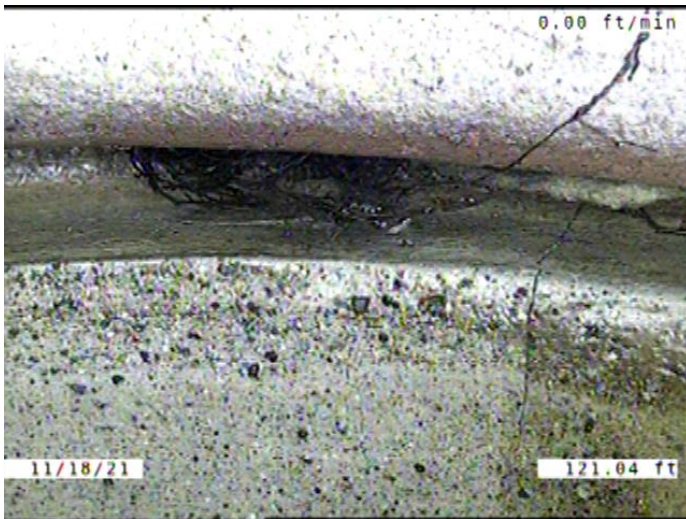
Code: **RFJ**
Description: **Roots Fine Joint**

Distance (ft): **121.0**
Structural Grade: **0**
O&M Grade: **1**
Clock Start/From: **2**
Clock To: **3**
1st Value:
2nd Value:
Value Percent:
Continuous Index:
Within 8" of Joint: **YES**
Remarks:

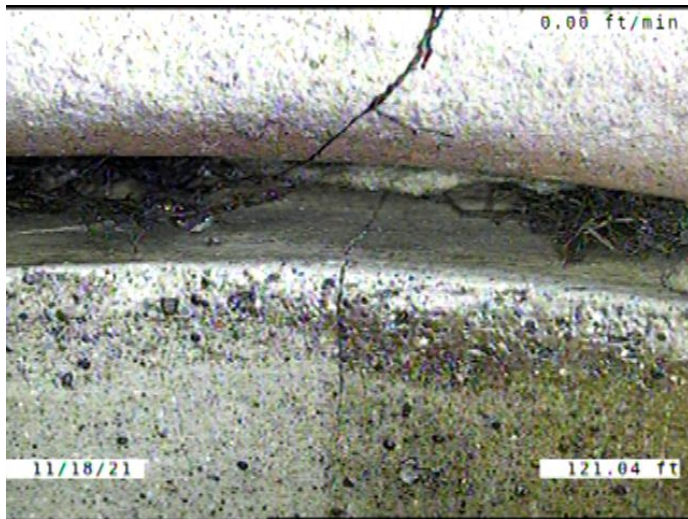
Code: **CL**
Description: **Crack Longitudinal**

Distance (ft): **121.0**
Structural Grade: **2**
O&M Grade: **0**
Clock Start/From: **2**
Clock To:
1st Value:
2nd Value:
Value Percent:
Continuous Index:
Within 8" of Joint: **YES**
Remarks:

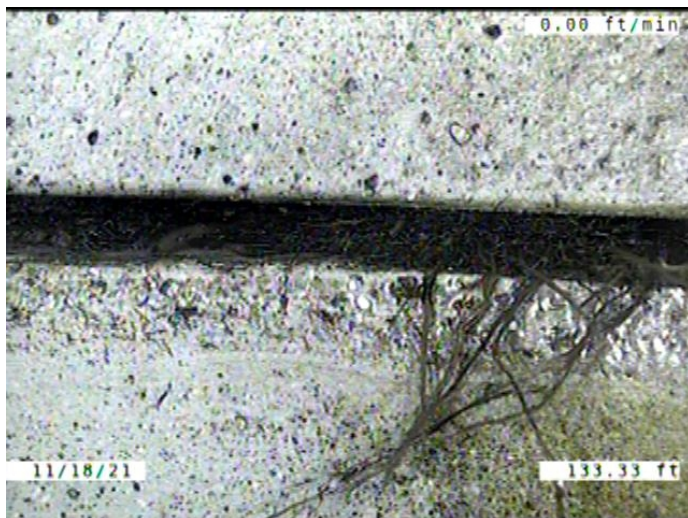
Code: **RFJ**
Description: **Roots Fine Joint**

Distance (ft): **133.3**
Structural Grade: **0**
O&M Grade: **1**
Clock Start/From: **9**
Clock To: **4**
1st Value:
2nd Value:
Value Percent:
Continuous Index: **S02**
Within 8" of Joint: **YES**
Remarks:

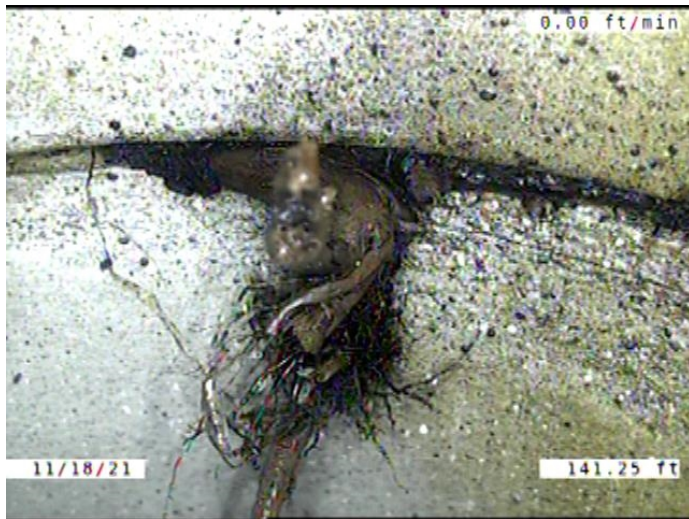
Code: **RTJ**
 Description: **Roots Tap Joint**

Distance (ft): **141.3**
 Structural Grade: **0**
 O&M Grade: **2**
 Clock Start/From: **1**
 Clock To: **2**
 1st Value:
 2nd Value:
 Value Percent: **5.000**
 Continuous Index:
 Within 8" of Joint: **YES**
 Remarks:

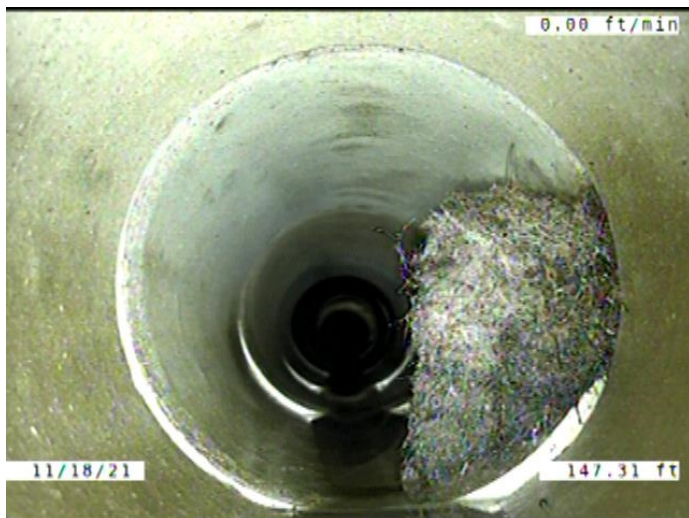
Code: **RMJ**
 Description: **Roots Medium Joint**

Distance (ft): **147.3**
 Structural Grade: **0**
 O&M Grade: **3**
 Clock Start/From: **2**
 Clock To: **6**
 1st Value:
 2nd Value:
 Value Percent: **20.000**
 Continuous Index:
 Within 8" of Joint: **YES**
 Remarks:
