Profile/Photo Observation Report

Date:	11/18/2021	Weather:		Coding:	PACP 7.0
Pipe Length (ft):	160.4	Owner:	City of Hobart	Pre Clean:	Heavy Cleaning
P.O.#:	YES502259	Surveyor:	S. Bucklin	PSR:	P-605-074-075
Customer:	City of Hobart	Clean Date:	11/18/2021	Shape:	C

Street:	South Ash Street	Flow Control:	Not Controlled
City:	Hobart, IN	Year Renewed:	
Location:	Local rural streets with light traffic, t	Tape/Media #:	
Purpose:	Routine Assessment	Dia/Height:	10"
Use:	Sanitary Sewage Pipe	Material:	VCP
Drain Area:		Lining:	None
Category:	NA		
Comment:			
Location Details:		Direction of Survey:	Downstream
US MH:	M-605-075	DS MH:	M-605-074
		Total Length Surveyed (ft):	160.4

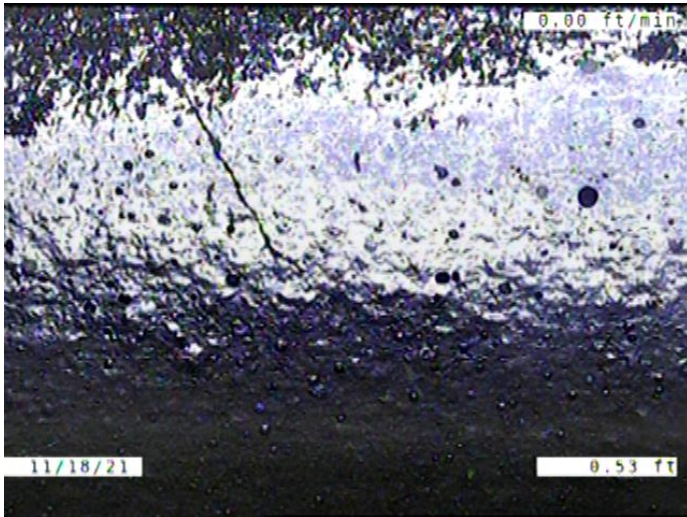
Code: **CM**
 Description: **Crack Multiple**

Distance (ft): **.5**
 Structural Grade: **3**
 O&M Grade: **0**
 Clock Start/From: **12**
 Clock To: **1**
 1st Value:
 2nd Value:
 Value Percent:
 Continuous Index:
 Within 8" of Joint: **YES**
 Remarks:

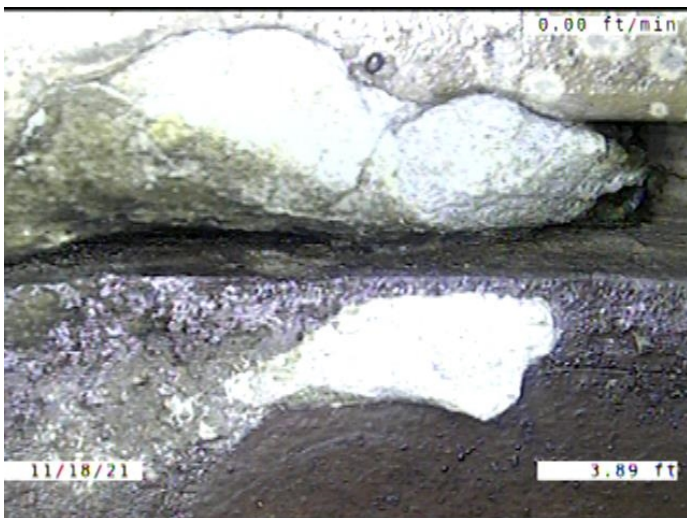
Code: **ISGT**
 Description: **Intruding Sealing Material Grout**

Distance (ft): **3.9**
 Structural Grade: **0**
 O&M Grade: **2**
 Clock Start/From: **12**
 Clock To: **12**
 1st Value:
 2nd Value:
 Value Percent: **5.000**
 Continuous Index: **S01**
 Within 8" of Joint: **NO**
 Remarks:

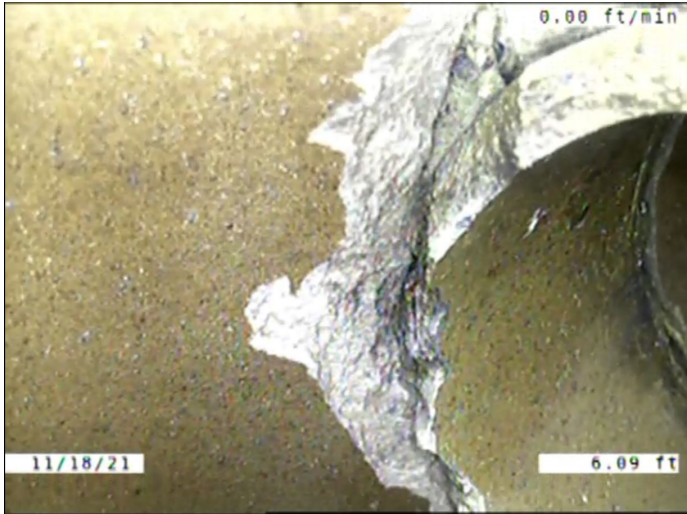
Code: **SSS**
 Description: **Surface Damage Surface Spalling**

Distance (ft): **6.1**
 Structural Grade: **2**
 O&M Grade: **0**
 Clock Start/From: **11**
 Clock To: **2**
 1st Value:
 2nd Value:
 Value Percent:
 Continuous Index:
 Within 8" of Joint: **NO**
 Remarks:

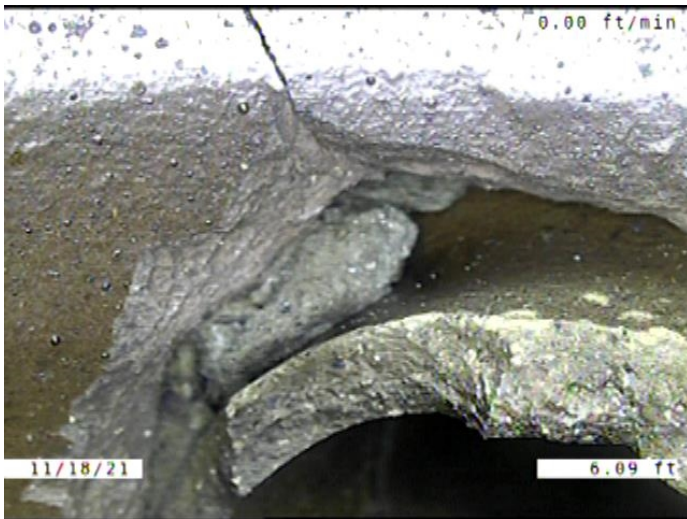
Code: **CM**
 Description: **Crack Multiple**

Distance (ft): **6.1**
 Structural Grade: **3**
 O&M Grade: **0**
 Clock Start/From: **11**
 Clock To: **2**
 1st Value:
 2nd Value:
 Value Percent:
 Continuous Index:
 Within 8" of Joint: **YES**
 Remarks:

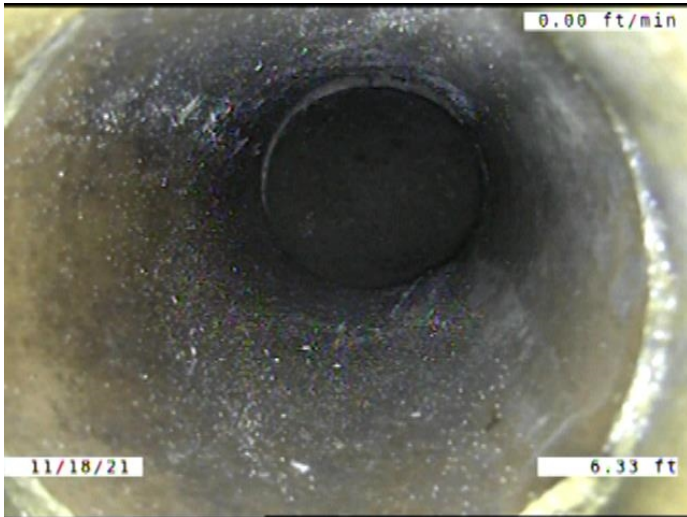
Code: **TBI**
 Description: **Tap Break-in Intruding**

Distance (ft): **6.3**
 Structural Grade: **0**
 O&M Grade: **2**
 Clock Start/From: **12**
 Clock To:
 1st Value: **6.000**
 2nd Value: **1.000**
 Value Percent:
 Continuous Index:
 Within 8" of Joint: **YES**
 Remarks:

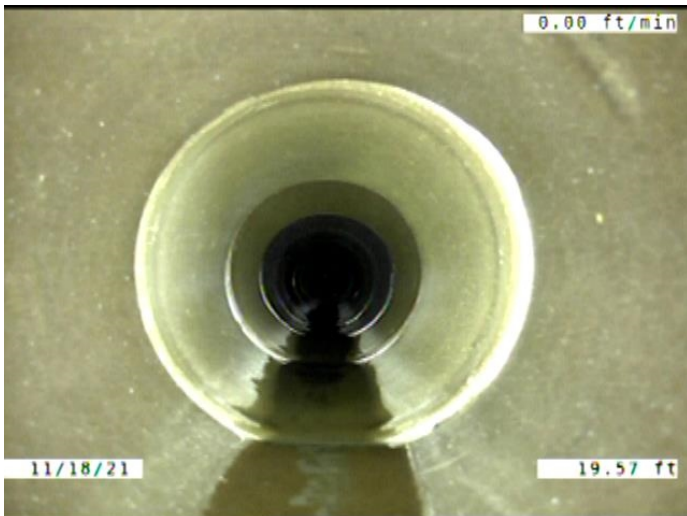
Code: **ISGT**
 Description: **Intruding Sealing Material Grout**

Distance (ft): **19.6**
 Structural Grade: **0**
 O&M Grade: **2**
 Clock Start/From: **12**
 Clock To: **12**
 1st Value:
 2nd Value:
 Value Percent: **5.000**
 Continuous Index: **F01**
 Within 8" of Joint: **NO**
 Remarks:

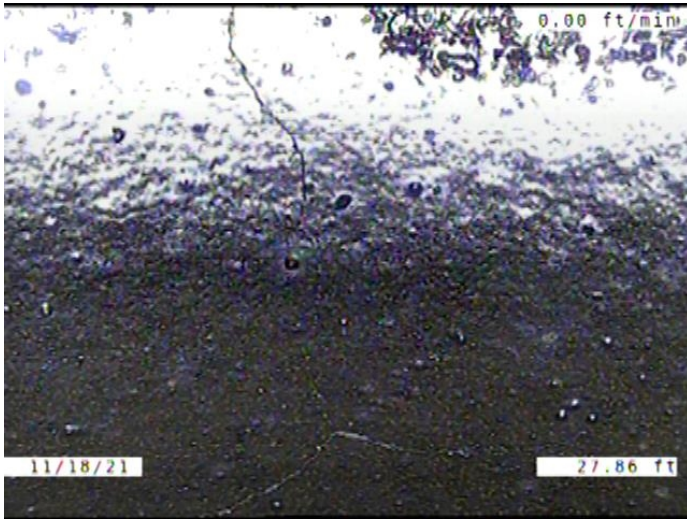
Code: **CM**
 Description: **Crack Multiple**

Distance (ft): **27.9**
 Structural Grade: **3**
 O&M Grade: **0**
 Clock Start/From: **11**
 Clock To: **2**
 1st Value:
 2nd Value:
 Value Percent:
 Continuous Index:
 Within 8" of Joint: **YES**
 Remarks:

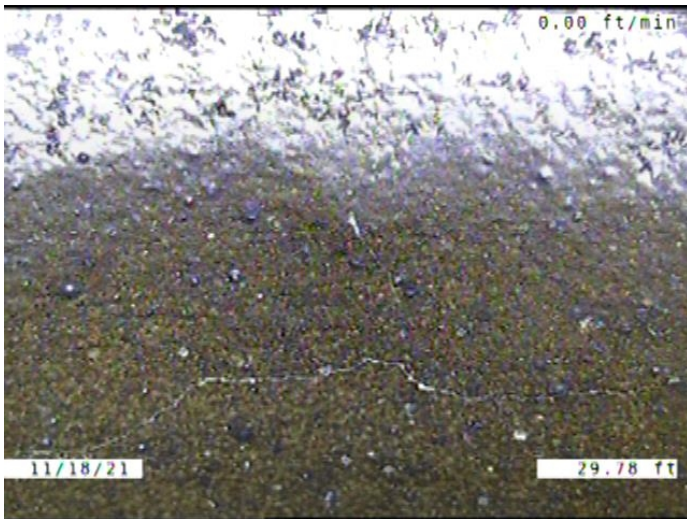
Code: **CM**
 Description: **Crack Multiple**

Distance (ft): **29.8**
 Structural Grade: **3**
 O&M Grade: **0**
 Clock Start/From: **12**
 Clock To: **3**
 1st Value:
 2nd Value:
 Value Percent:
 Continuous Index:
 Within 8" of Joint: **YES**
 Remarks:

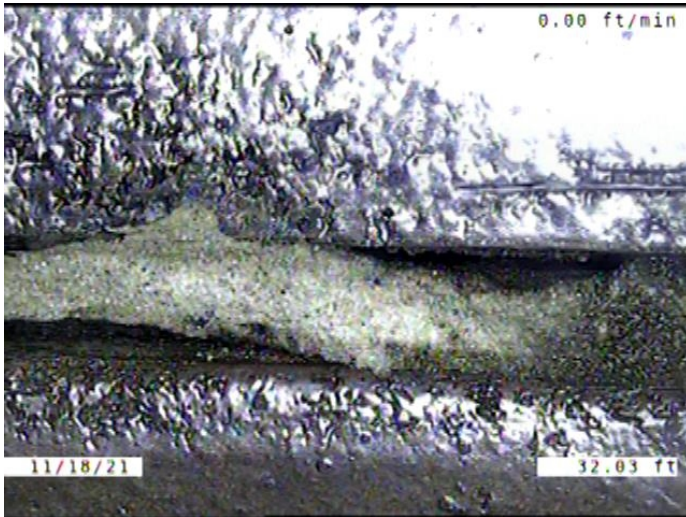
Code: **ISGT**
 Description: **Intruding Sealing Material Grout**

Distance (ft): **32.0**
 Structural Grade: **0**
 O&M Grade: **2**
 Clock Start/From: **3**
 Clock To: **9**
 1st Value:
 2nd Value:
 Value Percent: **5.000**
 Continuous Index:
 Within 8" of Joint: **NO**
 Remarks:

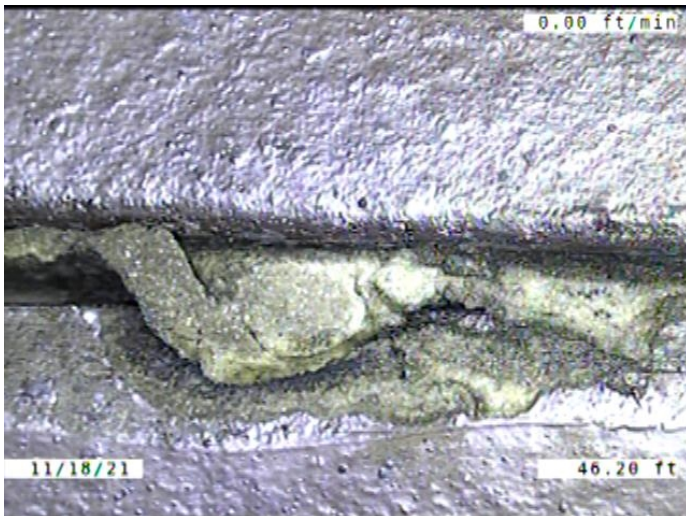
Code: **ISGT**
 Description: **Intruding Sealing Material Grout**

Distance (ft): **46.2**
 Structural Grade: **0**
 O&M Grade: **2**
 Clock Start/From: **12**
 Clock To: **12**
 1st Value:
 2nd Value:
 Value Percent: **5.000**
 Continuous Index:
 Within 8" of Joint: **NO**
 Remarks:

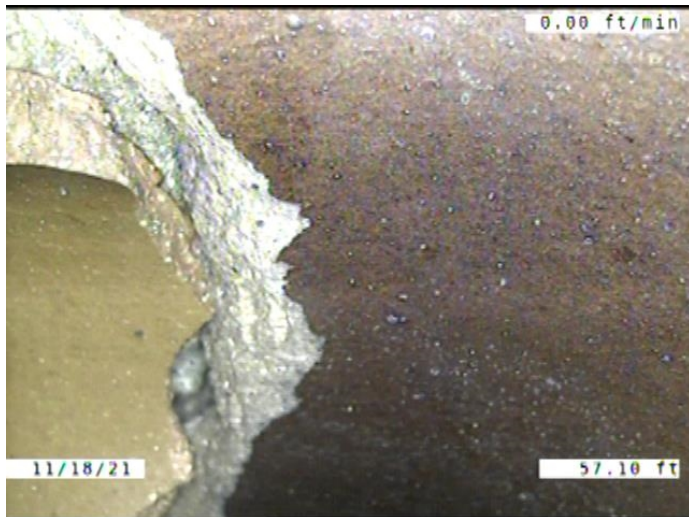
Code: **SSS**
 Description: **Surface Damage Surface Spalling**

Distance (ft): **57.1**
 Structural Grade: **2**
 O&M Grade: **0**
 Clock Start/From: **9**
 Clock To: **1**
 1st Value:
 2nd Value:
 Value Percent:
 Continuous Index:
 Within 8" of Joint: **YES**
 Remarks:

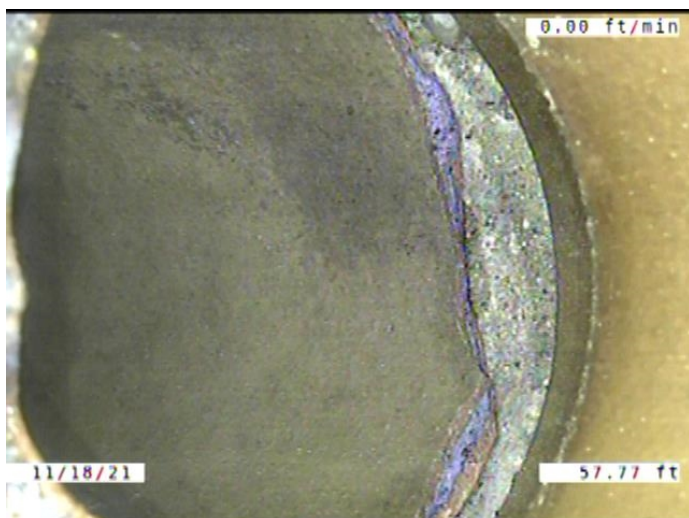
Code: **TBI**
 Description: **Tap Break-in Intruding**

Distance (ft): **57.8**
 Structural Grade: **0**
 O&M Grade: **2**
 Clock Start/From: **11**
 Clock To:
 1st Value: **6.000**
 2nd Value: **3.000**
 Value Percent:
 Continuous Index:
 Within 8" of Joint: **NO**
 Remarks:

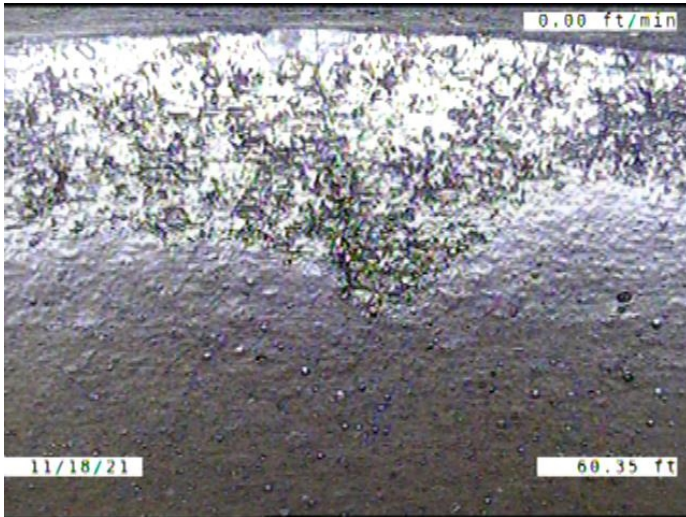
Code: **CM**
 Description: **Crack Multiple**

Distance (ft): **60.4**
 Structural Grade: **3**
 O&M Grade: **0**
 Clock Start/From: **10**
 Clock To: **4**
 1st Value:
 2nd Value:
 Value Percent:
 Continuous Index:
 Within 8" of Joint: **YES**
 Remarks:

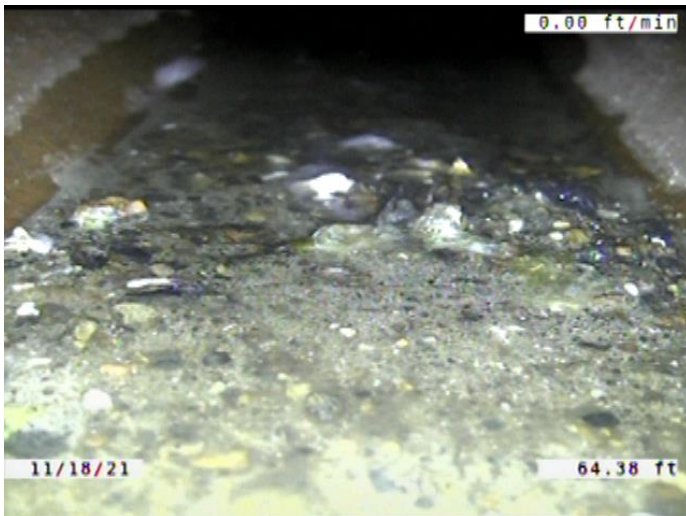
Code: **DSF**
 Description: **Deposits Settled Fine**

Distance (ft): **64.4**
 Structural Grade: **0**
 O&M Grade: **2**
 Clock Start/From: **5**
 Clock To: **7**
 1st Value:
 2nd Value:
 Value Percent: **5.000**
 Continuous Index:
 Within 8" of Joint: **YES**
 Remarks:

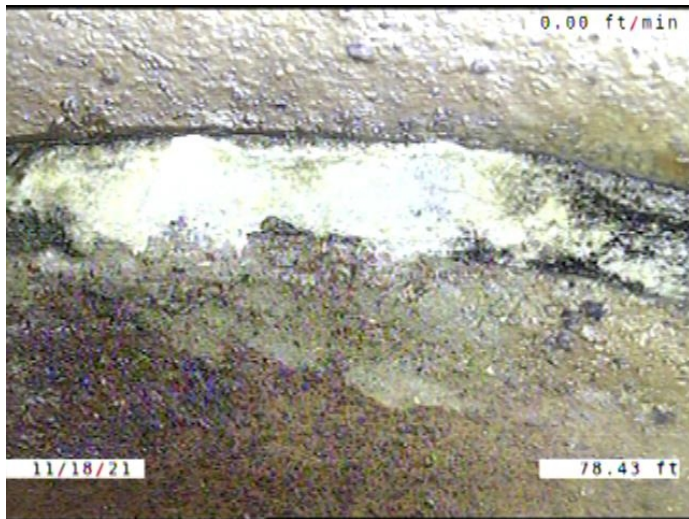
Code: **ISGT**
 Description: **Intruding Sealing Material Grout**

Distance (ft): **78.4**
 Structural Grade: **0**
 O&M Grade: **2**
 Clock Start/From: **3**
 Clock To: **10**
 1st Value:
 2nd Value:
 Value Percent: **5.000**
 Continuous Index:
 Within 8" of Joint: **NO**
 Remarks:

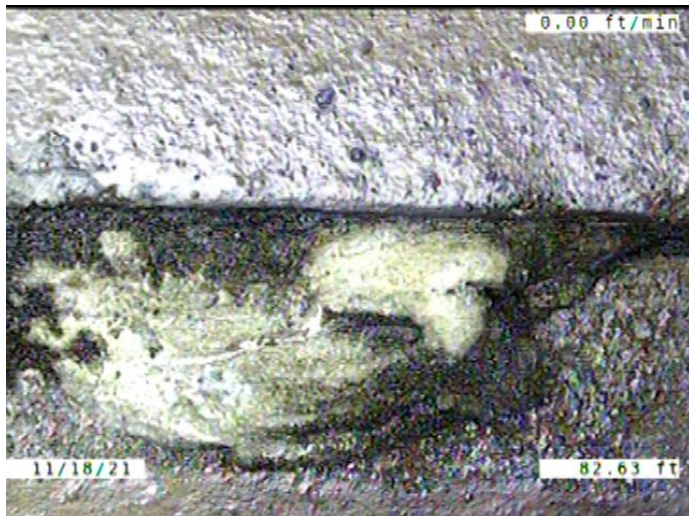
Code: **ISGT**
 Description: **Intruding Sealing Material Grout**

Distance (ft): **82.6**
 Structural Grade: **0**
 O&M Grade: **2**
 Clock Start/From: **2**
 Clock To: **10**
 1st Value:
 2nd Value:
 Value Percent: **5.000**
 Continuous Index:
 Within 8" of Joint: **NO**
 Remarks:

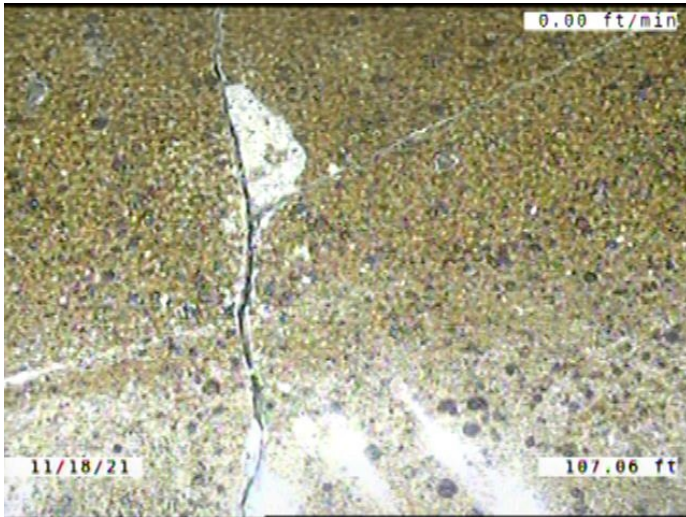
Code: **FM**
 Description: **Fracture Multiple**

Distance (ft): **107.1**
 Structural Grade: **4**
 O&M Grade: **0**
 Clock Start/From: **1**
 Clock To: **9**
 1st Value:
 2nd Value:
 Value Percent:
 Continuous Index:
 Within 8" of Joint: **YES**
 Remarks:

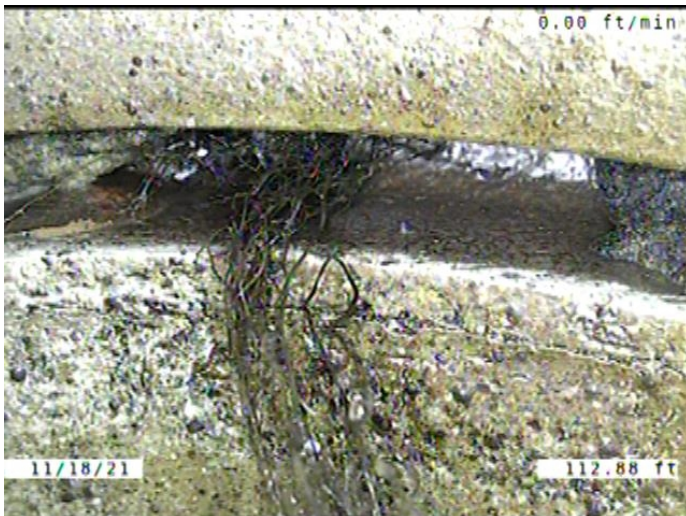
Code: **RFJ**
 Description: **Roots Fine Joint**

Distance (ft): **112.9**
 Structural Grade: **0**
 O&M Grade: **1**
 Clock Start/From: **3**
 Clock To:
 1st Value:
 2nd Value:
 Value Percent:
 Continuous Index:
 Within 8" of Joint: **YES**
 Remarks:

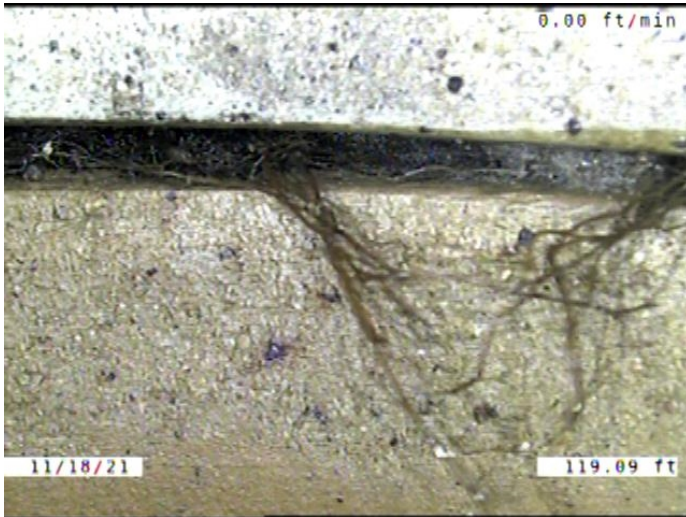
Code: **RFJ**
Description: **Roots Fine Joint**

Distance (ft): **119.1**
Structural Grade: **0**
O&M Grade: **1**
Clock Start/From: **10**
Clock To: **3**
1st Value:
2nd Value:
Value Percent:
Continuous Index:
Within 8" of Joint: **YES**
Remarks:

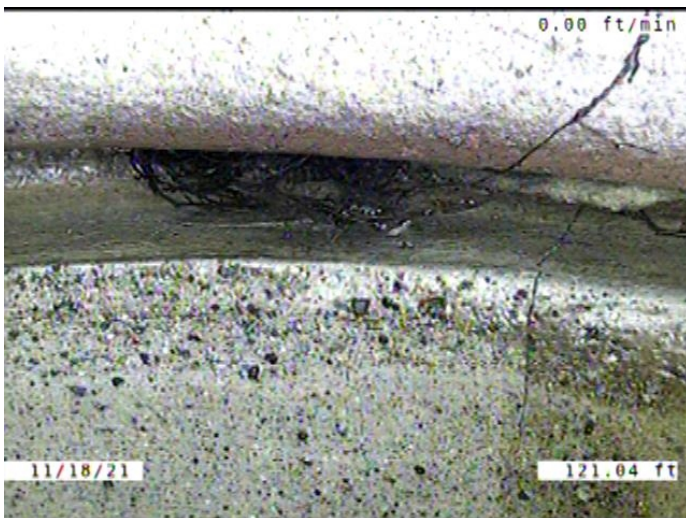
Code: **RFJ**
Description: **Roots Fine Joint**

Distance (ft): **121.0**
Structural Grade: **0**
O&M Grade: **1**
Clock Start/From: **2**
Clock To: **3**
1st Value:
2nd Value:
Value Percent:
Continuous Index:
Within 8" of Joint: **YES**
Remarks:

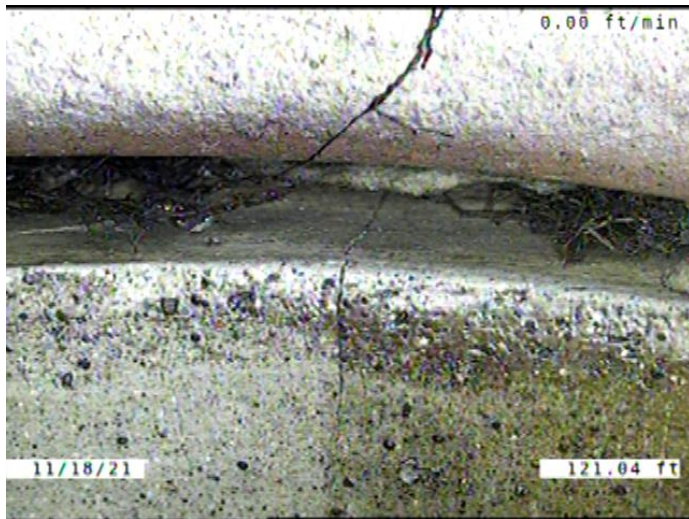
Code: **CL**
 Description: **Crack Longitudinal**

Distance (ft): **121.0**
 Structural Grade: **2**
 O&M Grade: **0**
 Clock Start/From: **2**
 Clock To:
 1st Value:
 2nd Value:
 Value Percent:
 Continuous Index:
 Within 8" of Joint: **YES**
 Remarks:

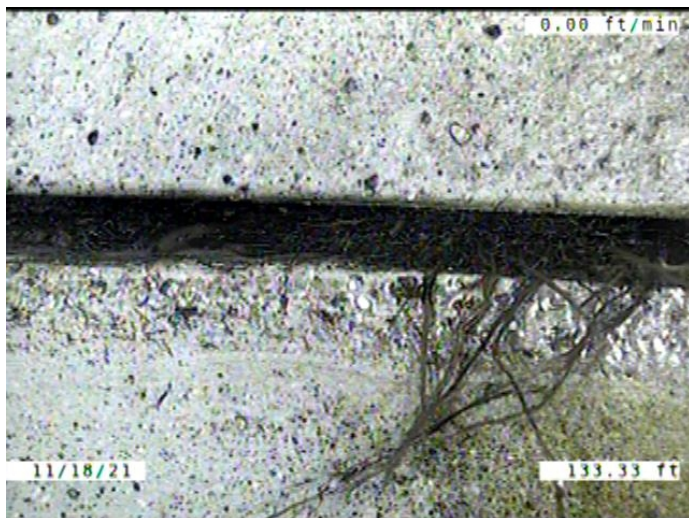
Code: **RFJ**
 Description: **Roots Fine Joint**

Distance (ft): **133.3**
 Structural Grade: **0**
 O&M Grade: **1**
 Clock Start/From: **9**
 Clock To: **4**
 1st Value:
 2nd Value:
 Value Percent:
 Continuous Index: **S02**
 Within 8" of Joint: **YES**
 Remarks:

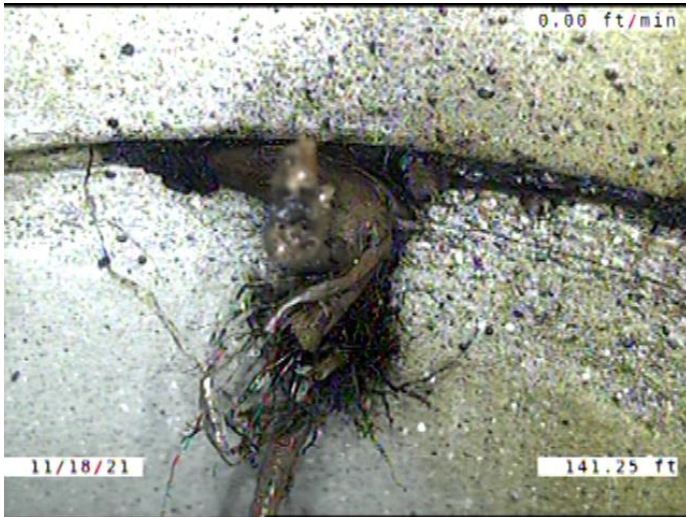
Code: **RTJ**
 Description: **Roots Tap Joint**

Distance (ft): **141.3**
 Structural Grade: **0**
 O&M Grade: **2**
 Clock Start/From: **1**
 Clock To: **2**
 1st Value:
 2nd Value:
 Value Percent: **5.000**
 Continuous Index:
 Within 8" of Joint: **YES**
 Remarks:

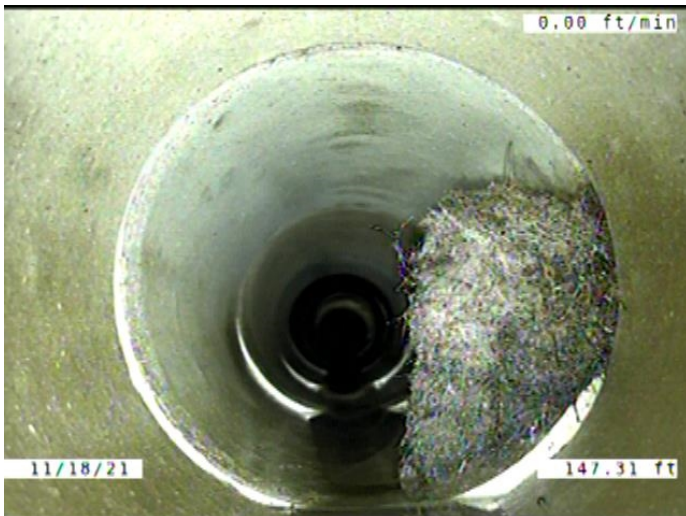
Code: **RMJ**
 Description: **Roots Medium Joint**

Distance (ft): **147.3**
 Structural Grade: **0**
 O&M Grade: **3**
 Clock Start/From: **2**
 Clock To: **6**
 1st Value:
 2nd Value:
 Value Percent: **20.000**
 Continuous Index:
 Within 8" of Joint: **YES**
 Remarks:

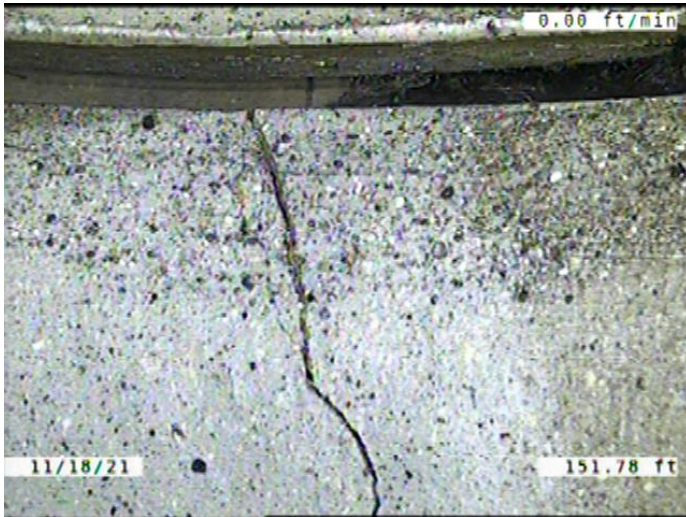
Code: **FM**
 Description: **Fracture Multiple**

Distance (ft): **151.8**
 Structural Grade: **4**
 O&M Grade: **0**
 Clock Start/From: **8**
 Clock To: **3**
 1st Value:
 2nd Value:
 Value Percent:
 Continuous Index:
 Within 8" of Joint: **YES**
 Remarks:

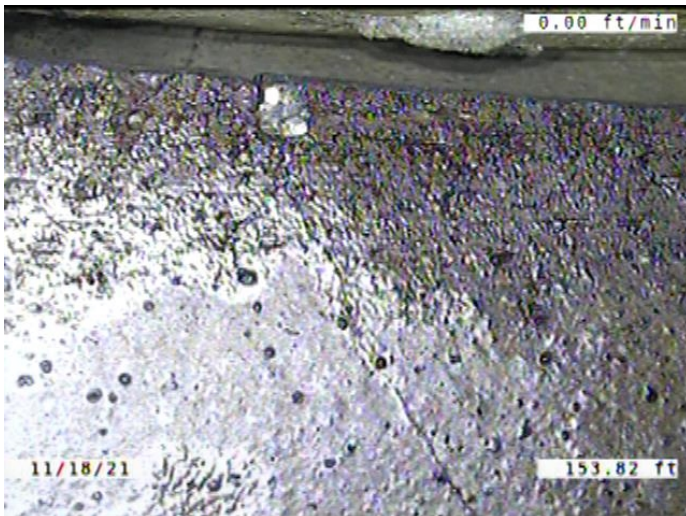
Code: **CS**
 Description: **Crack Spiral**

Distance (ft): **153.8**
 Structural Grade: **2**
 O&M Grade: **0**
 Clock Start/From: **8**
 Clock To: **12**
 1st Value:
 2nd Value:
 Value Percent:
 Continuous Index:
 Within 8" of Joint: **YES**
 Remarks:

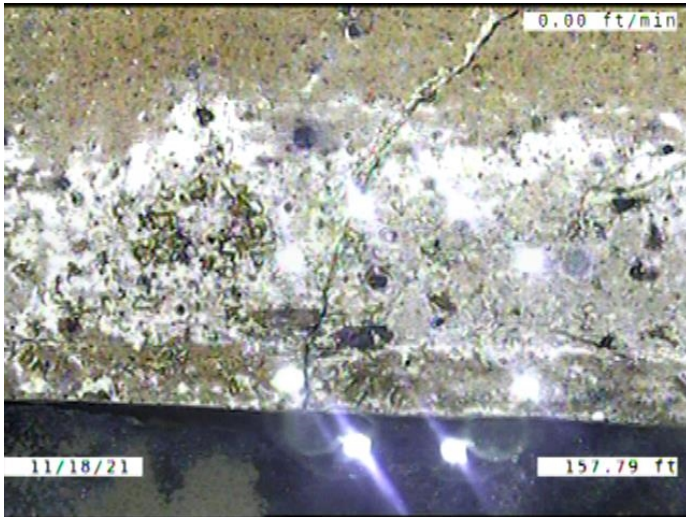
Code: **FS**
 Description: **Fracture Spiral**

Distance (ft): **157.8**
 Structural Grade: **3**
 O&M Grade: **0**
 Clock Start/From: **3**
 Clock To: **6**
 1st Value:
 2nd Value:
 Value Percent:
 Continuous Index:
 Within 8" of Joint: **YES**
 Remarks:

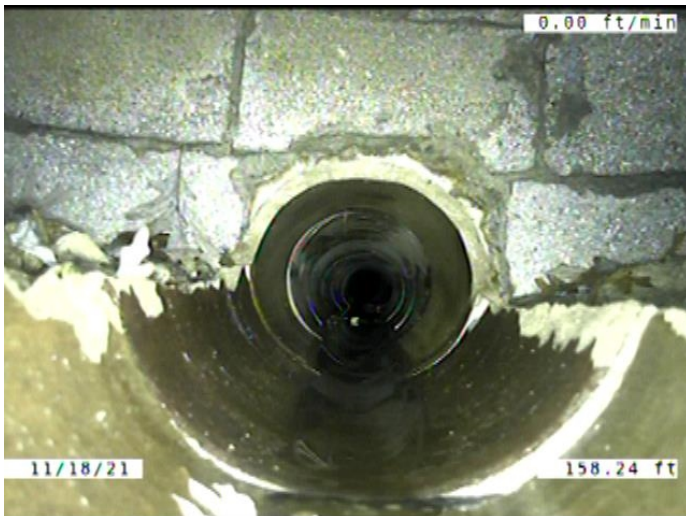
Code: **RFJ**
 Description: **Roots Fine Joint**

Distance (ft): **158.2**
 Structural Grade: **0**
 O&M Grade: **1**
 Clock Start/From: **9**
 Clock To: **4**
 1st Value:
 2nd Value:
 Value Percent:
 Continuous Index: **F02**
 Within 8" of Joint: **YES**
 Remarks:
