## Profile/Photo Observation Report

Street:	<b>Lake Park Avenue</b>	Flow Control:	<b>Not Controlled</b>
City:	<b>Hobart, IN</b>	Year Renewed:	
Location:	<b>Light Highway</b>	Tape/Media #:	<b>DEP 616</b>
Purpose:	<b>Routine Assessment</b>	Dia/Height:	<b>18"</b>
Use:	<b>Sanitary</b>	Material:	<b>VCP</b>
Drain Area:		Lining:	
Category:	<b>NA</b>		
Comment:	<b>5-21-2018</b>		
Location Details:		Direction of Survey:	<b>Downstream</b>
US MH:	<b>M-606-001</b>	DS MH:	<b>M-606-002</b>
		Total Length Surveyed (ft):	<b>5.6</b>

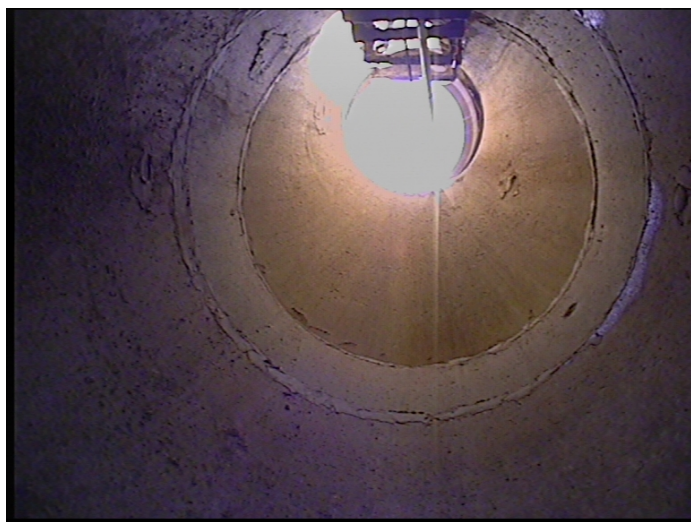
Code: **AMH**  
Description: **Manhole**

Distance (ft): **.0**  
Structural Grade: **0**  
O&M Grade: **0**  
Clock Start/From:  
Clock To:  
1st Value:  
2nd Value:  
Value Percent:  
Continuous Index:  
Within 8" of Joint: **NO**  
Remarks: **M-606-002**

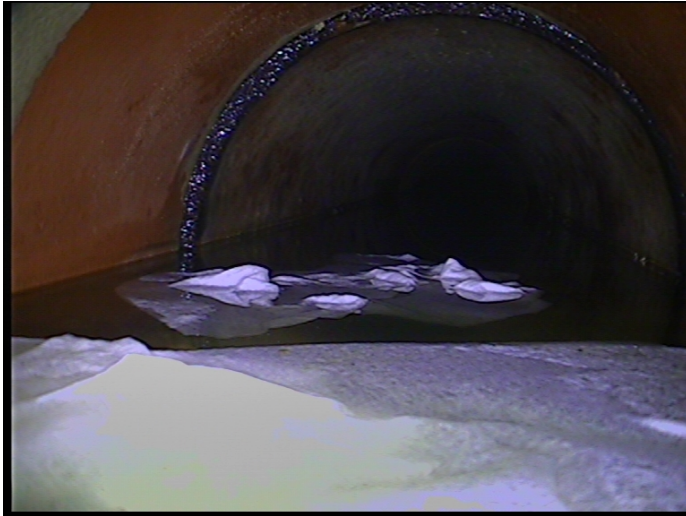
Code: **MWL**  
Description: **Water Level**

Distance (ft): **.0**  
Structural Grade: **0**  
O&M Grade: **0**  
Clock Start/From:  
Clock To:  
1st Value:  
2nd Value:  
Value Percent: **30.000**  
Continuous Index:  
Within 8" of Joint: **NO**  
Remarks:

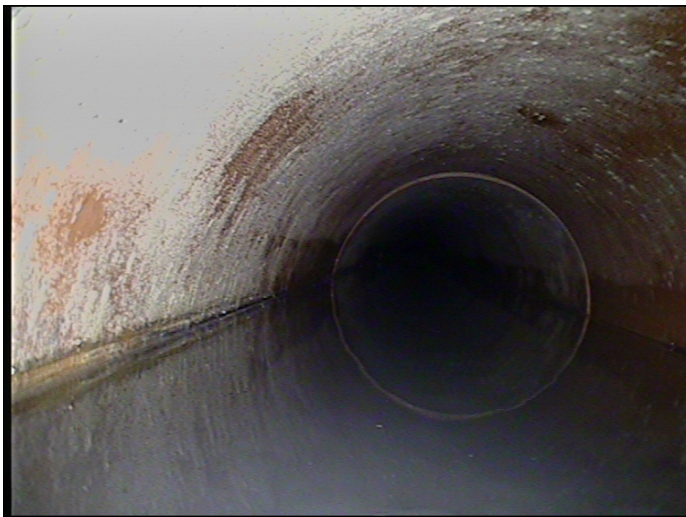
Code: **DSF**  
Description: **Deposits Settled Fine**

Distance (ft): **5.3**  
Structural Grade: **0**  
O&M Grade: **3**  
Clock Start/From: **4**  
Clock To: **8**  
1st Value:  
2nd Value:  
Value Percent: **20.000**  
Continuous Index:  
Within 8" of Joint: **YES**  
Remarks:

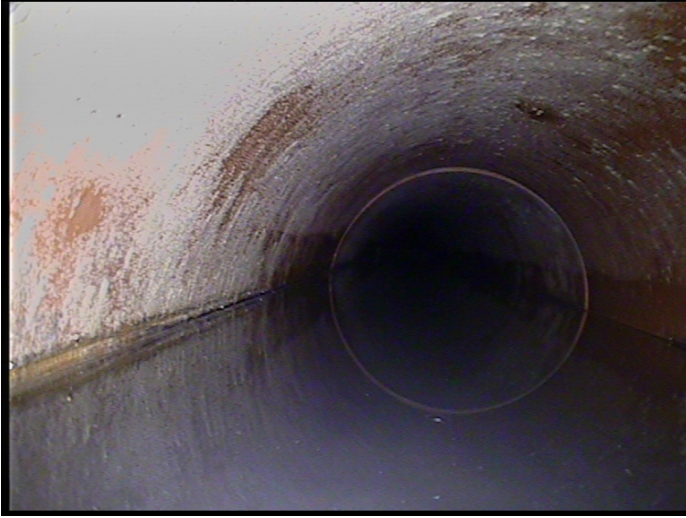
Code:	<b>MSA</b>
Description:	<b>Abandoned Survey</b>
Distance (ft):	<b>5.3</b>
Structural Grade:	<b>0</b>
O&M Grade:	<b>0</b>
Clock Start/From:	
Clock To:	
1st Value:	
2nd Value:	
Value Percent:	
Continuous Index:	
Within 8" of Joint:	<b>NO</b>
Remarks:	<b>sediment</b>
