Profile/Photo Observation Report

Date:	05/07/2018	Weather:		Coding:	PACP 6.0
Pipe Length (ft):		Owner:	City of Hobart	Pre Clean:	No Pre-Cleaning
P.O.#:	617	Surveyor:	M. Pielacha	PSR:	P-606-001-002
Customer:	City of Hobart	Clean Date:		Shape:	C

Street:	10th Street	Flow Control:	Not Controlled
City:	Hobart, IN	Year Renewed:	
Location:	Light Highway	Tape/Media #:	DEP 617
Purpose:	Routine Assessment	Dia/Height:	18"
Use:	Sanitary	Material:	VCP
Drain Area:		Lining:	
Category:	NA		
Comment:	5-21-2018

Location Details:		Direction of Survey:	Upstream
US MH:	M-606-002	DS MH:	M-606-001
		Total Length Surveyed (ft):	84.1

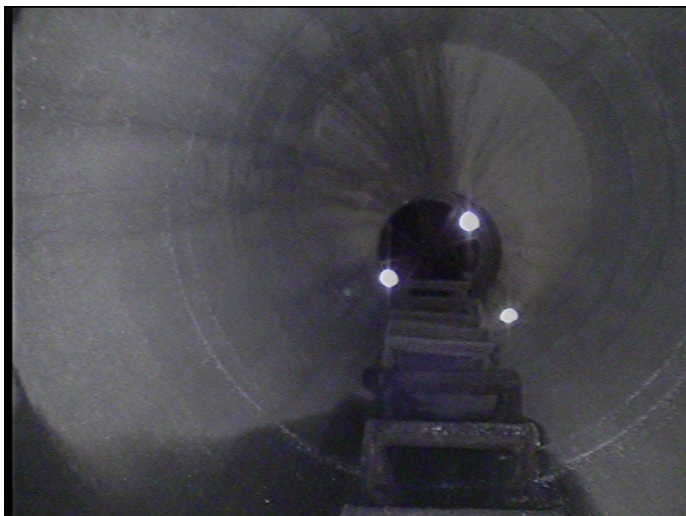
Code: **AMH**
Description: **Manhole**

Distance (ft): **.0**
Structural Grade: **0**
O&M Grade: **0**
Clock Start/From:
Clock To:
1st Value:
2nd Value:
Value Percent:
Continuous Index:
Within 8" of Joint: **NO**
Remarks: **M-606-001**

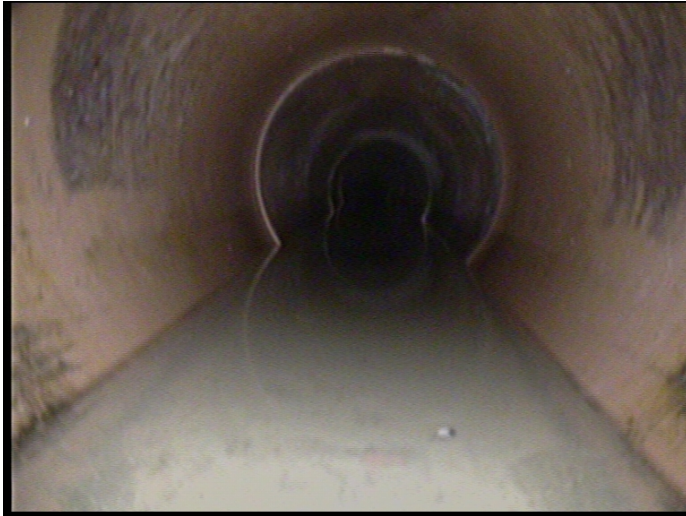
Code: **MWL**
Description: **Water Level**

Distance (ft): **.0**
Structural Grade: **0**
O&M Grade: **0**
Clock Start/From:
Clock To:
1st Value:
2nd Value:
Value Percent: **5.000**
Continuous Index:
Within 8" of Joint: **NO**
Remarks:

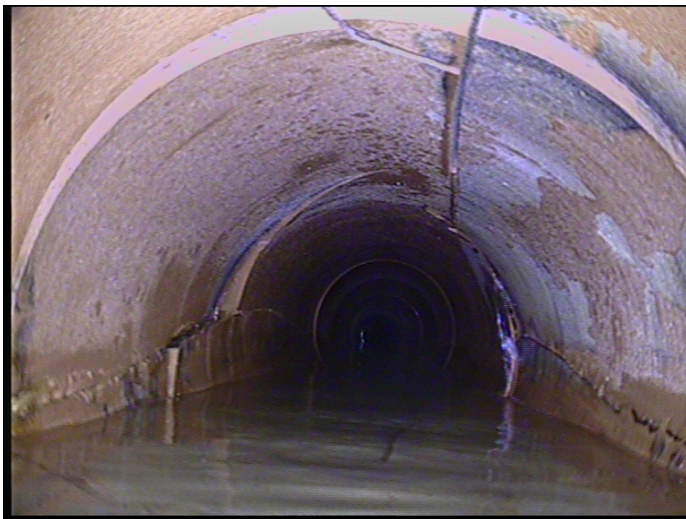
Code: **FH3**
Description: **Fracture Longitudinal Hinge, 3**

Distance (ft): **52.4**
Structural Grade: **5**
O&M Grade: **0**
Clock Start/From: **9**
Clock To: **3**
1st Value:
2nd Value:
Value Percent:
Continuous Index:
Within 8" of Joint: **YES**
Remarks:

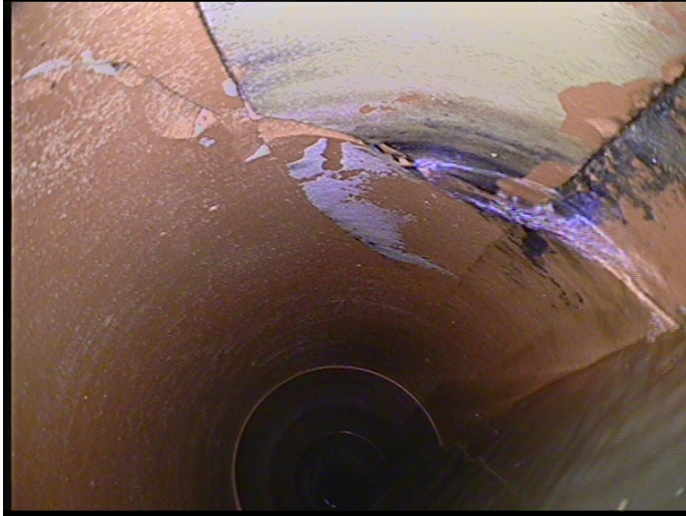
Code: **IR**
Description: **Infil Runner**

Distance (ft): **54.6**
Structural Grade: **0**
O&M Grade: **4**
Clock Start/From: **2**
Clock To:
1st Value:
2nd Value:
Value Percent:
Continuous Index:
Within 8" of Joint: **YES**
Remarks:

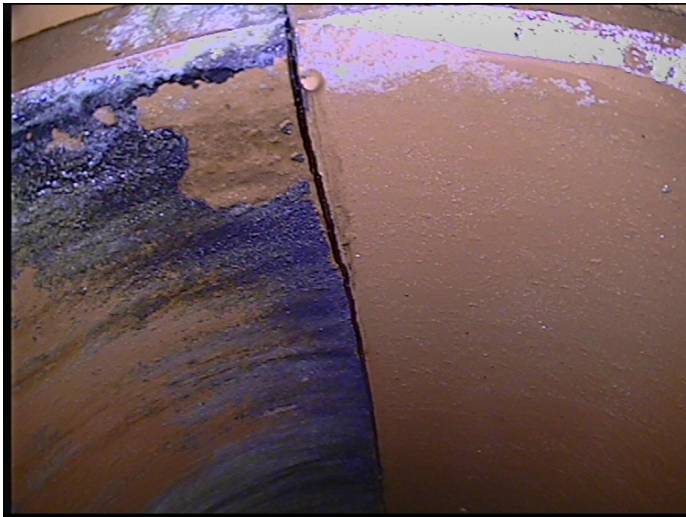
Code: **FL**
Description: **Fracture Longitudinal**

Distance (ft): **79.8**
Structural Grade: **3**
O&M Grade: **0**
Clock Start/From: **12**
Clock To:
1st Value:
2nd Value:
Value Percent:
Continuous Index:
Within 8" of Joint: **YES**
Remarks:

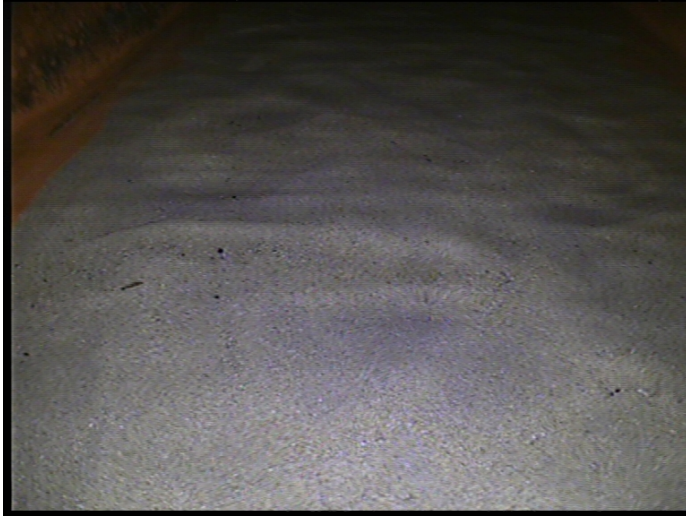
Code: **DSF**
Description: **Deposits Settled Fine**

Distance (ft): **82.9**
Structural Grade: **0**
O&M Grade: **3**
Clock Start/From: **4**
Clock To: **8**
1st Value:
2nd Value:
Value Percent: **15.000**
Continuous Index:
Within 8" of Joint: **YES**
Remarks:

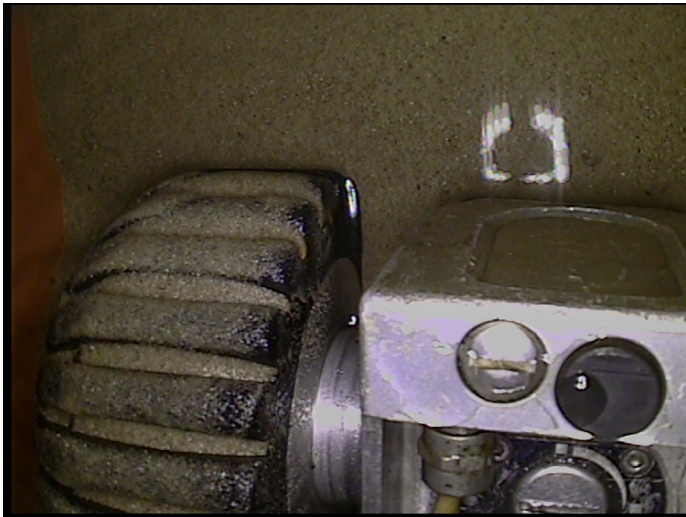
Code: **MSA**
Description: **Abandoned Survey**

Distance (ft): **84.0**
Structural Grade: **0**
O&M Grade: **0**
Clock Start/From:
Clock To:
1st Value:
2nd Value:
Value Percent:
Continuous Index:
Within 8" of Joint: **NO**
Remarks: **sediment.**
