Profile/Photo Observation Penort

Profile/Photo Observation Report								
Date: Pipe Length (ft P.O.#: Customer:	05/07/2018 :): 618 City of Hobart	Weather: Owner: Surveyor: Clean Date:	City of Hoba		Coding: Pre Clean: PSR: Shape:	PACP 6.0 No Pre-Cleaning P-606-002-003 C		
Street: Lake Park Avenue		Flow Control:		Not Controlled				
City:	Hobart, IN		Year Renewe					
Location:	Light Highway		Tape/Media	# :	DEP 618			
Purpose:	Routine Assessment		Dia/Height:		18"			
Use:	Sanitary		Material:		PVC			
Drain Area:			Lining:					
Category:	NA							
Comment:	5-21-2018							
Location Details:		Direction of Survey:		Downstream				
US MH:	M-606-002	DS MH:	M-606-003	То	tal Length Surveyed (ft):	70.3		
0&M Index:	2.00	O&M Quick:	-	2A00	O&M Rating:	28.00		
tructural Index	0.00	— Structural Qւ	uick:	0000	Structural Rating:	0.00		
Overall Index:	2.00	Overall Quicl		2A00	Overall Rating:	28.00

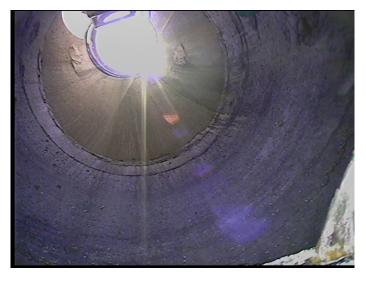
Code: Description:	AMH Manhole
Distance (ft):	.0
Structural Grade:	0
O&M Grade:	0
Clock Start/From:	
Clock To:	
1st Value:	
2nd Value:	
Value Percent:	
Continuous Index:	
Within 8" of Joint:	NO
Remarks:	M-606-003

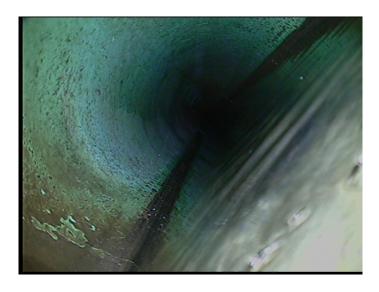
Code: MWL

Description: **Water Level**

Distance (ft): .0 Structural Grade: 0

15.000

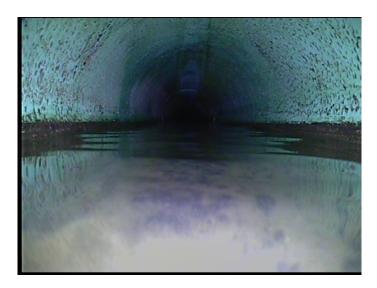
Code: **DSF**

Description: **Deposits Settled Fine**

Distance (ft): .5 Structural Grade: 0 O&M Grade: 2 Clock Start/From: 4 Clock To: 8 1st Value:

Value Percent: 10.000 Continuous Index: **S01** Within 8" of Joint: YES

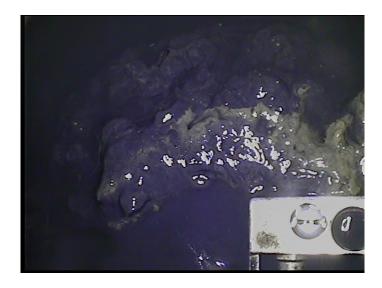
Code: **DSF**

Description: Deposits Settled Fine

Distance (ft): 70.3
Structural Grade: 0
O&M Grade: 3
Clock Start/From: 4
Clock To: 8

Value Percent: 20.000
Continuous Index: F01
Within 8" of Joint: NO

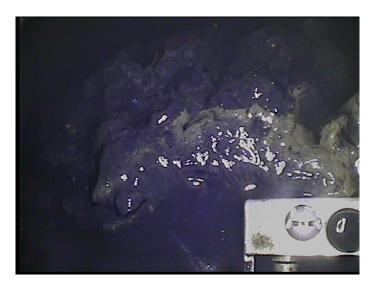
Code: MSA

Description: Abandoned Survey

Distance (ft): 70.3
Structural Grade: 0
O&M Grade: 0

Within 8" of Joint: NO Remarks: debris
