Profile/Photo Observation Report

Date:	05/04/2018	Weather:		Coding:	PACP 6.0
Pipe Length (ft):		Owner:	City of Hobart	Pre Clean:	Not Known
P.O.#:	300	Surveyor:	B. Helbling	PSR:	P-606-003-004
Customer:	City of Hobart	Clean Date:		Shape:	C

Street:	South Lake Park	Flow Control:	Not Controlled
City:	Hobart, IN	Year Renewed:	
Location:	Light Highway	Tape/Media #:	DEP300
Purpose:	Routine Assessment	Dia/Height:	18"
Use:	Sanitary	Material:	VCP
Drain Area:		Lining:	
Category:	NA		
Comment:	5-21-2018		
Location Details:		Direction of Survey:	Downstream
US MH:	M-606-003	DS MH:	M-606-004
		Total Length Surveyed (ft):	1.8

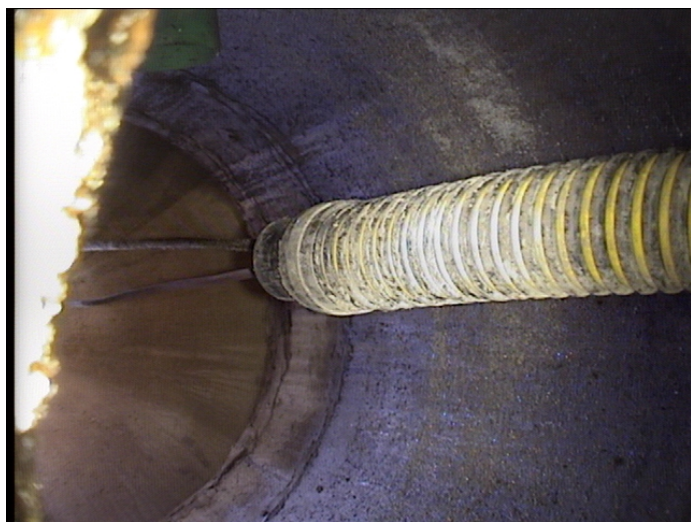
Code: **AMH**
Description: **Manhole**

Distance (ft): **.0**
Structural Grade: **0**
O&M Grade: **0**
Clock Start/From:
Clock To:
1st Value:
2nd Value:
Value Percent:
Continuous Index:
Within 8" of Joint: **NO**
Remarks: **M-606-003**

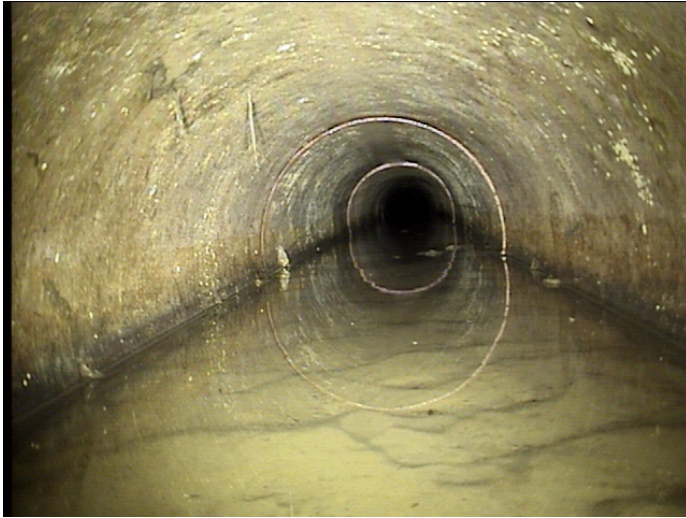
Code: **MWL**
Description: **Water Level**

Distance (ft): **.0**
Structural Grade: **0**
O&M Grade: **0**
Clock Start/From:
Clock To:
1st Value:
2nd Value:
Value Percent: **20.000**
Continuous Index:
Within 8" of Joint: **NO**
Remarks:

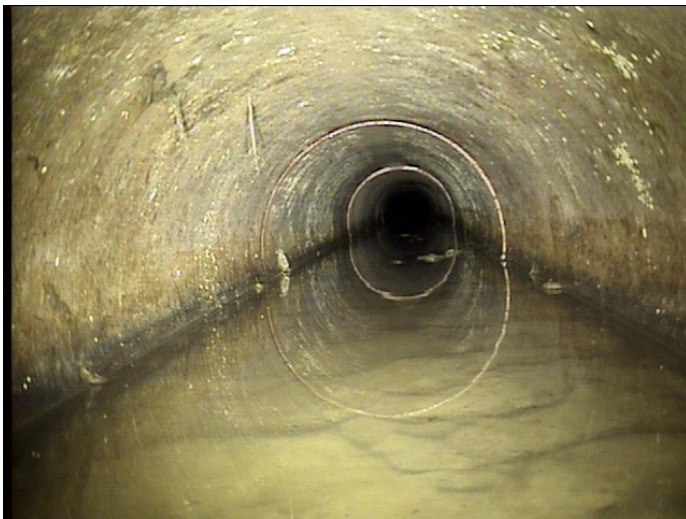
Code: **DSF**
Description: **Deposits Settled Fine**

Distance (ft): **1.8**
Structural Grade: **0**
O&M Grade: **3**
Clock Start/From: **4**
Clock To: **8**
1st Value:
2nd Value:
Value Percent: **20.000**
Continuous Index:
Within 8" of Joint: **NO**
Remarks:

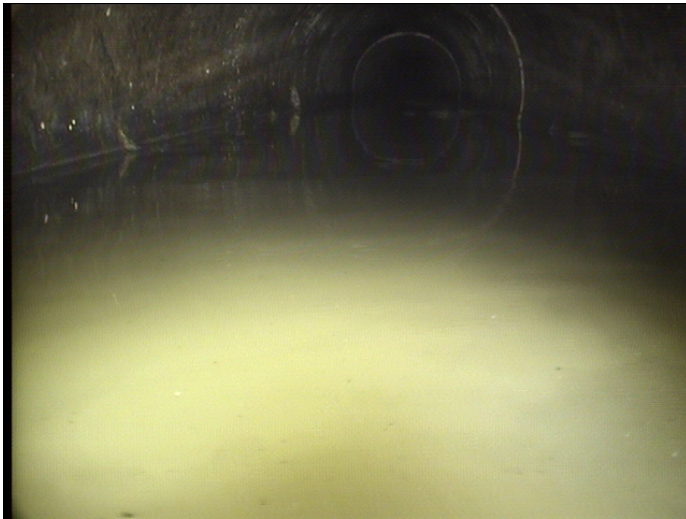
Code:	MSA
Description:	Abandoned Survey
Distance (ft):	1.8
Structural Grade:	0
O&M Grade:	0
Clock Start/From:	
Clock To:	
1st Value:	
2nd Value:	
Value Percent:	
Continuous Index:	
Within 8" of Joint:	NO
Remarks:	Heavy Sediment
