## Profile/Photo Observation Report

Date:	<b>05/04/2018</b>	Weather:		Coding:	<b>PACP 6.0</b>
Pipe Length (ft):		Owner:	<b>City of Hobart</b>	Pre Clean:	<b>Not Known</b>
P.O.#:	<b>298</b>	Surveyor:	<b>B. Helbling</b>	PSR:	<b>P-606-004-005</b>
Customer:	<b>City of Hobart</b>	Clean Date:		Shape:	<b>C</b>

Street:	<b>South Lake Park</b>	Flow Control:	<b>Not Controlled</b>
City:	<b>Hobart, IN</b>	Year Renewed:	
Location:	<b>Light Highway</b>	Tape/Media #:	<b>DEP298</b>
Purpose:	<b>Routine Assessment</b>	Dia/Height:	<b>18"</b>
Use:	<b>Sanitary</b>	Material:	<b>VCP</b>
Drain Area:		Lining:	
Category:	<b>NA</b>		
Comment:	<b>5-21-2018</b>		
Location Details:		Direction of Survey:	<b>Downstream</b>
US MH:	<b>M-606-004</b>	DS MH:	<b>M-606-005</b>
		Total Length Surveyed (ft):	<b>5.1</b>

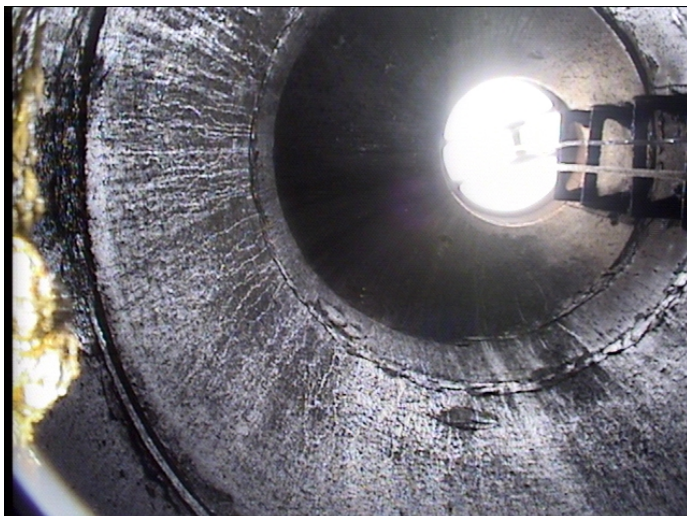
Code: **AMH**  
Description: **Manhole**

Distance (ft): **.0**  
Structural Grade: **0**  
O&M Grade: **0**  
Clock Start/From:  
Clock To:  
1st Value:  
2nd Value:  
Value Percent:  
Continuous Index:  
Within 8" of Joint: **NO**  
Remarks: **M-606-004**

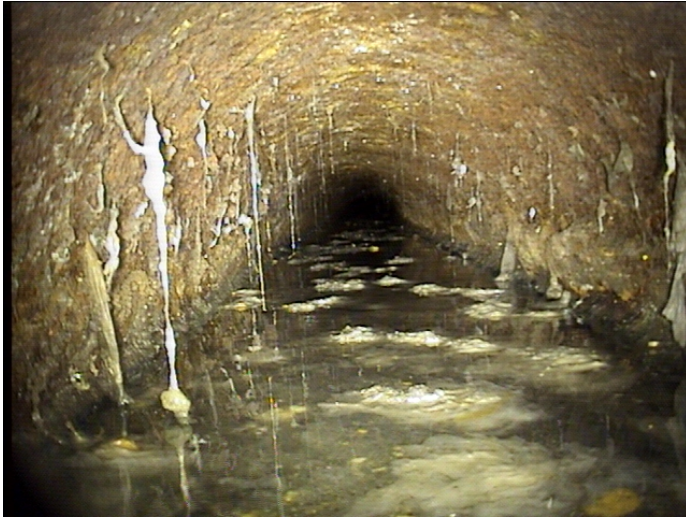
Code: **MWL**  
Description: **Water Level**

Distance (ft): **.0**  
Structural Grade: **0**  
O&M Grade: **0**  
Clock Start/From:  
Clock To:  
1st Value:  
2nd Value:  
Value Percent: **25.000**  
Continuous Index:  
Within 8" of Joint: **NO**  
Remarks:

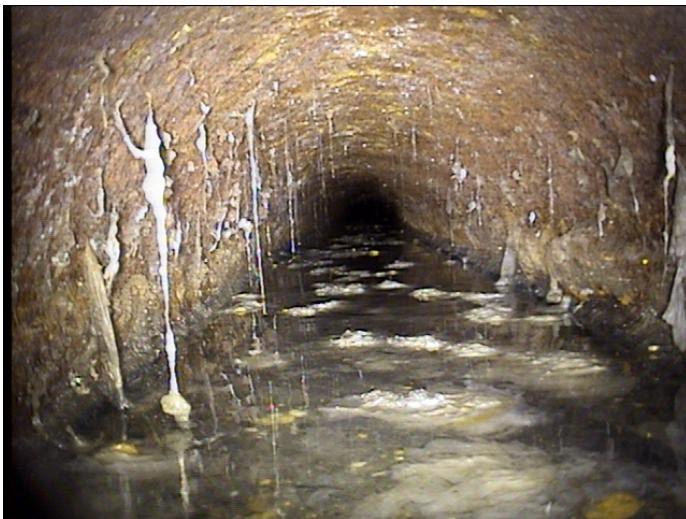
Code: **DSF**  
Description: **Deposits Settled Fine**

Distance (ft): **.0**  
Structural Grade: **0**  
O&M Grade: **3**  
Clock Start/From: **4**  
Clock To: **8**  
1st Value:  
2nd Value:  
Value Percent: **20.000**  
Continuous Index: **S01**  
Within 8" of Joint: **NO**  
Remarks:

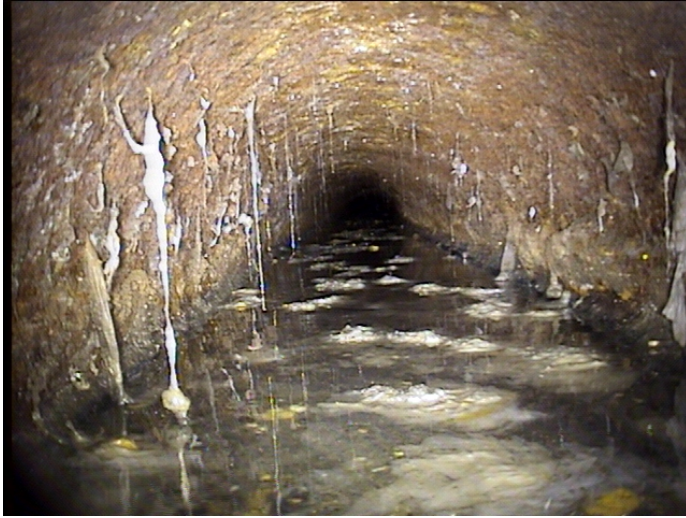
Code:	<b>DAE</b>
Description:	<b>Deposits Attached Encrustation</b>
Distance (ft):	<b>.0</b>
Structural Grade:	<b>0</b>
O&M Grade:	<b>2</b>
Clock Start/From:	<b>8</b>
Clock To:	<b>4</b>
1st Value:	
2nd Value:	
Value Percent:	<b>5.000</b>
Continuous Index:	<b>S02</b>
Within 8" of Joint:	<b>NO</b>
Remarks:

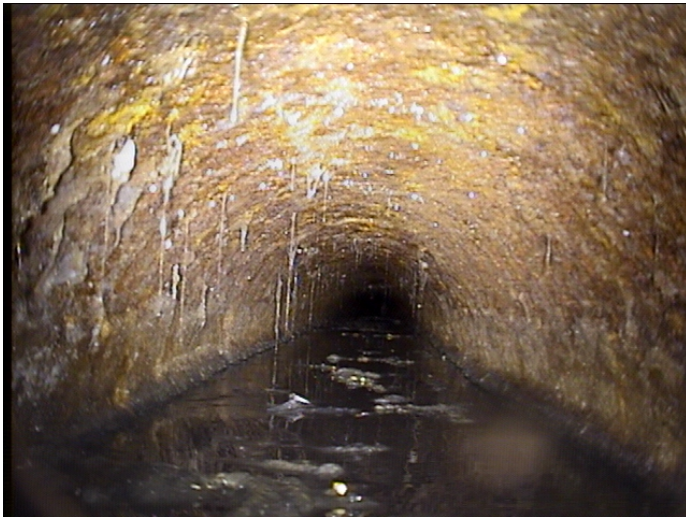
Code:	<b>DAE</b>
Description:	<b>Deposits Attached Encrustation</b>
Distance (ft):	<b>5.1</b>
Structural Grade:	<b>0</b>
O&M Grade:	<b>2</b>
Clock Start/From:	<b>8</b>
Clock To:	<b>4</b>
1st Value:	
2nd Value:	
Value Percent:	<b>5.000</b>
Continuous Index:	<b>F02</b>
Within 8" of Joint:	<b>NO</b>
Remarks:

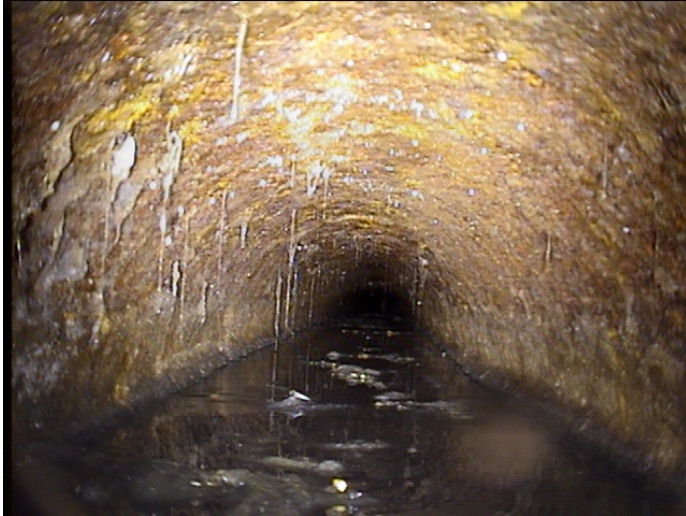
Code: **DSF**  
Description: **Deposits Settled Fine**

Distance (ft): **5.1**  
Structural Grade: **0**  
O&M Grade: **3**  
Clock Start/From: **4**  
Clock To: **8**  
1st Value:  
2nd Value:  
Value Percent: **20.000**  
Continuous Index: **F01**  
Within 8" of Joint: **NO**  
Remarks:

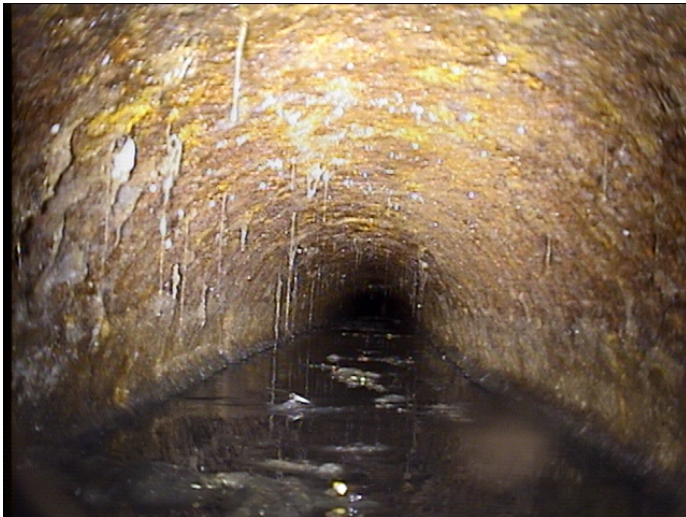
Code: **MSA**  
Description: **Abandoned Survey**

Distance (ft): **5.1**  
Structural Grade: **0**  
O&M Grade: **0**  
Clock Start/From:  
Clock To:  
1st Value:  
2nd Value:  
Value Percent:  
Continuous Index:  
Within 8" of Joint: **NO**  
Remarks: **30% Heavy Sediment**
