## Profile/Photo Observation Report

| Street: | <b>South Lake Park</b> | Flow Control: | <b>Not Controlled</b> |
| US MH: | <b>M-606-005</b> | DS MH: | <b>M-606-006</b> |

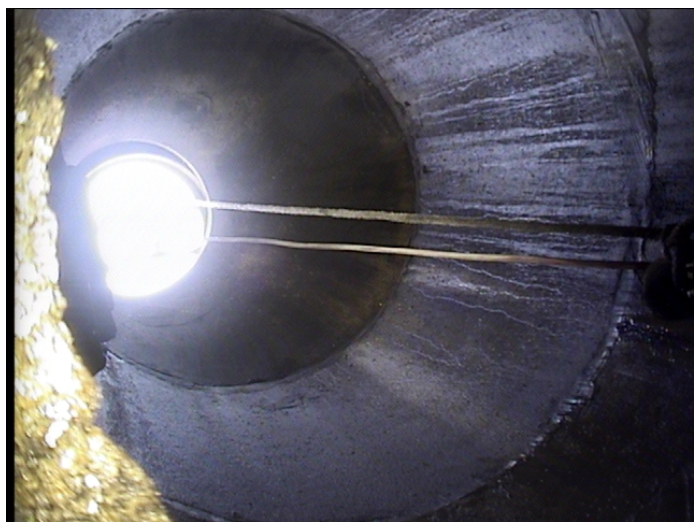
Code: **AMH**  
 Description: **Manhole**

Distance (ft): **.0**  
 Structural Grade: **0**  
 O&M Grade: **0**  
 Clock Start/From:  
 Clock To:  
 1st Value:  
 2nd Value:  
 Value Percent:  
 Continuous Index:  
 Within 8" of Joint: **NO**  
 Remarks: **M-606-005**

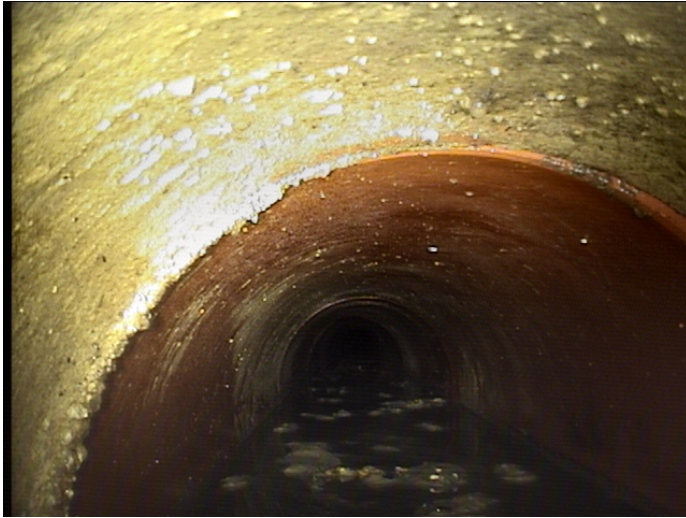
Code: **MWL**  
Description: **Water Level**

Distance (ft): **.0**  
Structural Grade: **0**  
O&M Grade: **0**  
Clock Start/From:  
Clock To:  
1st Value:  
2nd Value:  
Value Percent: **30.000**  
Continuous Index:  
Within 8" of Joint: **NO**  
Remarks:

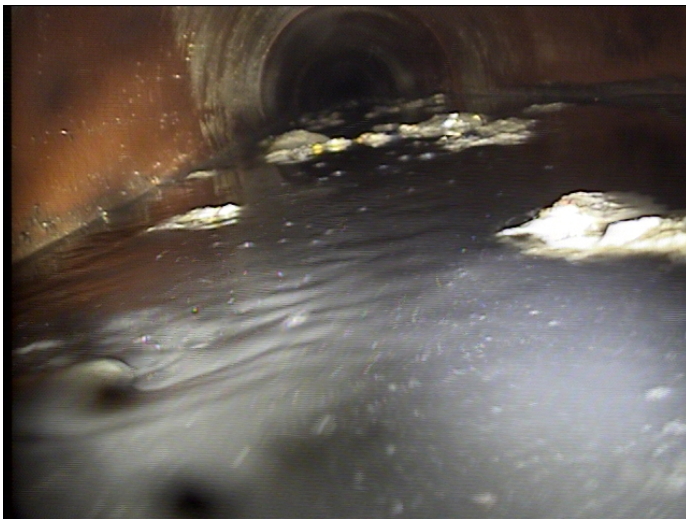
Code: **DSF**  
Description: **Deposits Settled Fine**

Distance (ft): **1.2**  
Structural Grade: **0**  
O&M Grade: **4**  
Clock Start/From: **4**  
Clock To: **8**  
1st Value:  
2nd Value:  
Value Percent: **25.000**  
Continuous Index:  
Within 8" of Joint: **NO**  
Remarks:

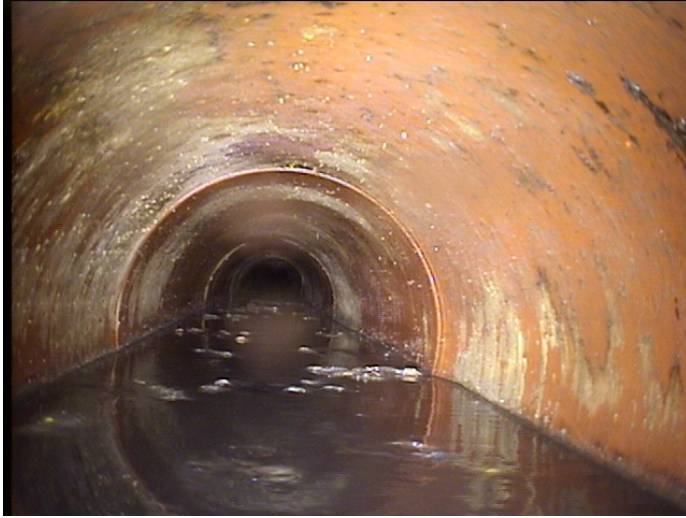
| Code: | <b>MSA</b> |
| Description: | <b>Abandoned Survey</b> |
| Distance (ft): | <b>2.6</b> |
| Remarks: | <b>Cannot pass heavy sediment</b> |
