Profile/Photo Observation Report

Date:	05/08/2018	Weather:		Coding:	PACP 6.0
Pipe Length (ft):		Owner:	City of Hobart	Pre Clean:	Not Known
P.O.#:	305	Surveyor:	B. Helbling	PSR:	P-606-006-007
Customer:	City of Hobart	Clean Date:		Shape:	C

Street:	South Lake Park Avenue	Flow Control:	Not Controlled
City:	Hobart, IN	Year Renewed:	
Location:	Light Highway	Tape/Media #:	DEP305
Purpose:	Routine Assessment	Dia/Height:	18"
Use:	Sanitary	Material:	VCP
Drain Area:		Lining:	
Category:	NA		
Comment:	5-21-2018

Location Details:		Direction of Survey:	Downstream
US MH:	M-606-006	DS MH:	M-606-007
		Total Length Surveyed (ft):	48.9

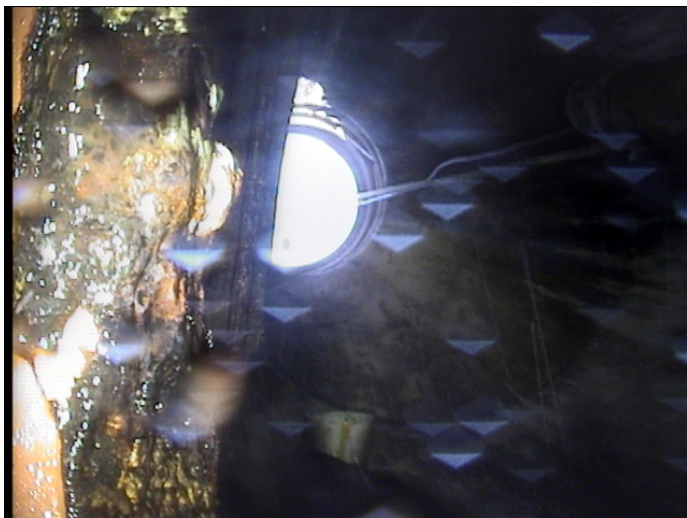
Code: **AMH**
 Description: **Manhole**

Distance (ft): **.0**
 Structural Grade: **0**
 O&M Grade: **0**
 Clock Start/From:
 Clock To:
 1st Value:
 2nd Value:
 Value Percent:
 Continuous Index:
 Within 8" of Joint: **NO**
 Remarks: **M-606-006**

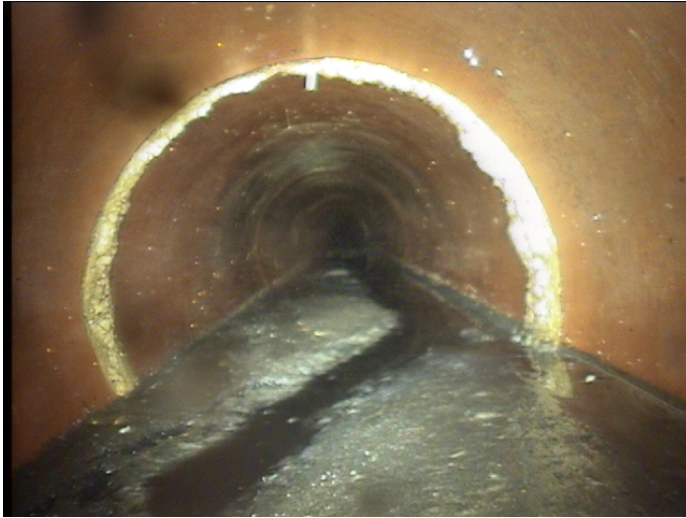
Code: **MWL**
Description: **Water Level**

Distance (ft): **.0**
Structural Grade: **0**
O&M Grade: **0**
Clock Start/From:
Clock To:
1st Value:
2nd Value:
Value Percent: **35.000**
Continuous Index:
Within 8" of Joint: **NO**
Remarks:

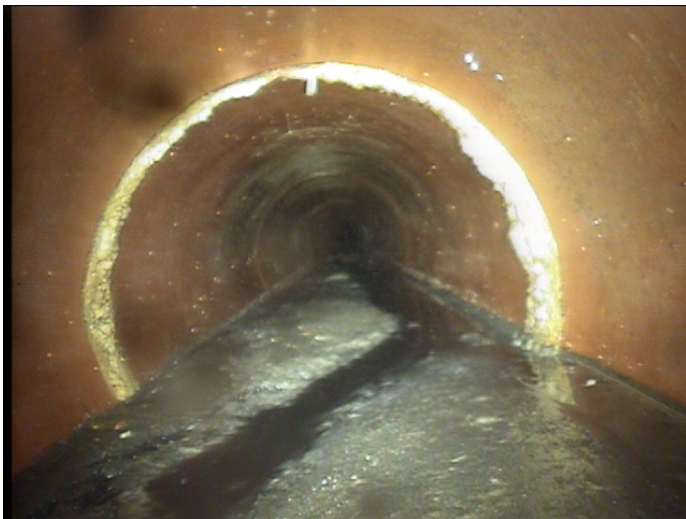
Code: **DSF**
Description: **Deposits Settled Fine**

Distance (ft): **.5**
Structural Grade: **0**
O&M Grade: **4**
Clock Start/From: **4**
Clock To: **8**
1st Value:
2nd Value:
Value Percent: **30.000**
Continuous Index: **S01**
Within 8" of Joint: **NO**
Remarks:

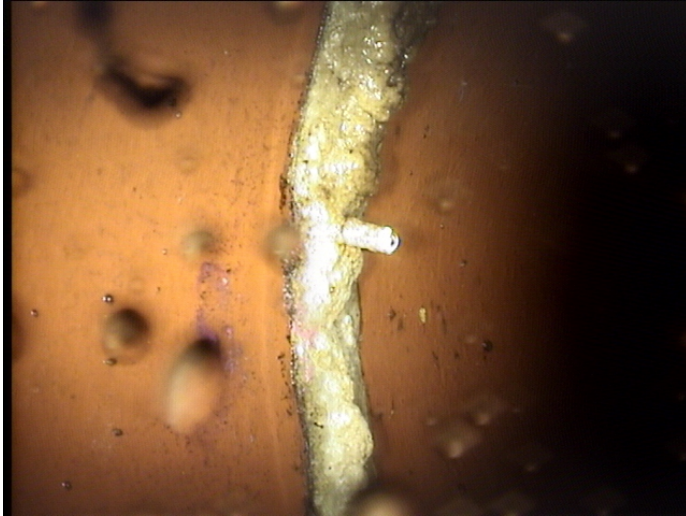
Code: **ID**
Description: **Infil Dripper**

Distance (ft): **2.1**
Structural Grade: **0**
O&M Grade: **3**
Clock Start/From: **12**
Clock To:
1st Value:
2nd Value:
Value Percent:
Continuous Index:
Within 8" of Joint: **YES**
Remarks:

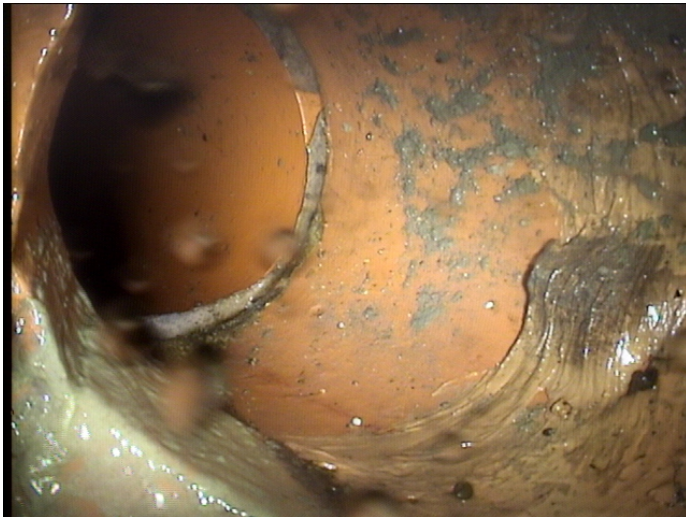
Code: **TFA**
Description: **Tap Factory Active**

Distance (ft): **13.3**
Structural Grade: **0**
O&M Grade: **0**
Clock Start/From: **11**
Clock To:
1st Value: **6.000**
2nd Value:
Value Percent:
Continuous Index:
Within 8" of Joint: **NO**
Remarks:

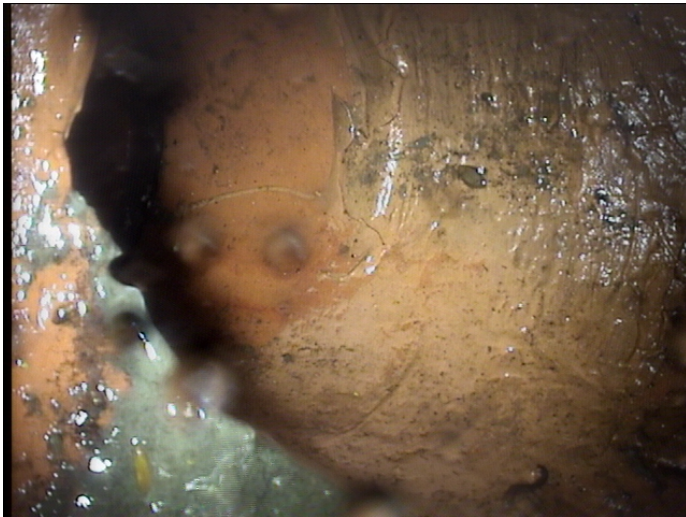
Code: **TFA**
Description: **Tap Factory Active**

Distance (ft): **16.2**
Structural Grade: **0**
O&M Grade: **0**
Clock Start/From: **11**
Clock To:
1st Value: **6.000**
2nd Value:
Value Percent:
Continuous Index:
Within 8" of Joint: **NO**
Remarks:

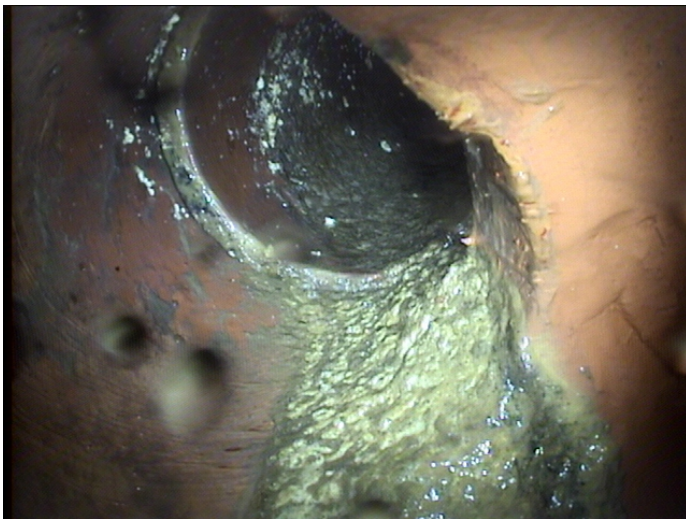
Code: **TF**
Description: **Tap Factory**

Distance (ft): **47.2**
Structural Grade: **0**
O&M Grade: **0**
Clock Start/From: **1**
Clock To:
1st Value: **6.000**
2nd Value:
Value Percent:
Continuous Index:
Within 8" of Joint: **NO**
Remarks:

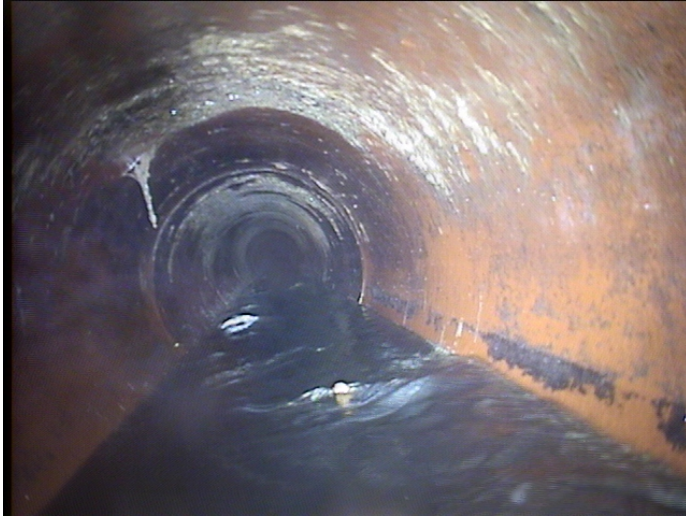
Code: **DSF**
Description: **Deposits Settled Fine**

Distance (ft): **48.8**
Structural Grade: **0**
O&M Grade: **4**
Clock Start/From: **4**
Clock To: **8**
1st Value:
2nd Value:
Value Percent: **30.000**
Continuous Index: **F01**
Within 8" of Joint: **NO**
Remarks:

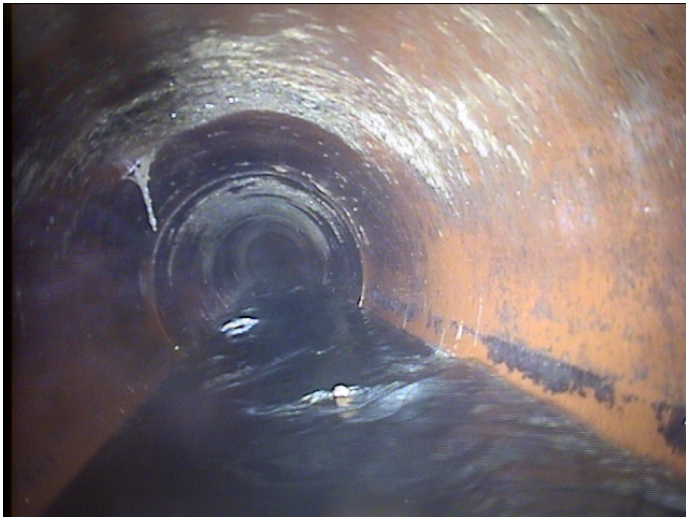
Code: **MSA**
Description: **Abandoned Survey**

Distance (ft): **48.8**
Structural Grade: **0**
O&M Grade: **0**
Clock Start/From:
Clock To:
1st Value:
2nd Value:
Value Percent:
Continuous Index:
Within 8" of Joint: **NO**
Remarks: **Cannot pass heavy debris/sediment**
