Profile/Photo Observation Report

Date:	05/08/2018	Weather:		Coding:	PACP 6.0
Pipe Length (ft):		Owner:	City of Hobart	Pre Clean:	Not Known
P.O.#:	306	Surveyor:	B. Helbling	PSR:	P-606-006-007
Customer:	City of Hobart	Clean Date:		Shape:	C

Street:	South Lake Park Avenue	Flow Control:	Not Controlled
City:	Hobart, IN	Year Renewed:	
Location:	Light Highway	Tape/Media #:	DEP306
Purpose:	Routine Assessment	Dia/Height:	18"
Use:	Sanitary	Material:	VCP
Drain Area:		Lining:	
Category:	NA		
Comment:	5-21-2018		
Location Details:		Direction of Survey:	Upstream
US MH:	M-606-006	DS MH:	M-606-007
		Total Length Surveyed (ft):	24.3

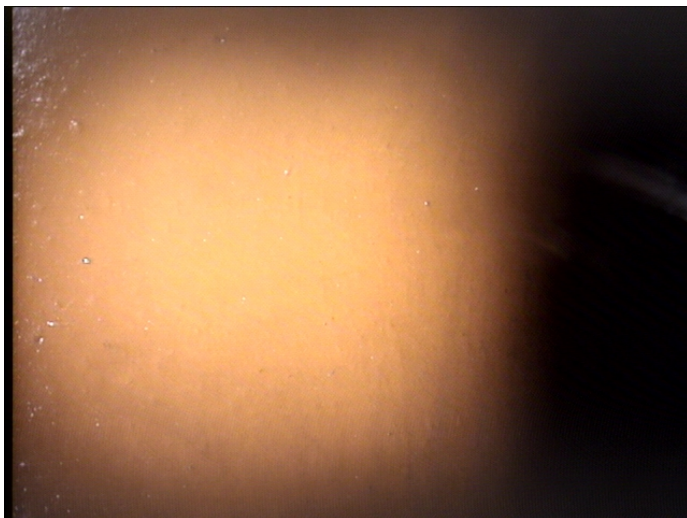
Code: **AMH**
Description: **Manhole**

Distance (ft): **.0**
Structural Grade: **0**
O&M Grade: **0**
Clock Start/From:
Clock To:
1st Value:
2nd Value:
Value Percent:
Continuous Index:
Within 8" of Joint: **NO**
Remarks: **M-606-007**

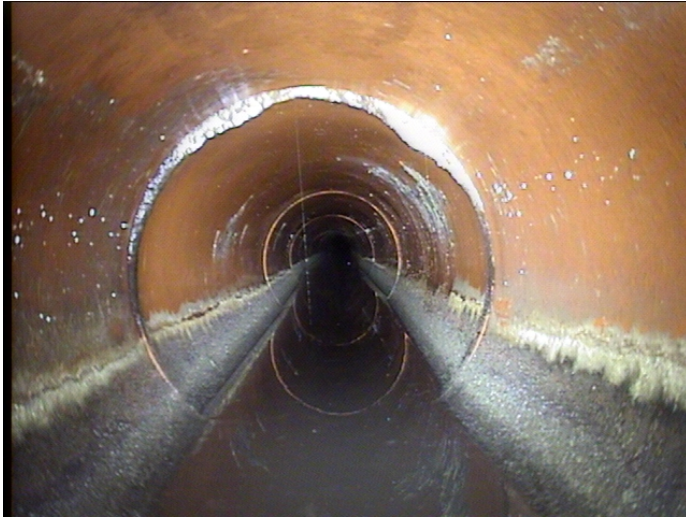
Code: **MWL**
Description: **Water Level**

Distance (ft): **.0**
Structural Grade: **0**
O&M Grade: **0**
Clock Start/From:
Clock To:
1st Value:
2nd Value:
Value Percent: **10.000**
Continuous Index:
Within 8" of Joint: **NO**
Remarks:

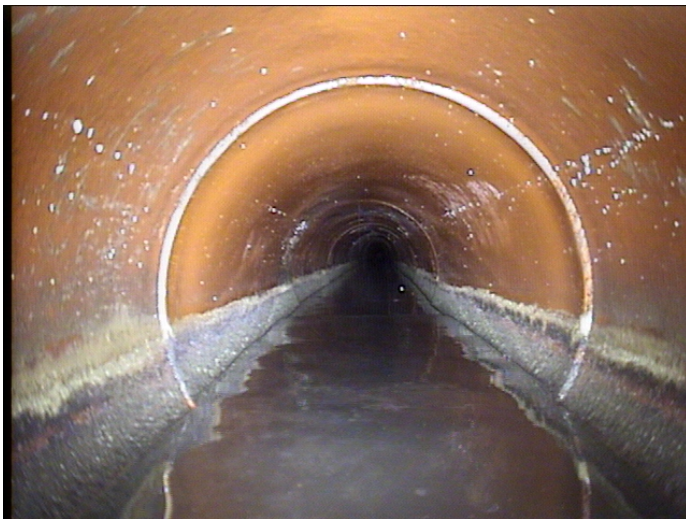
Code: **DSF**
Description: **Deposits Settled Fine**

Distance (ft): **10.8**
Structural Grade: **0**
O&M Grade: **2**
Clock Start/From: **5**
Clock To: **7**
1st Value:
2nd Value:
Value Percent: **10.000**
Continuous Index: **S01**
Within 8" of Joint: **NO**
Remarks:

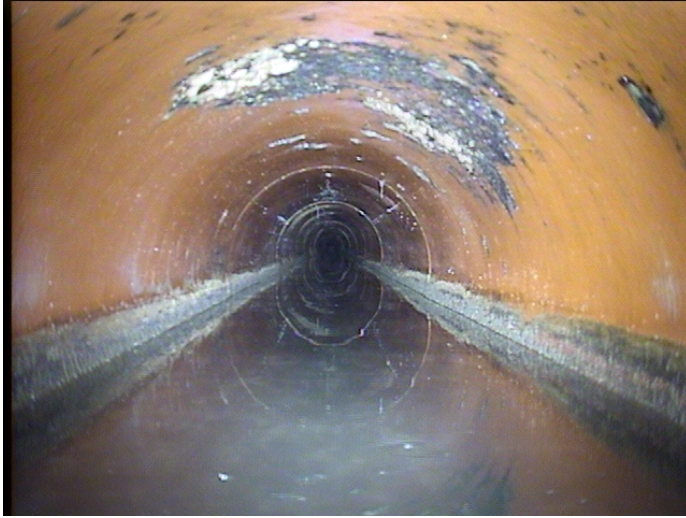
Code: **DSF**
Description: **Deposits Settled Fine**

Distance (ft): **24.2**
Structural Grade: **0**
O&M Grade: **2**
Clock Start/From: **5**
Clock To: **7**
1st Value:
2nd Value:
Value Percent: **10.000**
Continuous Index: **F01**
Within 8" of Joint: **NO**
Remarks:

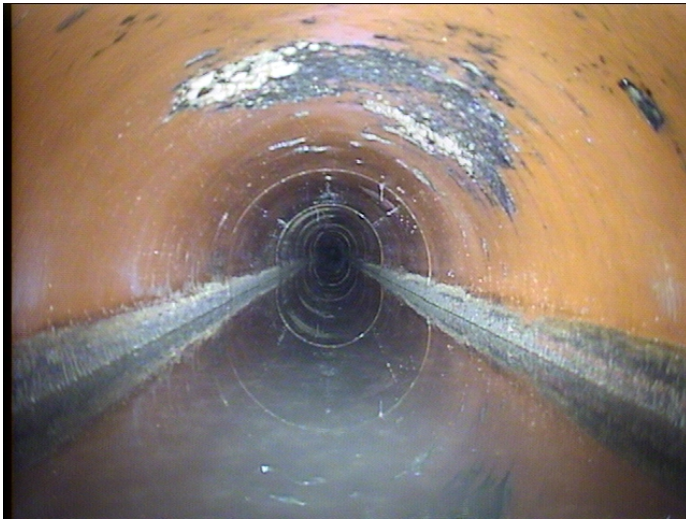
Code: **MSA**
Description: **Abandoned Survey**

Distance (ft): **24.2**
Structural Grade: **0**
O&M Grade: **0**
Clock Start/From:
Clock To:
1st Value:
2nd Value:
Value Percent:
Continuous Index:
Within 8" of Joint: **NO**
Remarks: **Cannot pass heavy debris/sediment.**
