## Profile/Photo Observation Report

Street:	<b>West 8th Street</b>	Flow Control:	<b>Not Controlled</b>
City:	<b>Hobart, IN</b>	Year Renewed:	
Location:	<b>Light Highway</b>	Tape/Media #:	<b>DEP302</b>
Purpose:	<b>Routine Assessment</b>	Dia/Height:	<b>18"</b>
Use:	<b>Sanitary</b>	Material:	<b>VCP</b>
Drain Area:		Lining:	
Category:	<b>NA</b>		
Comment:	<b>5-21-2018</b>

Location Details:		Direction of Survey:	<b>Downstream</b>
US MH:	<b>M-606-008</b>	DS MH:	<b>M-606-009</b>
		Total Length Surveyed (ft):	<b>98.4</b>

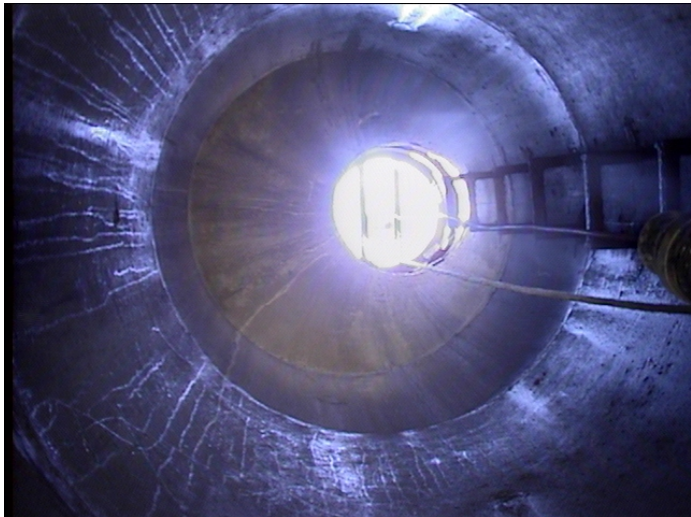
AMH

Manhole

M-606-009

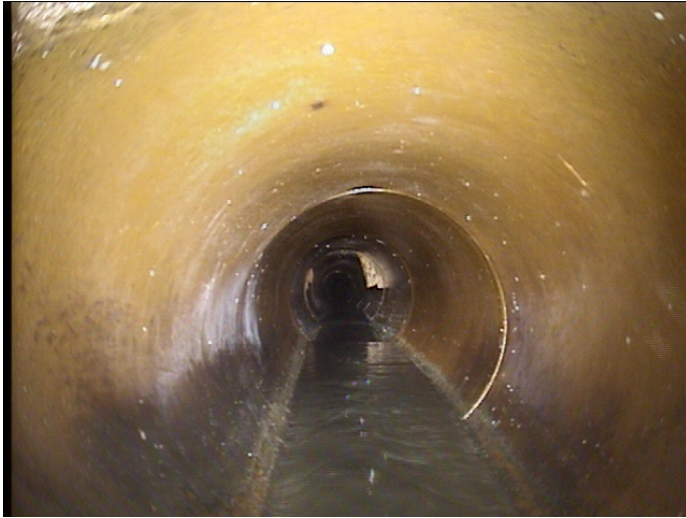
Code: **MWL**  
Description: **Water Level**

Distance (ft): **.0**  
Structural Grade: **0**  
O&M Grade: **0**  
Clock Start/From:  
Clock To:  
1st Value:  
2nd Value:  
Value Percent: **10.000**  
Continuous Index:  
Within 8" of Joint: **NO**  
Remarks:

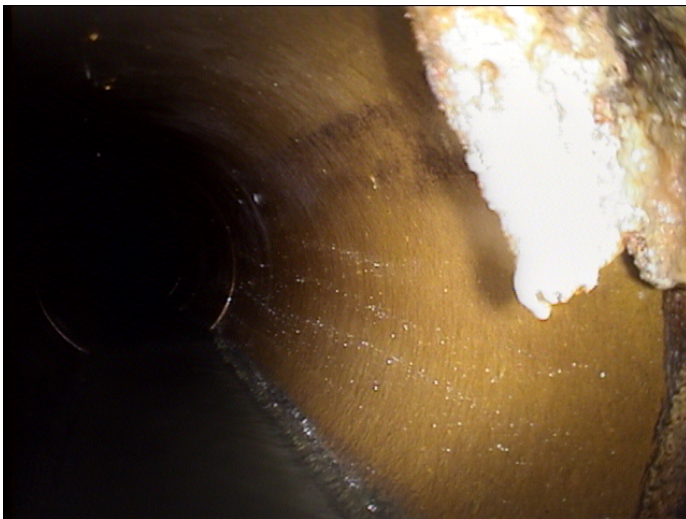
Code: **DAE**  
Description: **Deposits Attached Encrustation**

Distance (ft): **11.4**  
Structural Grade: **0**  
O&M Grade: **2**  
Clock Start/From: **12**  
Clock To: **3**  
1st Value:  
2nd Value:  
Value Percent: **5.000**  
Continuous Index:  
Within 8" of Joint: **YES**  
Remarks:

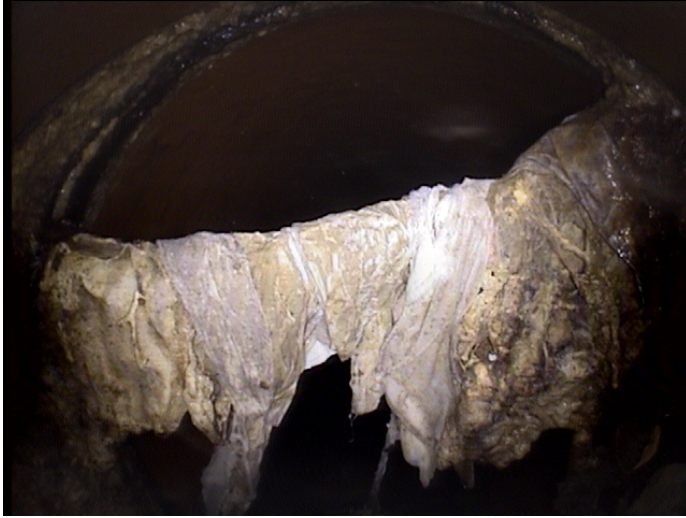
Code:	<b>OBZ</b>
Description:	<b>Obstacle Other</b>
Distance (ft):	<b>96.8</b>
Structural Grade:	<b>0</b>
O&M Grade:	<b>3</b>
Clock Start/From:	<b>8</b>
Clock To:	<b>3</b>
1st Value:	
2nd Value:	
Value Percent:	<b>20.000</b>
Continuous Index:	
Within 8" of Joint:	<b>NO</b>
Remarks:	<b>Unknown obstruction across pipe</b>

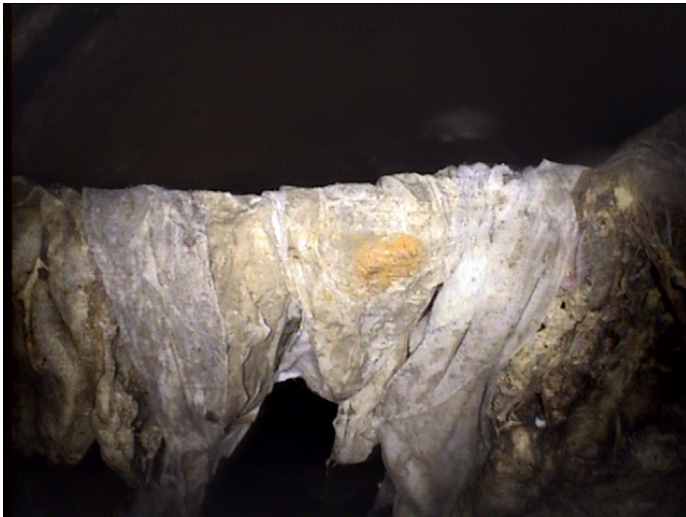
Code:	<b>MSA</b>
Description:	<b>Abandoned Survey</b>
Distance (ft):	<b>98.4</b>
Structural Grade:	<b>0</b>
O&M Grade:	<b>0</b>
Clock Start/From:	
Clock To:	
1st Value:	
2nd Value:	
Value Percent:	
Continuous Index:	
Within 8" of Joint:	<b>NO</b>
Remarks:	<b>Cannot pass unknown object in pipe</b>
