Profile/Photo Observation Report

Street:	West 8th Street	Flow Control:	Not Controlled
City:	Hobart, IN	Year Renewed:	
Location:	Light Highway	Tape/Media #:	DEP303
Purpose:	Routine Assessment	Dia/Height:	18"
Use:	Sanitary	Material:	VCP
Drain Area:		Lining:	
Category:	NA		
Comment:	5-21-2018

Location Details:		Direction of Survey:	Upstream
US MH:	M-606-009	DS MH:	M-606-008
		Total Length Surveyed (ft):	76.6

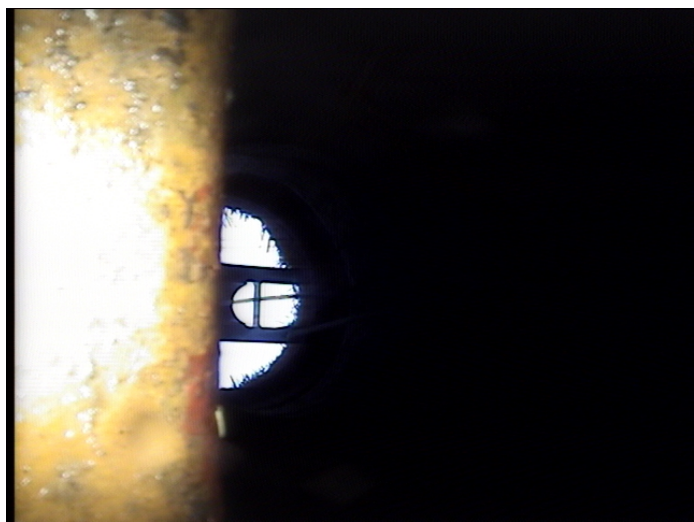
Code: **AMH**
 Description: **Manhole**

Distance (ft): **.0**
 Structural Grade: **0**
 O&M Grade: **0**
 Clock Start/From:
 Clock To:
 1st Value:
 2nd Value:
 Value Percent:
 Continuous Index:
 Within 8" of Joint: **NO**
 Remarks: **M-606-008**

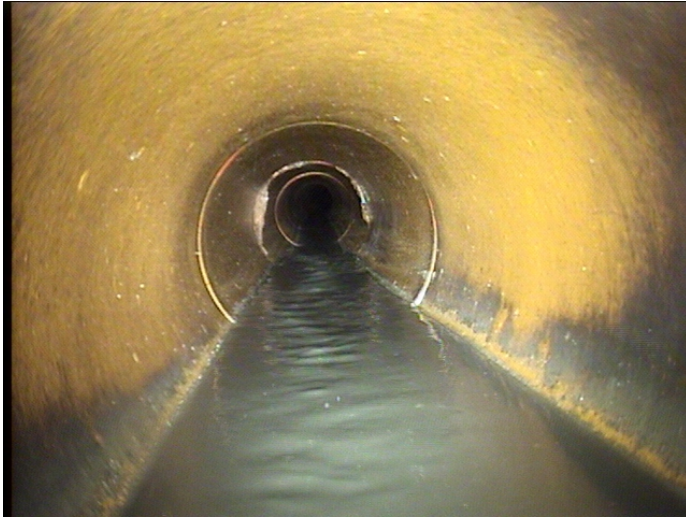
Code: **MWL**
Description: **Water Level**

Distance (ft): **.0**
Structural Grade: **0**
O&M Grade: **0**
Clock Start/From:
Clock To:
1st Value:
2nd Value:
Value Percent: **10.000**
Continuous Index:
Within 8" of Joint: **NO**
Remarks:

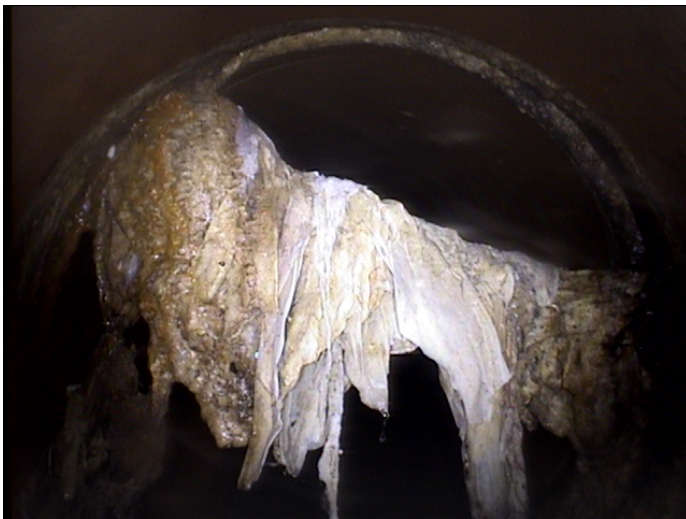
Code: **OBZ**
Description: **Obstacle Other**

Distance (ft): **76.6**
Structural Grade: **0**
O&M Grade: **4**
Clock Start/From: **8**
Clock To: **4**
1st Value:
2nd Value:
Value Percent: **25.000**
Continuous Index:
Within 8" of Joint: **NO**
Remarks: **Unknown obstruction blocking camera.**

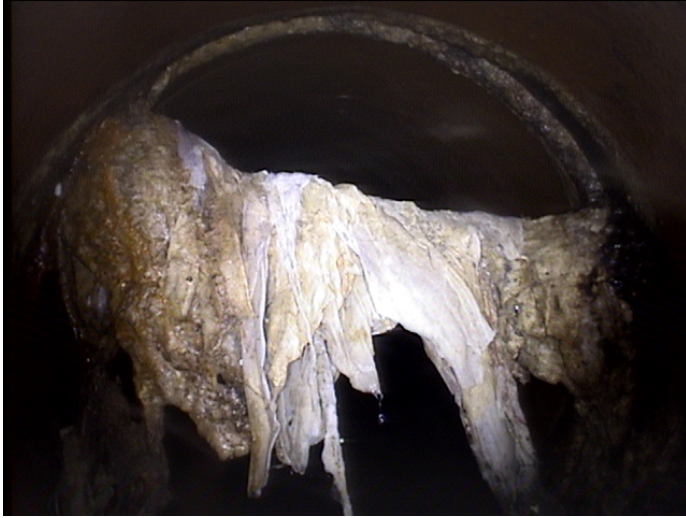
Code:	MSA
Description:	Abandoned Survey
Distance (ft):	76.6
Structural Grade:	0
O&M Grade:	0
Clock Start/From:	
Clock To:	
1st Value:	
2nd Value:	
Value Percent:	
Continuous Index:	
Within 8" of Joint:	NO
Remarks:	Unknown obstruction across pipe.
