Pipe Length (ft): Owner: City of Hobart Pre Clean: P.O.#: 301 Surveyor: B. Helbling PSR: Customer: City of Hobart Clean Date: Shape: Street: West 8th Street Flow Control: Not Controlled	PACP 6.0 Not Known
	P-606-021-009 C
City Very Penewada	
City: Hobart, IN Year Renewed:	
Location: Light Highway Tape/Media #: DEP301	
Purpose: Routine Assessment Dia/Height: 18"	
Use: Sanitary Material: VCP	
Drain Area: Lining:	
Category: NA	
Comment: 5-21-2018	
Location Details: Direction of Survey: Upstream	
US MH: M-606-009 DS MH: M-606-021 Total Length Surveyed (ft):	242.9
O&M Index: 2.41 O&M Quick: 4233 O&M Rating:	41.00
Structural Index: 3.00 Structural Quick: 4121 Structural Rating:	6.00
Overall Index: 2.47 Overall Quick: 4333 Overall Rating:	47.00

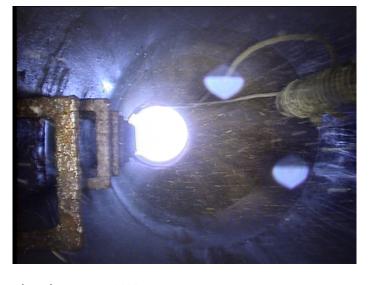
Code:	АМН
Description:	Manhole
Distance (ft):	.0
Structural Grade:	0
O&M Grade:	0
Clock Start/From:	
Clock To:	
1st Value:	
2nd Value:	
Value Percent:	
Continuous Index:	
Within 8" of Joint:	NO
Remarks:	M-606-009

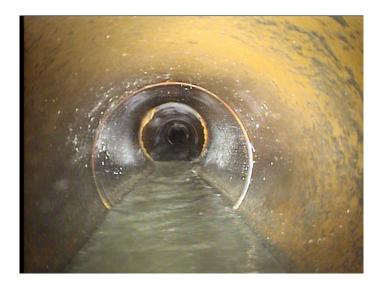
Code: MWL Description: **Water Level**

Distance (ft): .0 Structural Grade: 0 O&M Grade: 0 Clock Start/From:

Value Percent: 10.000

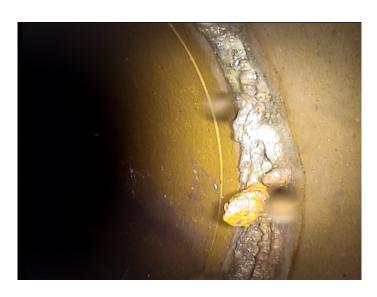
Code: ID Description: **Infil Dripper**

Distance (ft): 34.9 Structural Grade: 0 O&M Grade: 3 Clock Start/From: 1

Within 8" of Joint: YES

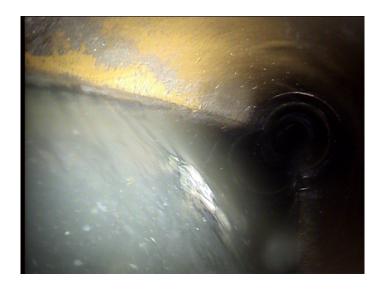
Code: **DSF**

Description: Deposits Settled Fine

Distance (ft): 62.9
Structural Grade: 0
O&M Grade: 2
Clock Start/From: 5
Clock To: 7

Value Percent: 5.000

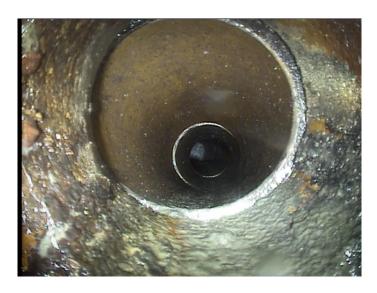
Code: **TF**

Description: Tap Factory

Distance (ft): 68.7
Structural Grade: 0

Clock Start/From: 10

1st Value: **6.000**

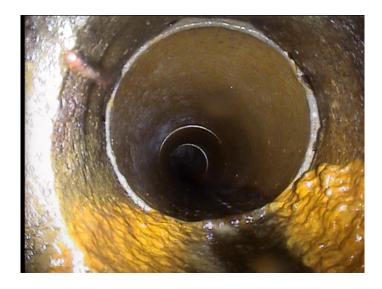
Code: **TFA**

Description: **Tap Factory Active**

Distance (ft): 77.1 Structural Grade: 0 0 O&M Grade: Clock Start/From: 1

1st Value: 6.000

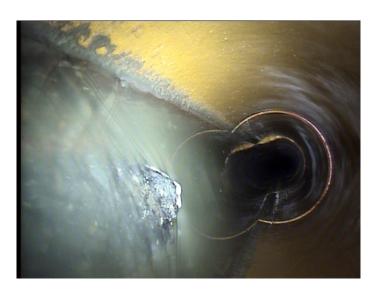
Code: DSF

Description: **Deposits Settled Fine**

Distance (ft): 81.1 Structural Grade: 0 O&M Grade: 2 Clock Start/From: 5 7 Clock To: 1st Value:

Value Percent: 5.000 Continuous Index: **S01** NO

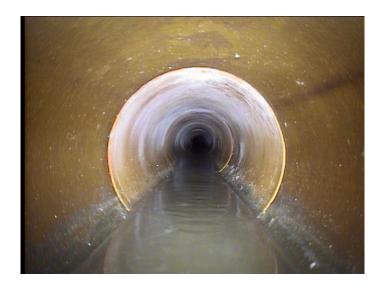
Code: **DSF**

Description: **Deposits Settled Fine**

Distance (ft): 119.8 Structural Grade: 0 2 O&M Grade: Clock Start/From: 5 7 Clock To:

5.000 Value Percent: Continuous Index: F01 Within 8" of Joint: NO

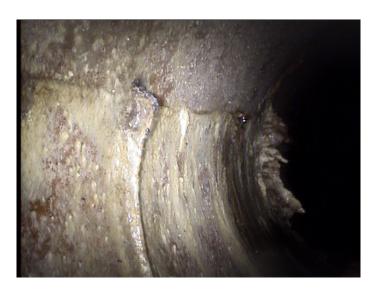
CL Code:

Description: **Crack Longitudinal**

Distance (ft): 167.7 Structural Grade: 2 O&M Grade: 0 Clock Start/From: 12

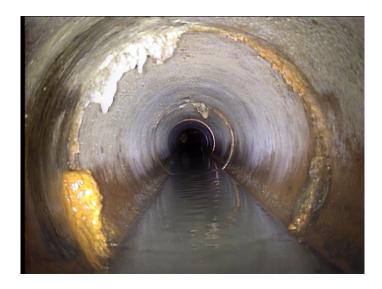
Code: DAE

Description: **Deposits Attached Encrustation**

Distance (ft): 167.7 Structural Grade: 0 2 O&M Grade: Clock Start/From: 7 Clock To: 5

5.000 Value Percent:

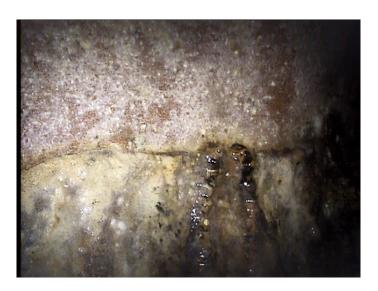
Code: ID

Description: **Infil Dripper**

Distance (ft): 169.3 Structural Grade: 0

O&M Grade: 3 Clock Start/From: 12

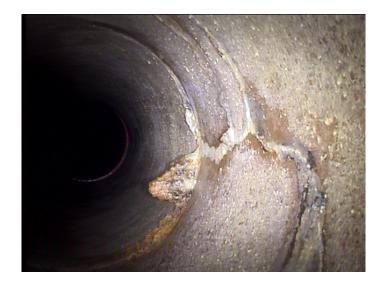
Code: FΜ

Description: **Fracture Multiple**

Distance (ft): 171.9 Structural Grade: 4 O&M Grade: 0 Clock Start/From: 9 Clock To: 3

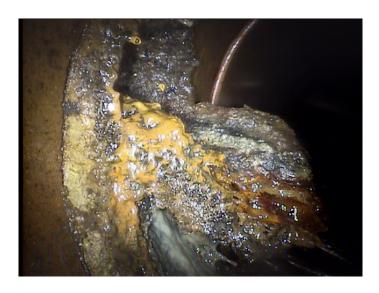
Code: DAE

Description: **Deposits Attached Encrustation**

Distance (ft): 191.9 Structural Grade: 0 O&M Grade: 3 Clock Start/From: 7 Clock To: 11 1st Value:

Value Percent: 15.000

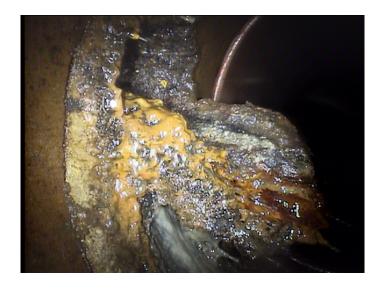
Code: IR

Description: **Infil Runner**

Distance (ft): 191.9 Structural Grade: 0 O&M Grade: 4 Clock Start/From: 10

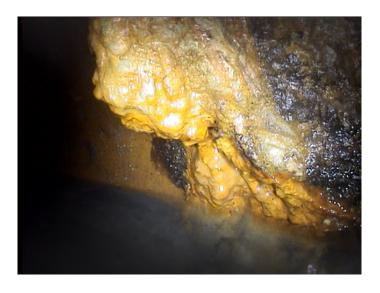
Code: DAE

Description: **Deposits Attached Encrustation**

Distance (ft): 212.3 Structural Grade: 0 O&M Grade: 2 Clock Start/From: 1 5 Clock To: 1st Value:

Value Percent: 5.000

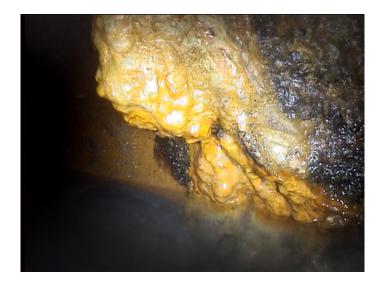
Code: IR

Description: Infil Runner

Distance (ft): 212.3
Structural Grade: 0
O&M Grade: 4
Clock Start/From: 5

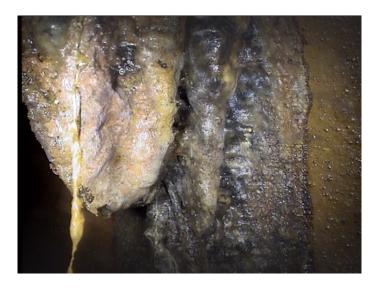
Code: DAE

Description: Deposits Attached Encrustation

Distance (ft): 232.8
Structural Grade: 0
O&M Grade: 2
Clock Start/From: 1
Clock To: 5
1st Value:

Value Percent: 5.000

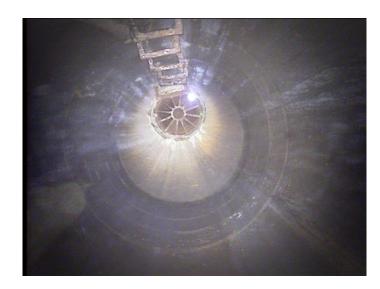
Code: AMH
Description: Manhole

Distance (ft): 242.9
Structural Grade: 0
O&M Grade: 0

Remarks: M-606-021
