Profile/Photo Observation Report

Date:	04/11/2018	Weather:		Coding:	PACP 6.0
Pipe Length (ft):	230.2	Owner:	NA	Pre Clean:	No Pre-Cleaning
P.O.#:		Surveyor:	Jen Costello	PSR:	P-606-011-010
Customer:		Clean Date:	01/01/1900	Shape:	C

Street:	W 8TH ST & W 8TH PL	Flow Control:	Not Controlled
City:	Hobart, IN	Year Renewed:	
Location:	Yard	Tape/Media #:	
Purpose:	Routine Assessment	Dia/Height:	10"
Use:	Sanitary	Material:	VCP
Drain Area:	NA	Lining:	
Category:	NA		
Comment:	Flow direction is marked wrong.		
Location Details:		Direction of Survey:	Downstream
US MH:	M-606-010	DS MH:	M-606-011
		Total Length Surveyed (ft):	213.5

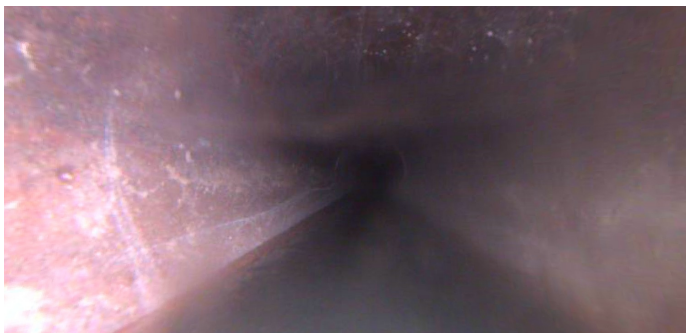
Code: **AMH**
Description: **Manhole**

Distance (ft): **.0**
Structural Grade: **0**
O&M Grade: **0**
Clock Start/From:
Clock To:
1st Value:
2nd Value:
Value Percent:
Continuous Index:
Within 8" of Joint: **NO**
Remarks: **M-606-010**

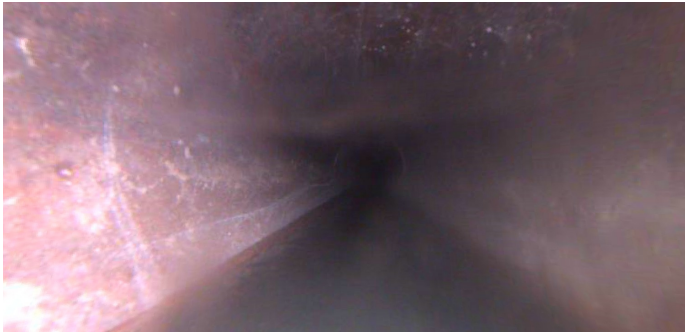
Code:	MWL
Description:	Water Level

Distance (ft):	.0
Structural Grade:	0
O&M Grade:	0
Clock Start/From:	
Clock To:	
1st Value:	
2nd Value:	
Value Percent:	20.000
Continuous Index:	
Within 8" of Joint:	NO
Remarks:

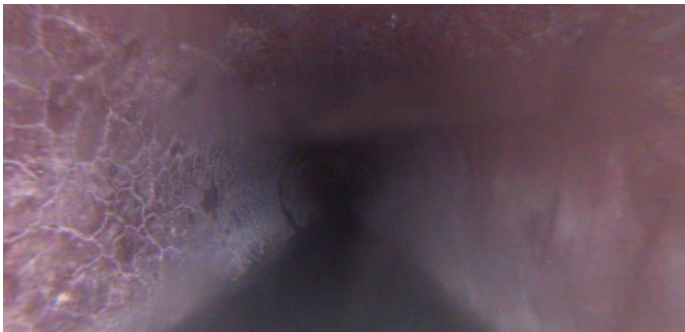
Code:	CM
Description:	Crack Multiple

Distance (ft):	2.7
Structural Grade:	3
O&M Grade:	0
Clock Start/From:	8
Clock To:	4
1st Value:	
2nd Value:	
Value Percent:	
Continuous Index:	
Within 8" of Joint:	YES
Remarks:

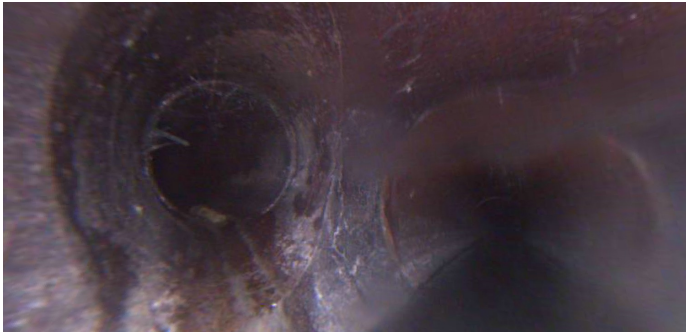
Code: **TF**
Description: **Tap Factory**

Distance (ft): **4.4**
Structural Grade: **0**
O&M Grade: **0**
Clock Start/From: **9**
Clock To:
1st Value: **4.000**
2nd Value:
Value Percent:
Continuous Index:
Within 8" of Joint:
Remarks:

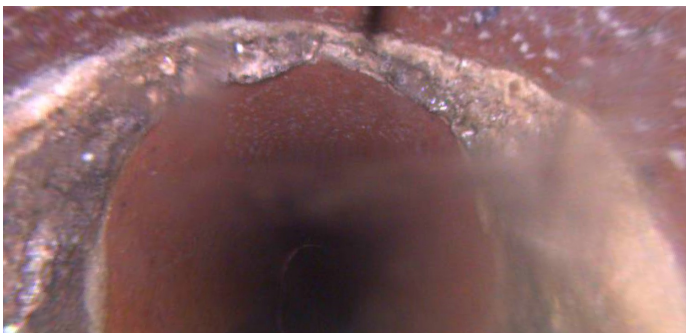
Code: **DAE**
Description: **Deposits Attached Encrustation**

Distance (ft): **67.0**
Structural Grade: **0**
O&M Grade: **2**
Clock Start/From: **8**
Clock To: **4**
1st Value:
2nd Value:
Value Percent: **5.000**
Continuous Index:
Within 8" of Joint: **YES**
Remarks:

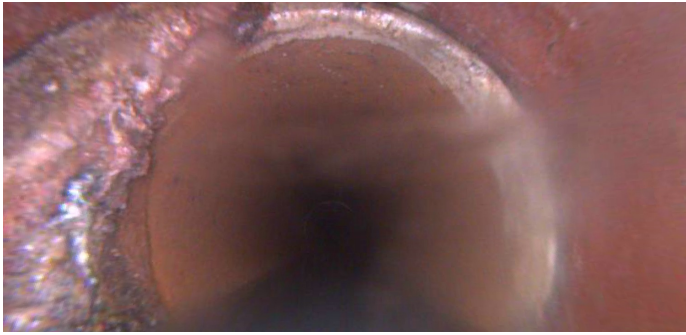
Code: **DAE**
Description: **Deposits Attached Encrustation**

Distance (ft): **70.9**
Structural Grade: **0**
O&M Grade: **2**
Clock Start/From: **8**
Clock To: **12**
1st Value:
2nd Value:
Value Percent: **10.000**
Continuous Index:
Within 8" of Joint: **YES**
Remarks:

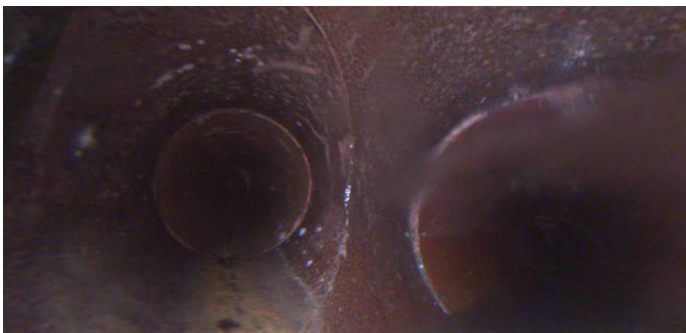
Code: **TFA**
Description: **Tap Factory Active**

Distance (ft): **85.0**
Structural Grade: **0**
O&M Grade: **0**
Clock Start/From: **9**
Clock To:
1st Value: **4.000**
2nd Value:
Value Percent:
Continuous Index:
Within 8" of Joint:
Remarks:

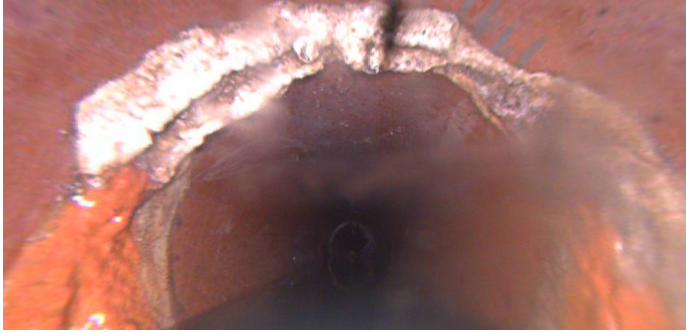
Code: **DAE**
Description: **Deposits Attached Encrustation**

Distance (ft): **112.8**
Structural Grade: **0**
O&M Grade: **2**
Clock Start/From: **8**
Clock To: **4**
1st Value:
2nd Value:
Value Percent: **10.000**
Continuous Index:
Within 8" of Joint: **YES**
Remarks:

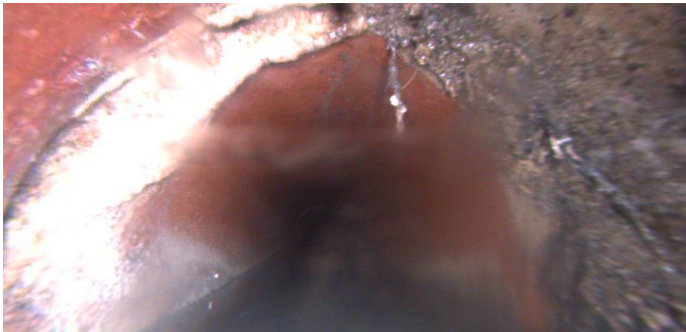
Code: **RFJ**
Description: **Roots Fine Joint**

Distance (ft): **116.9**
Structural Grade: **0**
O&M Grade: **1**
Clock Start/From: **12**
Clock To: **3**
1st Value:
2nd Value:
Value Percent:
Continuous Index:
Within 8" of Joint: **YES**
Remarks:

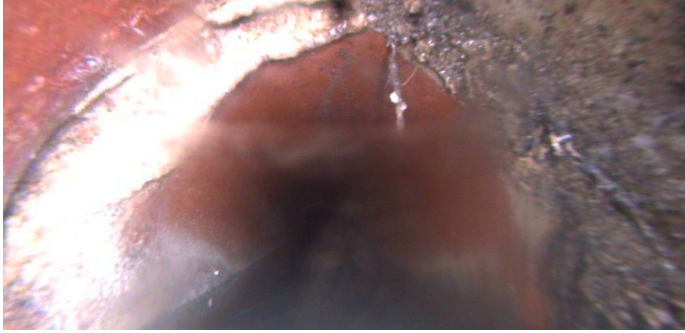
Code: **DAE**
Description: **Deposits Attached Encrustation**

Distance (ft): **116.9**
Structural Grade: **0**
O&M Grade: **2**
Clock Start/From: **8**
Clock To: **4**
1st Value:
2nd Value:
Value Percent: **10.000**
Continuous Index:
Within 8" of Joint: **YES**
Remarks:

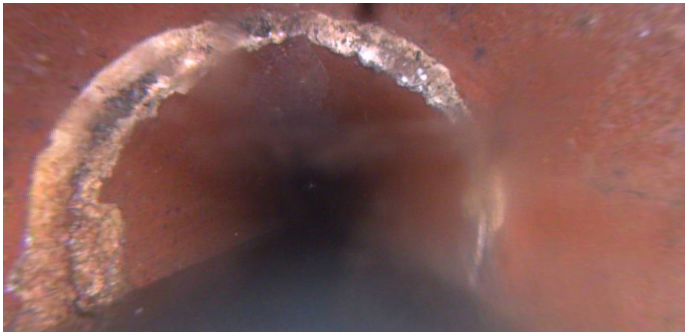
Code: **DAE**
Description: **Deposits Attached Encrustation**

Distance (ft): **140.1**
Structural Grade: **0**
O&M Grade: **2**
Clock Start/From: **8**
Clock To: **4**
1st Value:
2nd Value:
Value Percent: **5.000**
Continuous Index:
Within 8" of Joint: **YES**
Remarks:

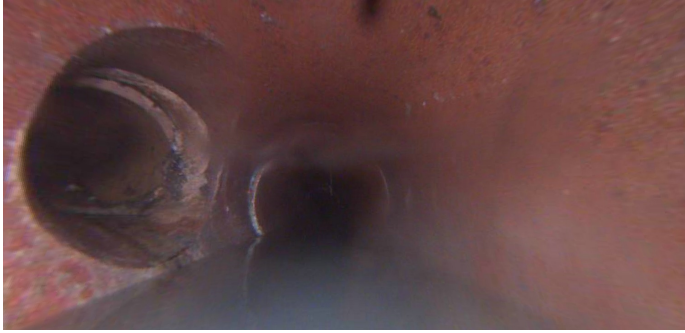
Code: **TF**
Description: **Tap Factory**

Distance (ft): **153.8**
Structural Grade: **0**
O&M Grade: **0**
Clock Start/From: **9**
Clock To:
1st Value: **4.000**
2nd Value:
Value Percent:
Continuous Index:
Within 8" of Joint:
Remarks:

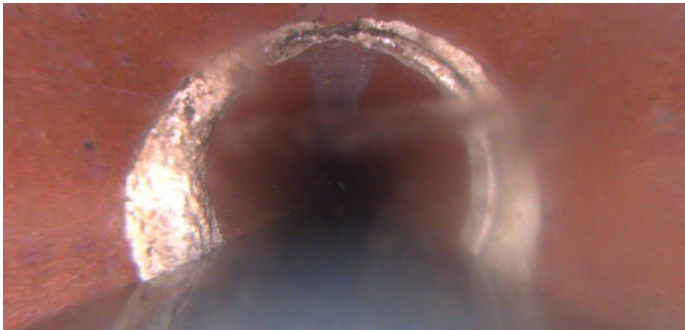
Code: **DAE**
Description: **Deposits Attached Encrustation**

Distance (ft): **177.9**
Structural Grade: **0**
O&M Grade: **2**
Clock Start/From: **8**
Clock To: **4**
1st Value:
2nd Value:
Value Percent: **5.000**
Continuous Index:
Within 8" of Joint: **YES**
Remarks:

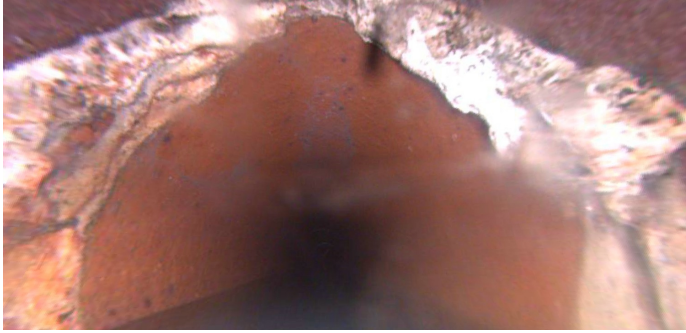
Code:	DAE
Description:	Deposits Attached Encrustation

Distance (ft):	186.0
Structural Grade:	0
O&M Grade:	2
Clock Start/From:	8
Clock To:	4
1st Value:	
2nd Value:	
Value Percent:	10.000
Continuous Index:	
Within 8" of Joint:	YES
Remarks:

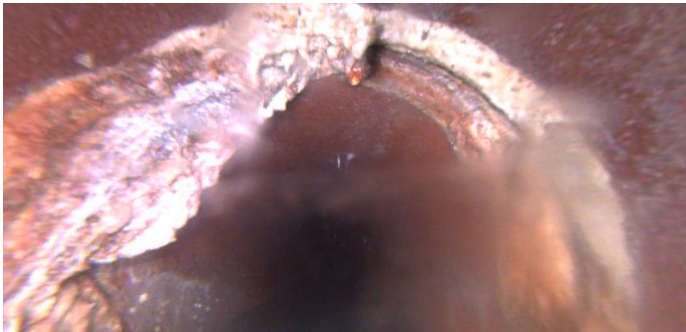
Code:	ID
Description:	Infil Dripper

Distance (ft):	201.5
Structural Grade:	0
O&M Grade:	3
Clock Start/From:	12
Clock To:	
1st Value:	
2nd Value:	
Value Percent:	
Continuous Index:	
Within 8" of Joint:	YES
Remarks:

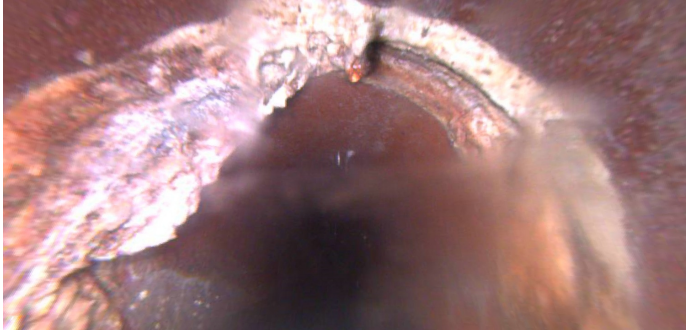
Code: **DAE**
Description: **Deposits Attached Encrustation**

Distance (ft): **201.5**
Structural Grade: **0**
O&M Grade: **3**
Clock Start/From: **8**
Clock To: **4**
1st Value:
2nd Value:
Value Percent: **15.000**
Continuous Index:
Within 8" of Joint: **YES**
Remarks:

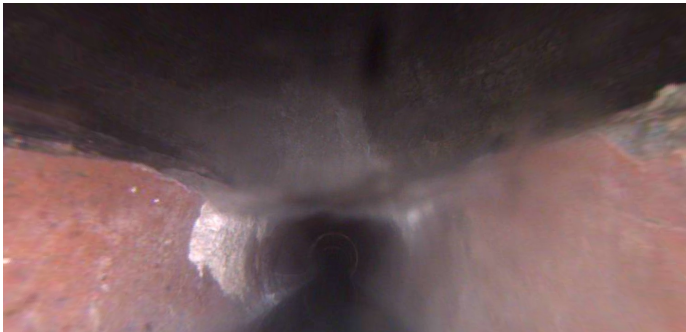
Code: **AMH**
Description: **Manhole**

Distance (ft): **213.5**
Structural Grade: **0**
O&M Grade: **0**
Clock Start/From:
Clock To:
1st Value:
2nd Value:
Value Percent:
Continuous Index:
Within 8" of Joint: **NO**
Remarks: **M-606-011**
