Profile/Photo Observation Report

Date:	04/11/2018	Weather:		Coding:	PACP 6.0
Pipe Length (ft):	231.6	Owner:	NA	Pre Clean:	No Pre-Cleaning
P.O.#:		Surveyor:	Jen Costello	PSR:	P-606-012-011
Customer:		Clean Date:	01/01/1900	Shape:	C

Street:	W 8TH PL	Flow Control:	Not Controlled
City:	Hobart, IN	Year Renewed:	
Location:	Yard	Tape/Media #:	
Purpose:	Routine Assessment	Dia/Height:	10"
Use:	Sanitary	Material:	VCP
Drain Area:	NA	Lining:	
Category:	NA		
Comment:	Flow direction is marked wrong.		
Location Details:		Direction of Survey:	Upstream
US MH:	M-606-011	DS MH:	M-606-012
		Total Length Surveyed (ft):	221.0

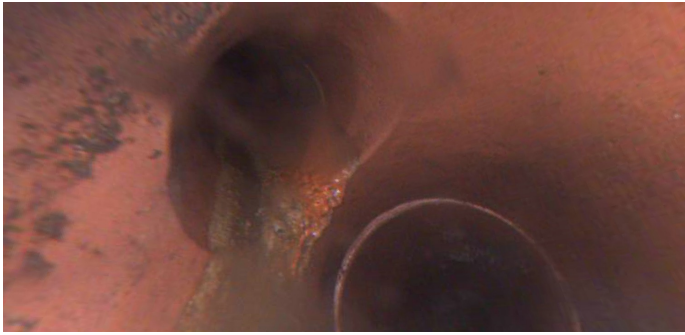
Code: **TFD**
Description: **Tap Factory Defective**

Distance (ft): **4.5**
Structural Grade: **0**
O&M Grade: **2**
Clock Start/From: **2**
Clock To:
1st Value: **4.000**
2nd Value:
Value Percent:
Continuous Index:
Within 8" of Joint:
Remarks: **dae**

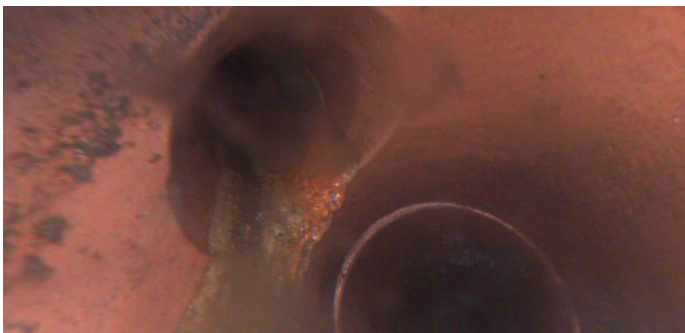
Code: **DAE**
Description: **Deposits Attached Encrustation**

Distance (ft): **4.5**
Structural Grade: **0**
O&M Grade: **2**
Clock Start/From: **2**
Clock To:
1st Value:
2nd Value:
Value Percent: **5.000**
Continuous Index:
Within 8" of Joint: **NO**
Remarks:

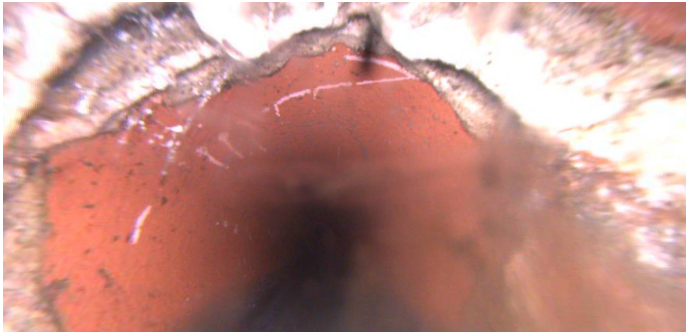
Code: **CC**
Description: **Crack Circumferential**

Distance (ft): **9.8**
Structural Grade: **1**
O&M Grade: **0**
Clock Start/From: **10**
Clock To: **2**
1st Value:
2nd Value:
Value Percent:
Continuous Index:
Within 8" of Joint:
Remarks:

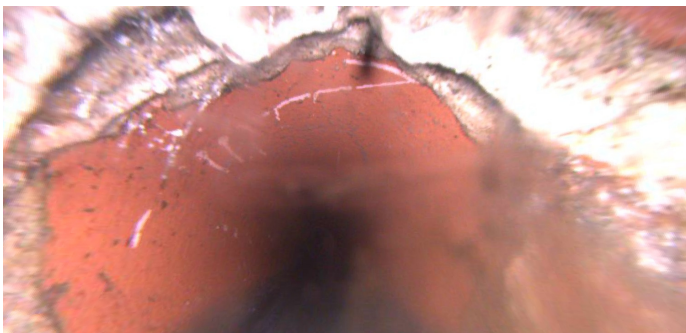
Code: **DAE**
Description: **Deposits Attached Encrustation**

Distance (ft): **9.8**
Structural Grade: **0**
O&M Grade: **2**
Clock Start/From: **8**
Clock To: **4**
1st Value:
2nd Value:
Value Percent: **10.000**
Continuous Index:
Within 8" of Joint: **YES**
Remarks:

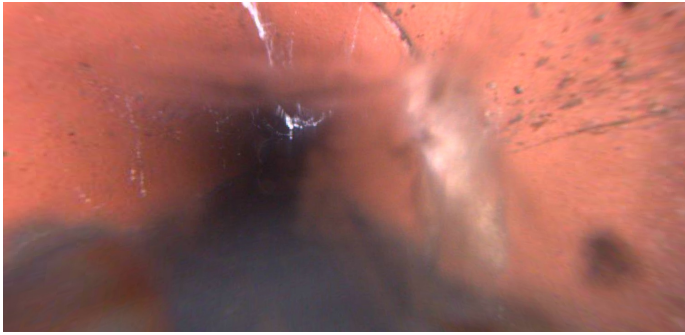
Code: **DAE**
Description: **Deposits Attached Encrustation**

Distance (ft): **19.4**
Structural Grade: **0**
O&M Grade: **2**
Clock Start/From: **3**
Clock To:
1st Value:
2nd Value:
Value Percent: **5.000**
Continuous Index:
Within 8" of Joint: **YES**
Remarks:

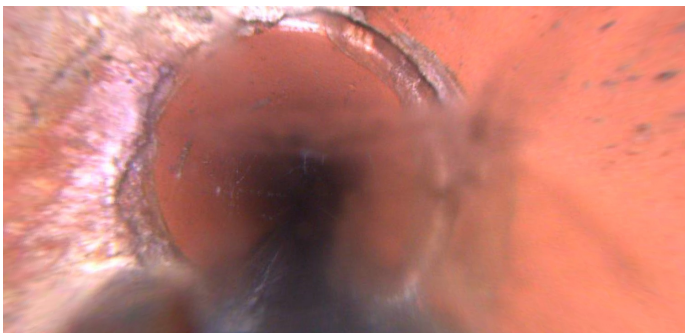
Code: **DAE**
Description: **Deposits Attached Encrustation**

Distance (ft): **24.1**
Structural Grade: **0**
O&M Grade: **2**
Clock Start/From: **8**
Clock To: **4**
1st Value:
2nd Value:
Value Percent: **10.000**
Continuous Index:
Within 8" of Joint: **YES**
Remarks:

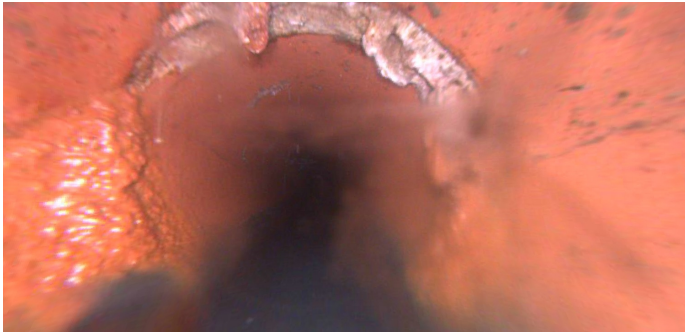
Code:	DAE
Description:	Deposits Attached Encrustation

Distance (ft):	38.8
Structural Grade:	0
O&M Grade:	2
Clock Start/From:	8
Clock To:	4
1st Value:	
2nd Value:	
Value Percent:	10.000
Continuous Index:	
Within 8" of Joint:	YES
Remarks:

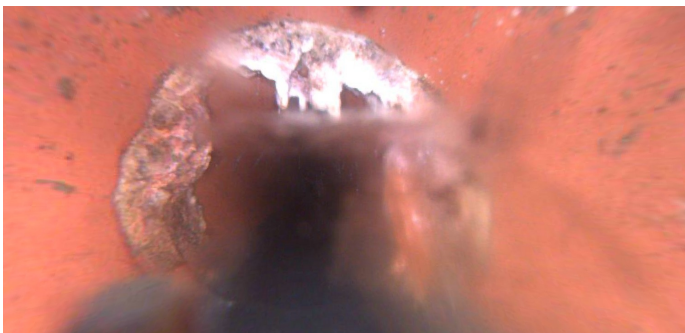
Code:	ID
Description:	Infil Dripper

Distance (ft):	48.4
Structural Grade:	0
O&M Grade:	3
Clock Start/From:	11
Clock To:	1
1st Value:	
2nd Value:	
Value Percent:	
Continuous Index:	
Within 8" of Joint:	YES
Remarks:

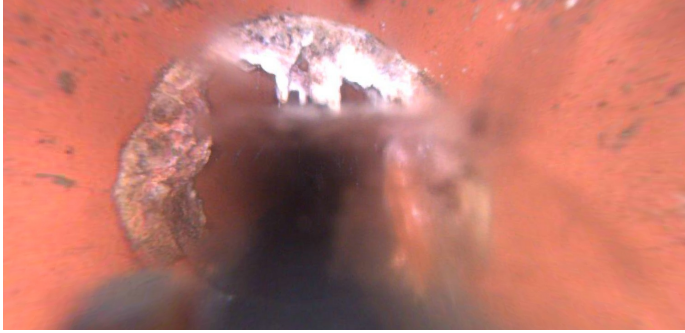
Code: **DAE**
Description: **Deposits Attached Encrustation**

Distance (ft): **48.4**
Structural Grade: **0**
O&M Grade: **2**
Clock Start/From: **8**
Clock To: **4**
1st Value:
2nd Value:
Value Percent: **10.000**
Continuous Index:
Within 8" of Joint: **YES**
Remarks:

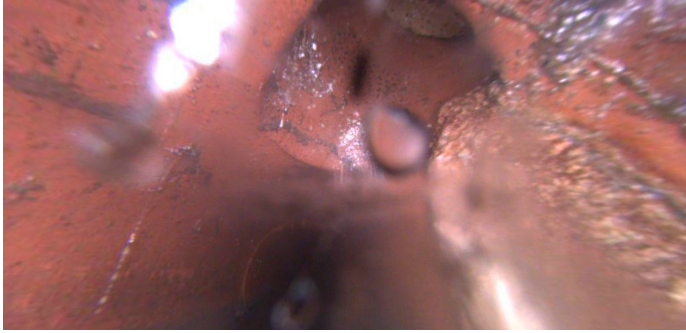
Code: **DAE**
Description: **Deposits Attached Encrustation**

Distance (ft): **54.3**
Structural Grade: **0**
O&M Grade: **2**
Clock Start/From: **1**
Clock To: **4**
1st Value:
2nd Value:
Value Percent: **10.000**
Continuous Index:
Within 8" of Joint: **NO**
Remarks:

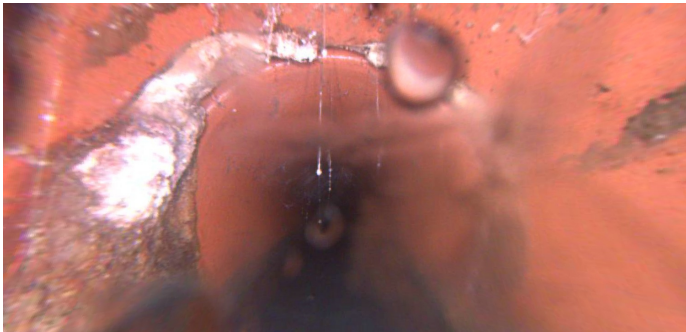
Code: **DAE**
Description: **Deposits Attached Encrustation**

Distance (ft): **65.1**
Structural Grade: **0**
O&M Grade: **2**
Clock Start/From: **8**
Clock To: **4**
1st Value:
2nd Value:
Value Percent: **10.000**
Continuous Index:
Within 8" of Joint: **YES**
Remarks:

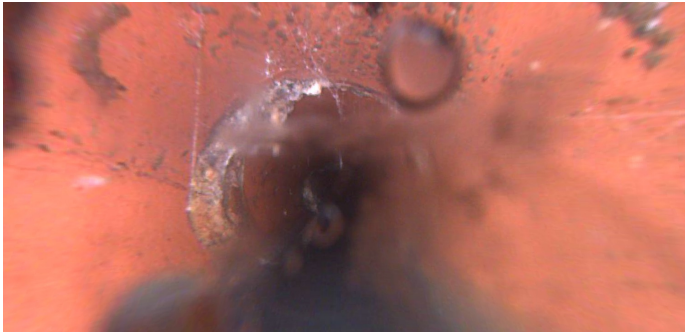
Code: **DAE**
Description: **Deposits Attached Encrustation**

Distance (ft): **74.6**
Structural Grade: **0**
O&M Grade: **2**
Clock Start/From: **8**
Clock To: **4**
1st Value:
2nd Value:
Value Percent: **10.000**
Continuous Index:
Within 8" of Joint: **YES**
Remarks:

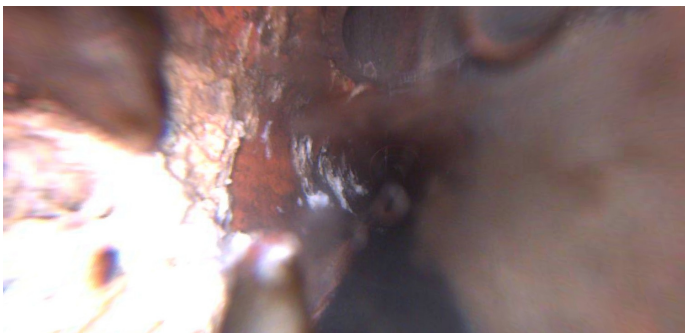
Code: **DAGS**
Description: **Deposits Attached Grease**

Distance (ft): **77.0**
Structural Grade: **0**
O&M Grade: **2**
Clock Start/From: **7**
Clock To: **12**
1st Value:
2nd Value:
Value Percent: **10.000**
Continuous Index:
Within 8" of Joint: **NO**
Remarks:

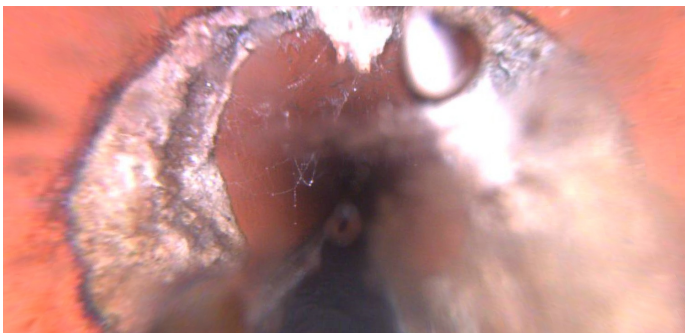
Code: **ID**
Description: **Infil Dripper**

Distance (ft): **84.8**
Structural Grade: **0**
O&M Grade: **3**
Clock Start/From: **12**
Clock To:
1st Value:
2nd Value:
Value Percent:
Continuous Index:
Within 8" of Joint: **YES**
Remarks:

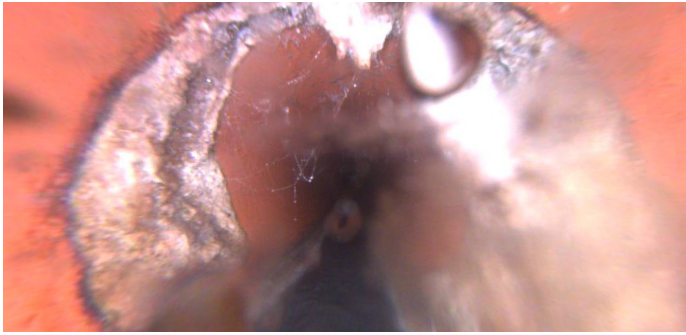
Code: **DAE**
Description: **Deposits Attached Encrustation**

Distance (ft): **84.8**
Structural Grade: **0**
O&M Grade: **2**
Clock Start/From: **8**
Clock To: **4**
1st Value:
2nd Value:
Value Percent: **10.000**
Continuous Index:
Within 8" of Joint: **YES**
Remarks:

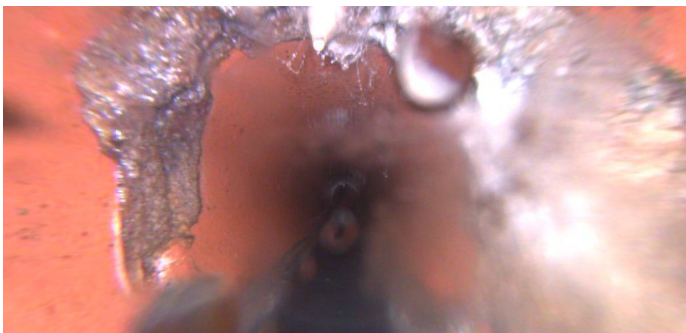
Code: **DAE**
Description: **Deposits Attached Encrustation**

Distance (ft): **94.6**
Structural Grade: **0**
O&M Grade: **2**
Clock Start/From: **8**
Clock To: **4**
1st Value:
2nd Value:
Value Percent: **0.000**
Continuous Index: **S01**
Within 8" of Joint: **YES**
Remarks:

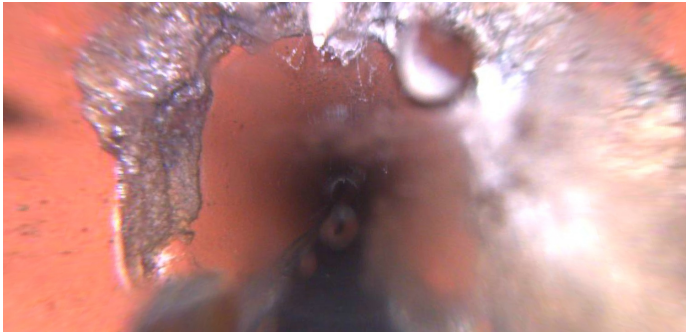
Code: ID
Description: Infil Dripper

Distance (ft): 94.6
Structural Grade: 0
O&M Grade: 3
Clock Start/From: 12
Clock To:
1st Value:
2nd Value:
Value Percent:
Continuous Index:
Within 8" of Joint: YES
Remarks:

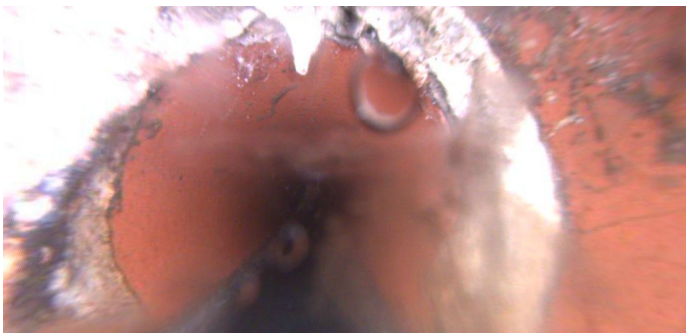
Code: ID
Description: Infil Dripper

Distance (ft): 99.6
Structural Grade: 0
O&M Grade: 3
Clock Start/From: 12
Clock To:
1st Value:
2nd Value:
Value Percent:
Continuous Index:
Within 8" of Joint: YES
Remarks:

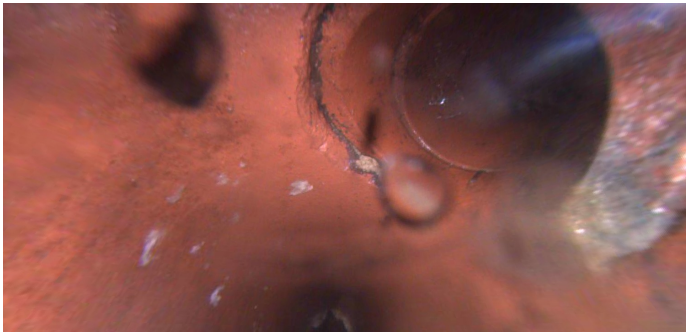
Code: **TBI**
Description: **Tap Break-in Intruding**

Distance (ft): **127.2**
Structural Grade: **0**
O&M Grade: **2**
Clock Start/From: **1**
Clock To:
1st Value: **4.000**
2nd Value: **1.000**
Value Percent:
Continuous Index:
Within 8" of Joint:
Remarks:

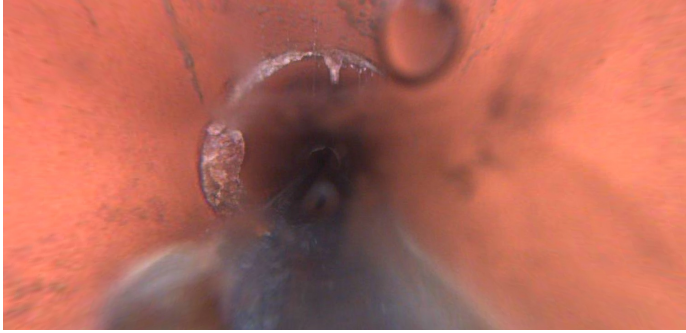
Code: ID
Description: Infil Dripper

Distance (ft): 145.2
Structural Grade: 0
O&M Grade: 3
Clock Start/From: 12
Clock To:
1st Value:
2nd Value:
Value Percent:
Continuous Index:
Within 8" of Joint: YES
Remarks:

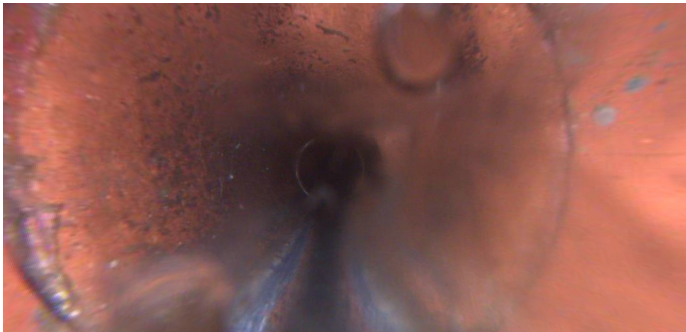
Code: DAE
Description: Deposits Attached Encrustation

Distance (ft): 197.0
Structural Grade: 0
O&M Grade: 2
Clock Start/From: 8
Clock To: 4
1st Value:
2nd Value:
Value Percent: 0.000
Continuous Index: F01
Within 8" of Joint: YES
Remarks:

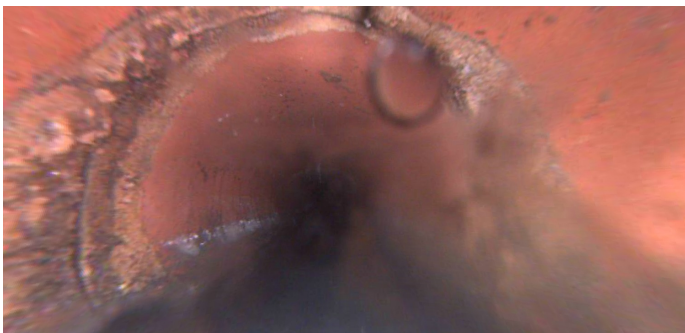
Code: **DAE**
Description: **Deposits Attached Encrustation**

Distance (ft): **210.6**
Structural Grade: **0**
O&M Grade: **2**
Clock Start/From: **8**
Clock To: **4**
1st Value:
2nd Value:
Value Percent: **5.000**
Continuous Index:
Within 8" of Joint: **YES**
Remarks:
