Profile/Photo Observation Report

Date:	04/10/2018	Weather:		Coding:	PACP 6.0
Pipe Length (ft):	71.9	Owner:	NA	Pre Clean:	No Pre-Cleaning
P.O.#:		Surveyor:	Byrd Fitzgerald	PSR:	P-606-013-012
Customer:		Clean Date:	01/01/1900	Shape:	C

Street:	W 8TH PL	Flow Control:	Not Controlled
City:	Hobart, IN	Year Renewed:	
Location:	Yard	Tape/Media #:	
Purpose:	Routine Assessment	Dia/Height:	10"
Use:	Sanitary	Material:	VCP
Drain Area:	NA	Lining:	
Category:	NA		
Comment:	Flow direction is marked wrong.		
Location Details:		Direction of Survey:	Upstream
US MH:	M-606-012	DS MH:	M-606-013
		Total Length Surveyed (ft):	54.6

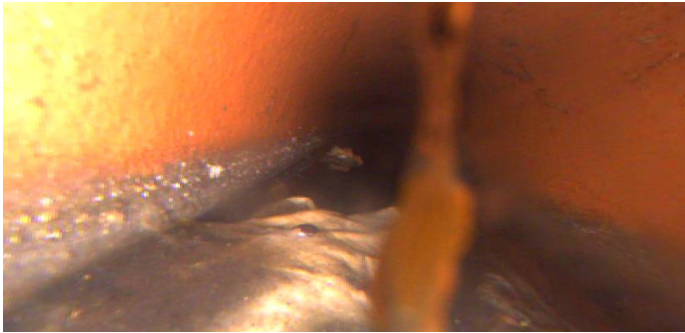
Code:	MWL
Description:	Water Level

Distance (ft):	.0
Structural Grade:	0
O&M Grade:	0
Clock Start/From:	
Clock To:	
1st Value:	
2nd Value:	
Value Percent:	5.000
Continuous Index:	
Within 8" of Joint:	NO
Remarks:

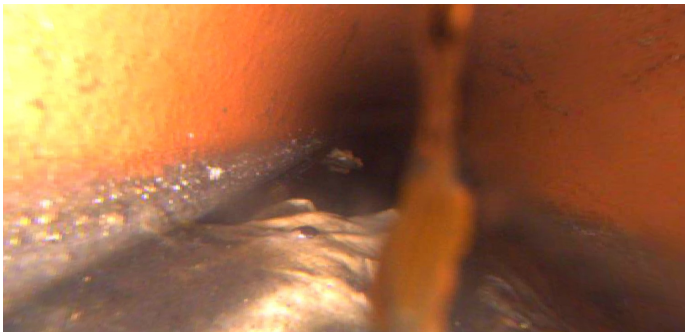
Code:	DSZ
Description:	Deposits Settled Other

Distance (ft):	.0
Structural Grade:	0
O&M Grade:	2
Clock Start/From:	6
Clock To:	
1st Value:	
2nd Value:	
Value Percent:	5.000
Continuous Index:	S01
Within 8" of Joint:	NO
Remarks:	tissue

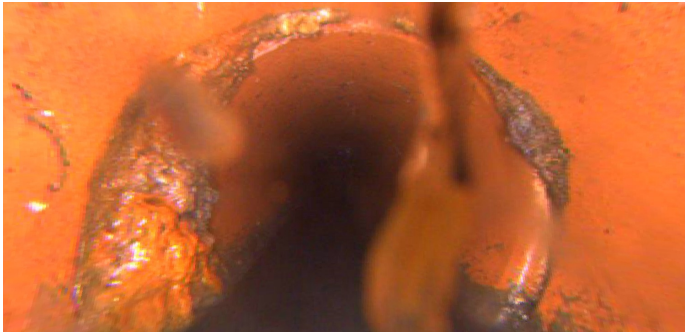
Code: **DAE**
Description: **Deposits Attached Encrustation**

Distance (ft): **23.6**
Structural Grade: **0**
O&M Grade: **2**
Clock Start/From: **7**
Clock To: **5**
1st Value:
2nd Value:
Value Percent: **5.000**
Continuous Index:
Within 8" of Joint: **YES**
Remarks:

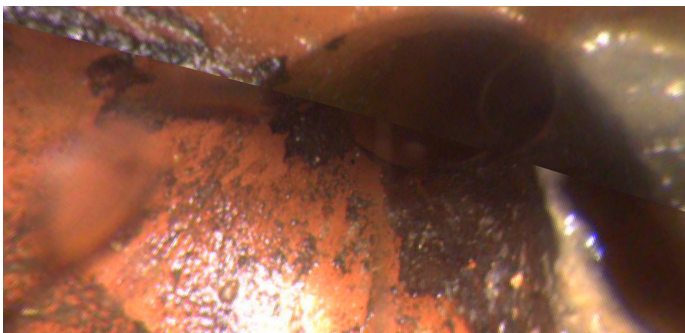
Code: **TF**
Description: **Tap Factory**

Distance (ft): **29.8**
Structural Grade: **0**
O&M Grade: **0**
Clock Start/From: **1**
Clock To:
1st Value: **4.000**
2nd Value:
Value Percent:
Continuous Index:
Within 8" of Joint: **YES**
Remarks:

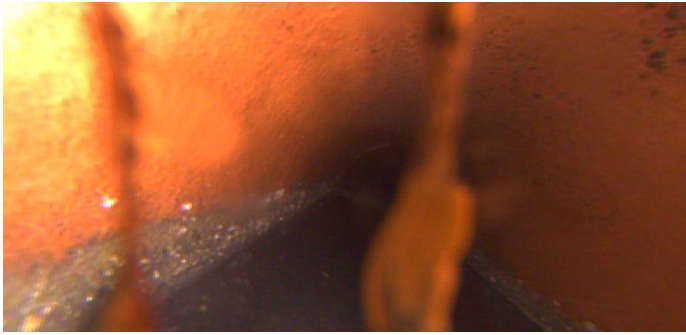
Code: **MSA**
Description: **Abandoned Survey**

Distance (ft): **54.6**
Structural Grade: **0**
O&M Grade: **0**
Clock Start/From:
Clock To:
1st Value:
2nd Value:
Value Percent:
Continuous Index:
Within 8" of Joint: **NO**
Remarks: **debris**

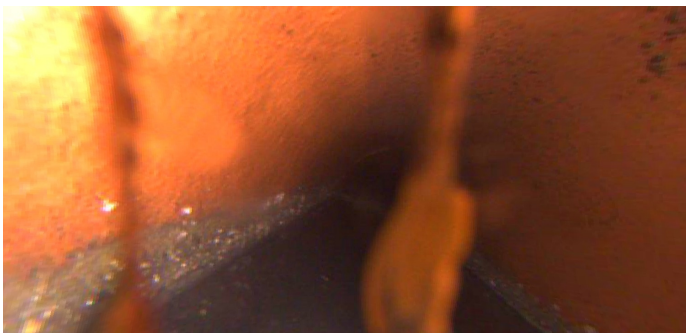
Code: **DSZ**
Description: **Deposits Settled Other**

Distance (ft): **54.6**
Structural Grade: **0**
O&M Grade: **2**
Clock Start/From: **6**
Clock To:
1st Value:
2nd Value:
Value Percent: **5.000**
Continuous Index: **F01**
Within 8" of Joint: **NO**
Remarks: **tissue**
