Profile/Photo Observation Report

Street:	FOXCROFT STREET	Flow Control:	Not Controlled
City:	Hobart, IN	Year Renewed:	
Location:	Yard	Tape/Media #:	
Purpose:	Routine Assessment	Dia/Height:	10"
Use:	Sanitary	Material:	VCP
Drain Area:	NA	Lining:	
Category:	NA		
Comment:	Flow direction is marked wrong.		
Location Details:		Direction of Survey:	Upstream
US MH:	M-606-012	DS MH:	M-606-013
		Total Length Surveyed (ft):	54.6

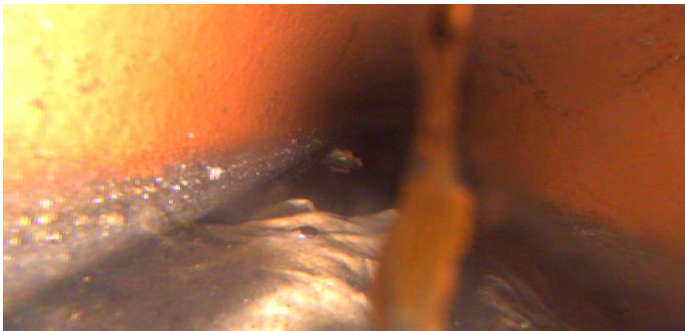
Code: **AMH**
Description: **Manhole**

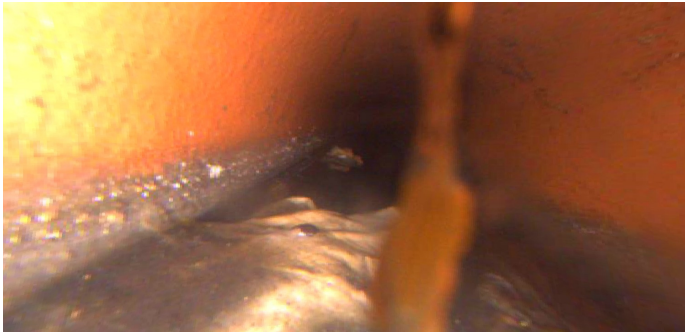
Code:	MWL
Description:	Water Level

Distance (ft):	.0
Structural Grade:	0
O&M Grade:	0
Clock Start/From:	
Clock To:	
1st Value:	
2nd Value:	
Value Percent:	5.000
Continuous Index:	
Within 8" of Joint:	NO
Remarks:

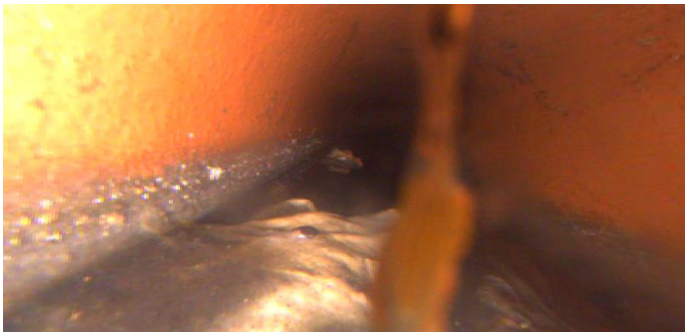
Code:	DSZ
Description:	Deposits Settled Other

Distance (ft):	.0
Structural Grade:	0
O&M Grade:	2
Clock Start/From:	6
Clock To:	
1st Value:	
2nd Value:	
Value Percent:	5.000
Continuous Index:	S01
Within 8" of Joint:	NO
Remarks:	tissue

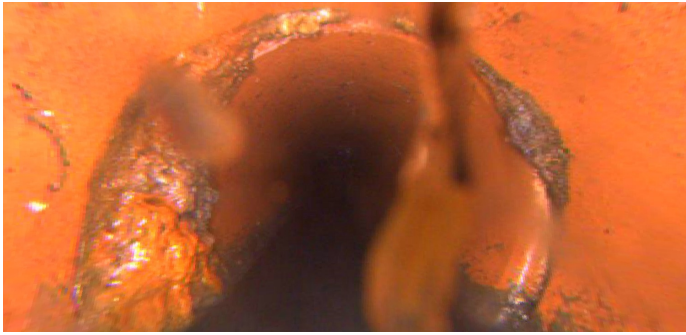
Code: **DAE**
Description: **Deposits Attached Encrustation**

Distance (ft): **23.6**
Structural Grade: **0**
O&M Grade: **2**
Clock Start/From: **7**
Clock To: **5**
1st Value:
2nd Value:
Value Percent: **5.000**
Continuous Index:
Within 8" of Joint: **YES**
Remarks:

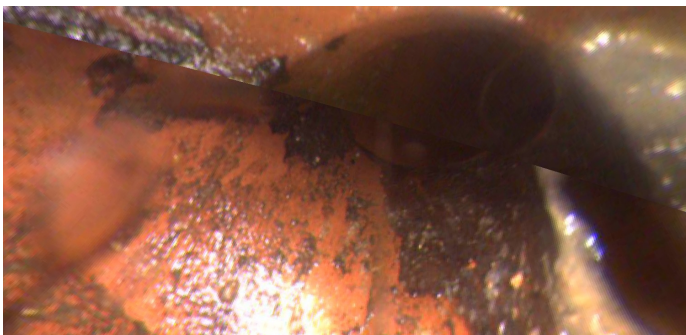
Code: **TF**
Description: **Tap Factory**

Distance (ft): **29.8**
Structural Grade: **0**
O&M Grade: **0**
Clock Start/From: **1**
Clock To:
1st Value: **4.000**
2nd Value:
Value Percent:
Continuous Index:
Within 8" of Joint: **YES**
Remarks:

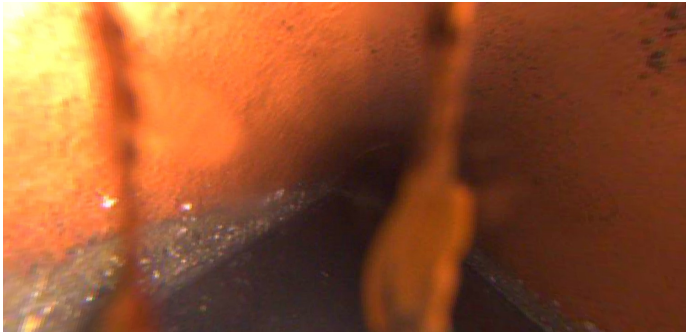
Code: **MSA**
Description: **Abandoned Survey**

Distance (ft): **54.6**
Structural Grade: **0**
O&M Grade: **0**
Clock Start/From:
Clock To:
1st Value:
2nd Value:
Value Percent:
Continuous Index:
Within 8" of Joint: **NO**
Remarks: **debris**

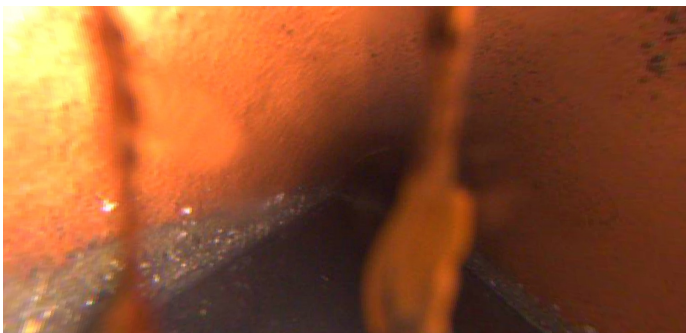
Code: **DSZ**
Description: **Deposits Settled Other**

Distance (ft): **54.6**
Structural Grade: **0**
O&M Grade: **2**
Clock Start/From: **6**
Clock To:
1st Value:
2nd Value:
Value Percent: **5.000**
Continuous Index: **F01**
Within 8" of Joint: **NO**
Remarks: **tissue**
