## Profile/Photo Observation Report

Street:	<b>W 8TH PL</b>	Flow Control:	<b>Not Controlled</b>
City:	<b>Hobart, IN</b>	Year Renewed:	
Location:	<b>Yard</b>	Tape/Media #:	
Purpose:	<b>Routine Assessment</b>	Dia/Height:	<b>10"</b>
Use:	<b>Sanitary</b>	Material:	<b>VCP</b>
Drain Area:	<b>NA</b>	Lining:	
Category:	<b>NA</b>		
Comment:

Location Details:		Direction of Survey:	<b>Downstream</b>
US MH:	<b>M-606-012</b>	DS MH:	<b>M-606-013</b>
		Total Length Surveyed (ft):	<b>2.7</b>

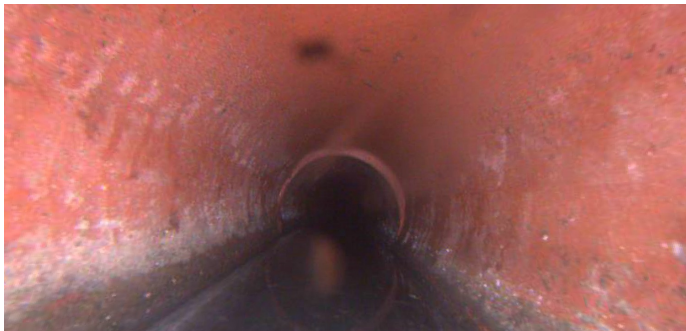
Code: **AMH**  
Description: **Manhole**

Distance (ft): **.0**  
Structural Grade: **0**  
O&M Grade: **0**  
Clock Start/From:  
Clock To:  
1st Value:  
2nd Value:  
Value Percent:  
Continuous Index:  
Within 8" of Joint: **NO**  
Remarks: **M-606-012**

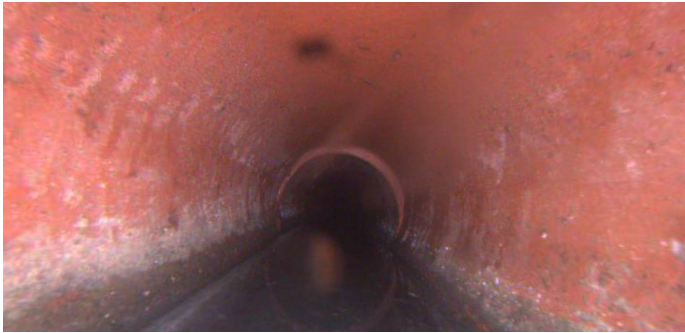
Code:	<b>MWL</b>
Description:	<b>Water Level</b>

Distance (ft):	<b>.0</b>
Structural Grade:	<b>0</b>
O&M Grade:	<b>0</b>
Clock Start/From:	
Clock To:	
1st Value:	
2nd Value:	
Value Percent:	<b>10.000</b>
Continuous Index:	
Within 8" of Joint:	<b>NO</b>
Remarks:

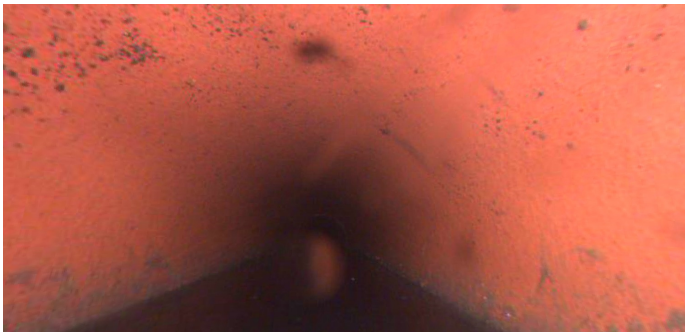
Code:	<b>MSA</b>
Description:	<b>Abandoned Survey</b>

Distance (ft):	<b>2.7</b>
Structural Grade:	<b>0</b>
O&M Grade:	<b>0</b>
Clock Start/From:	
Clock To:	
1st Value:	
2nd Value:	
Value Percent:	
Continuous Index:	
Within 8" of Joint:	<b>NO</b>
Remarks:	<b>debris under water</b>
