## Profile/Photo Observation Report

Street:	<b>FOXCROFT STREET</b>	Flow Control:	<b>Not Controlled</b>
City:	<b>Hobart, IN</b>	Year Renewed:	
Location:	<b>Yard</b>	Tape/Media #:	
Purpose:	<b>Routine Assessment</b>	Dia/Height:	<b>10"</b>
Use:	<b>Sanitary</b>	Material:	<b>VCP</b>
Drain Area:	<b>NA</b>	Lining:	
Category:	<b>NA</b>		
Comment:

Location Details:		Direction of Survey:	<b>Downstream</b>
US MH:	<b>M-606-012</b>	DS MH:	<b>M-606-013</b>
		Total Length Surveyed (ft):	<b>2.7</b>

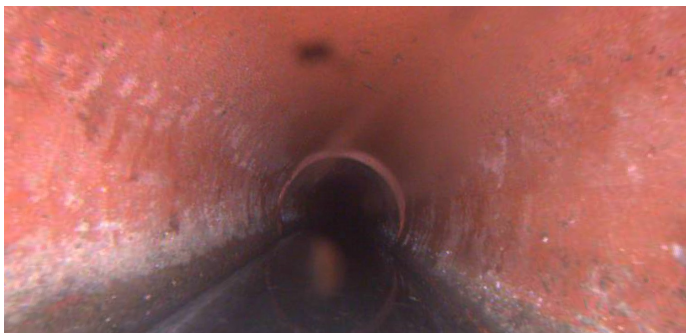
Code: **AMH**  
Description: **Manhole**

Distance (ft): **.0**  
Structural Grade: **0**  
O&M Grade: **0**  
Clock Start/From:  
Clock To:  
1st Value:  
2nd Value:  
Value Percent:  
Continuous Index:  
Within 8" of Joint: **NO**  
Remarks: **M-606-012**

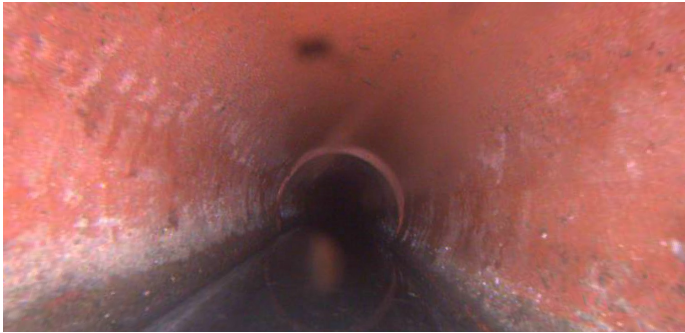
Code:	<b>MWL</b>
Description:	<b>Water Level</b>

Distance (ft):	<b>.0</b>
Structural Grade:	<b>0</b>
O&M Grade:	<b>0</b>
Clock Start/From:	
Clock To:	
1st Value:	
2nd Value:	
Value Percent:	<b>10.000</b>
Continuous Index:	
Within 8" of Joint:	<b>NO</b>
Remarks:

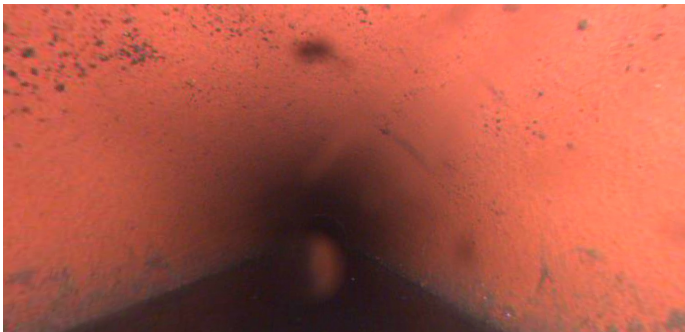
Code:	<b>MSA</b>
Description:	<b>Abandoned Survey</b>

Distance (ft):	<b>2.7</b>
Structural Grade:	<b>0</b>
O&M Grade:	<b>0</b>
Clock Start/From:	
Clock To:	
1st Value:	
2nd Value:	
Value Percent:	
Continuous Index:	
Within 8" of Joint:	<b>NO</b>
Remarks:	<b>debris under water</b>
