Profile/Photo Observation Report

Date:	02/18/2022	Weather:		Coding:	PACP 7.0
Pipe Length (ft):	73.3	Owner:	City of Hobart	Pre Clean:	Heavy Cleaning
P.O.#:	YES502259	Surveyor:	S. Bucklin	PSR:	P-606-013-012
Customer:	City of Hobart	Clean Date:	01/27/2022	Shape:	C

Street:	East 8th Place	Flow Control:	Not Controlled
City:	Hobart, IN	Year Renewed:	
Location:	Other	Tape/Media #:	
Purpose:	Routine Assessment	Dia/Height:	10"
Use:	Sanitary Sewage Pipe	Material:	VCP
Drain Area:		Lining:	None
Category:	NA		
Comment:			
Location Details:	DRIVE WAY	Direction of Survey:	Downstream
US MH:	M-606-012	DS MH:	M-606-013
		Total Length Surveyed (ft):	73.3

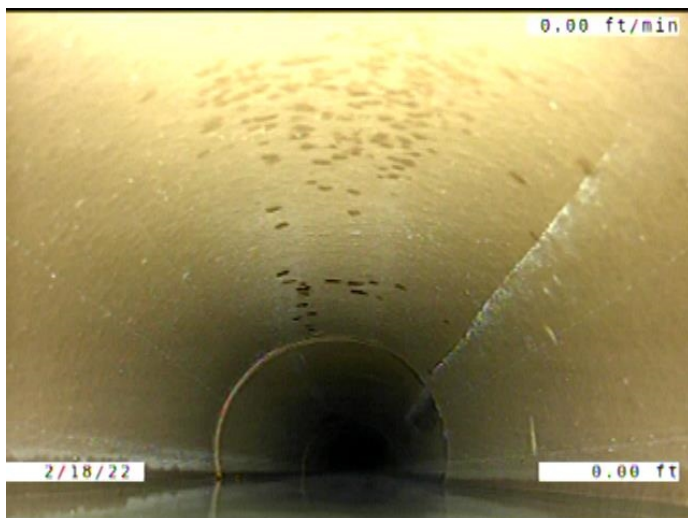
Code: **AMH**
Description: **Manhole**

Distance (ft): **.0**
Structural Grade: **0**
O&M Grade: **0**
Clock Start/From:
Clock To:
1st Value:
2nd Value:
Value Percent:
Continuous Index:
Within 8" of Joint: **NO**
Remarks: **M-606-012**

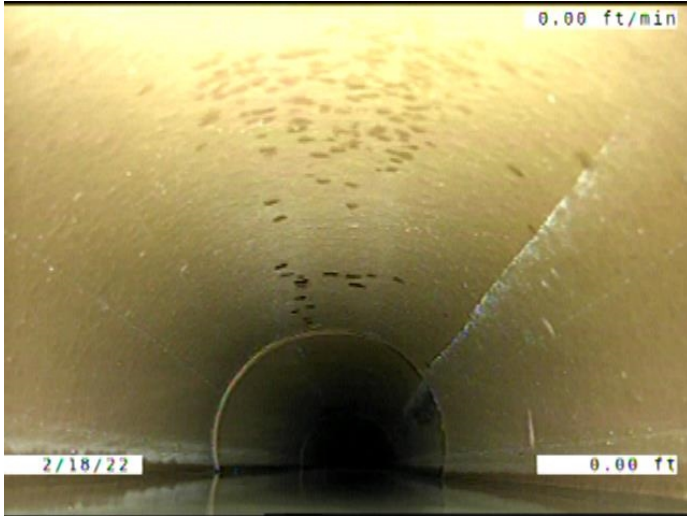
Code: **MWL**
Description: **Miscellaneous Water Level**

Distance (ft): **.0**
Structural Grade: **0**
O&M Grade: **0**
Clock Start/From:
Clock To:
1st Value:
2nd Value:
Value Percent: **20.000**
Continuous Index:
Within 8" of Joint: **NO**
Remarks:

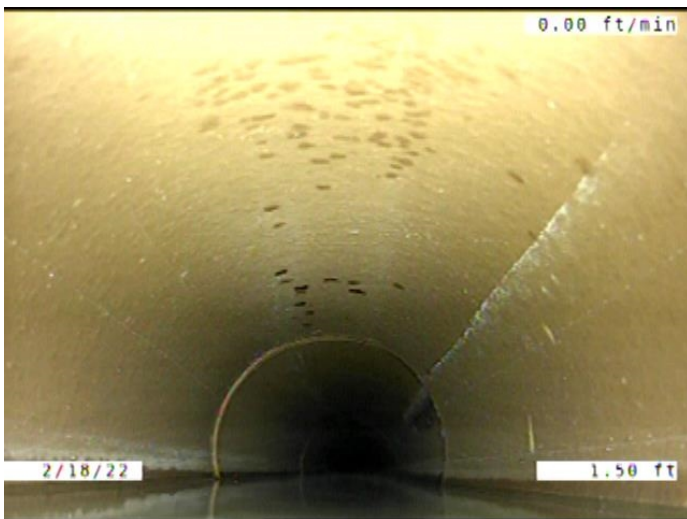
Code: **MGO**
Description: **Miscellaneous General Observation**

Distance (ft): **1.5**
Structural Grade: **0**
O&M Grade: **0**
Clock Start/From:
Clock To:
1st Value:
2nd Value:
Value Percent:
Continuous Index:
Within 8" of Joint: **NO**
Remarks: **BENCH IN THE MANHOLE SITS 4"-5" LOWER THEN THE PIPES. HAD TO ST**

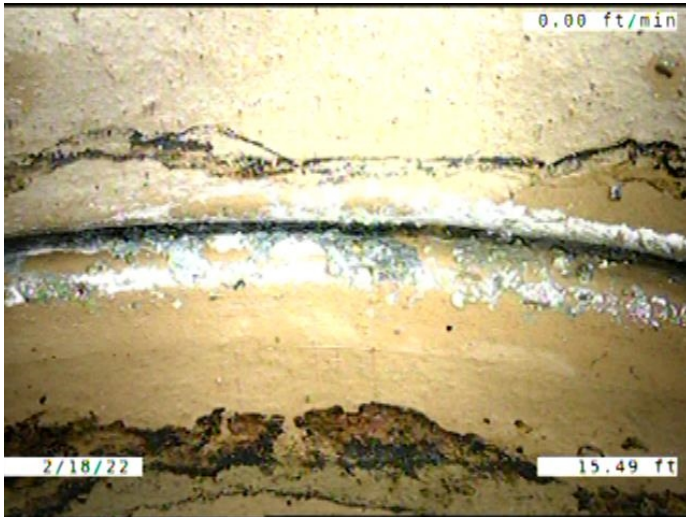
Code: **DAE**
 Description: **Deposits Attached Encrustation**

Distance (ft): **15.5**
 Structural Grade: **0**
 O&M Grade: **2**
 Clock Start/From: **9**
 Clock To: **3**
 1st Value:
 2nd Value:
 Value Percent: **5.000**
 Continuous Index:
 Within 8" of Joint: **YES**
 Remarks:

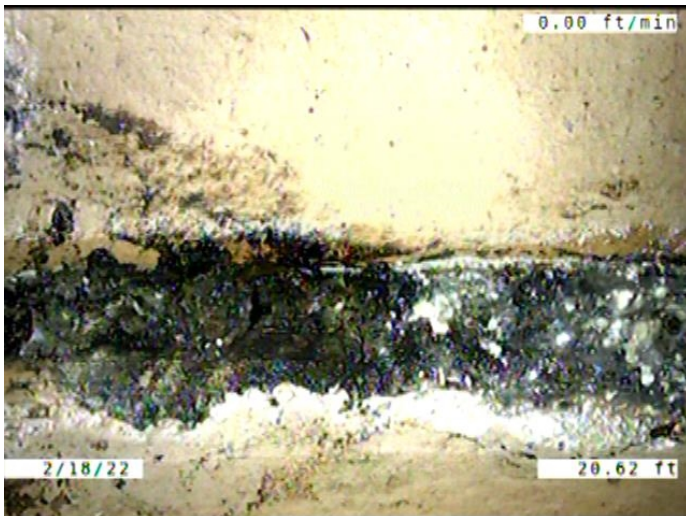
Code: **DAE**
 Description: **Deposits Attached Encrustation**

Distance (ft): **20.6**
 Structural Grade: **0**
 O&M Grade: **2**
 Clock Start/From: **9**
 Clock To: **11**
 1st Value:
 2nd Value:
 Value Percent: **5.000**
 Continuous Index:
 Within 8" of Joint: **YES**
 Remarks:

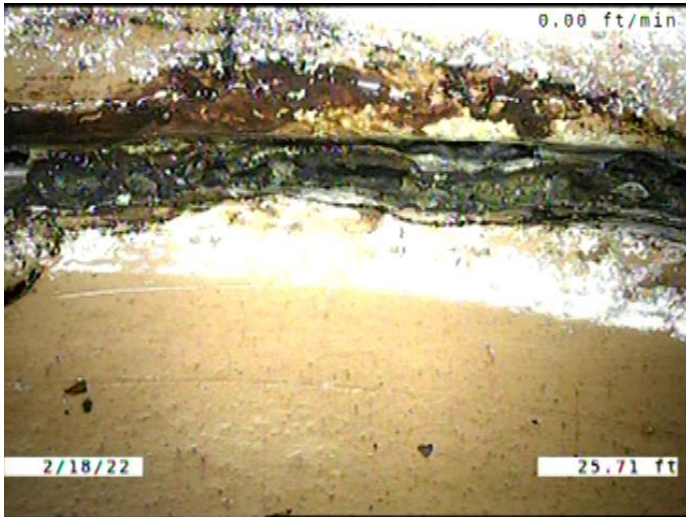
Code: **DAE**
 Description: **Deposits Attached Encrustation**

Distance (ft): **25.7**
 Structural Grade: **0**
 O&M Grade: **2**
 Clock Start/From: **8**
 Clock To: **3**
 1st Value:
 2nd Value:
 Value Percent: **5.000**
 Continuous Index:
 Within 8" of Joint: **YES**
 Remarks:

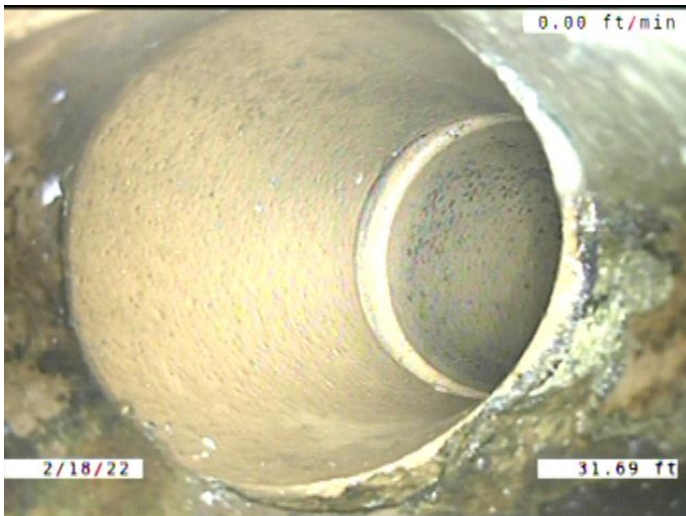
Code: **TF**
 Description: **Tap Factory**

Distance (ft): **31.7**
 Structural Grade: **0**
 O&M Grade: **0**
 Clock Start/From: **1**
 Clock To:
 1st Value: **4.000**
 2nd Value:
 Value Percent:
 Continuous Index:
 Within 8" of Joint: **YES**
 Remarks: **CONSTANTLY RUNNING WATER.**

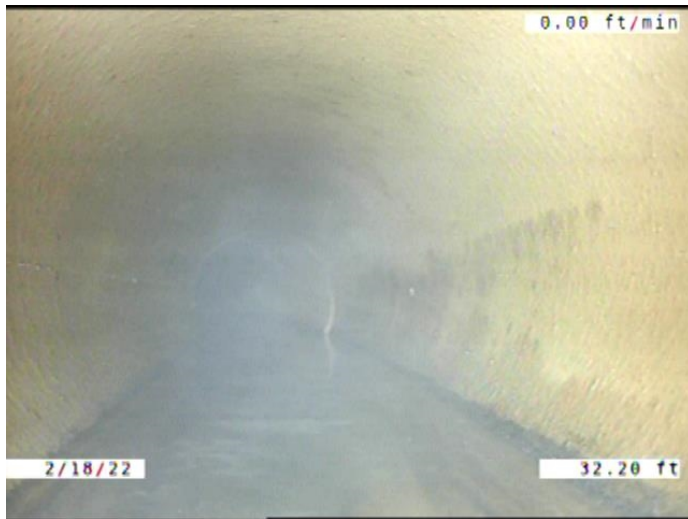
Code: **LL**
Description: **Line Left**

Distance (ft): **32.2**
Structural Grade: **0**
O&M Grade: **2**
Clock Start/From:
Clock To:
1st Value:
2nd Value:
Value Percent: **15.000**
Continuous Index: **S01**
Within 8" of Joint: **NO**
Remarks:

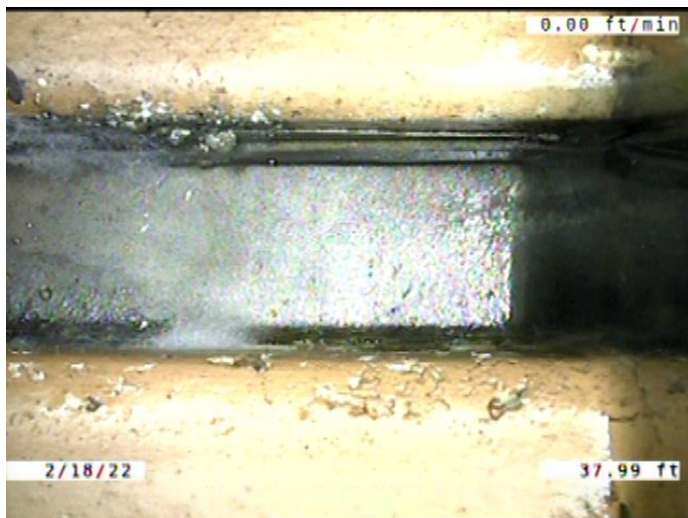
Code: **JAL**
Description: **Joint Angular Large**

Distance (ft): **38.0**
Structural Grade: **4**
O&M Grade: **0**
Clock Start/From:
Clock To:
1st Value:
2nd Value:
Value Percent:
Continuous Index:
Within 8" of Joint: **NO**
Remarks:

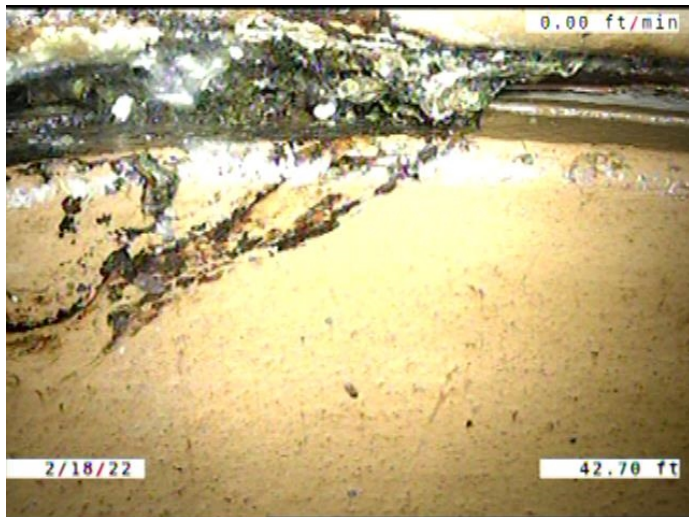
Code: **DAE**
 Description: **Deposits Attached Encrustation**

Distance (ft): **42.7**
 Structural Grade: **0**
 O&M Grade: **2**
 Clock Start/From: **9**
 Clock To: **3**
 1st Value:
 2nd Value:
 Value Percent: **5.000**
 Continuous Index:
 Within 8" of Joint: **YES**
 Remarks:

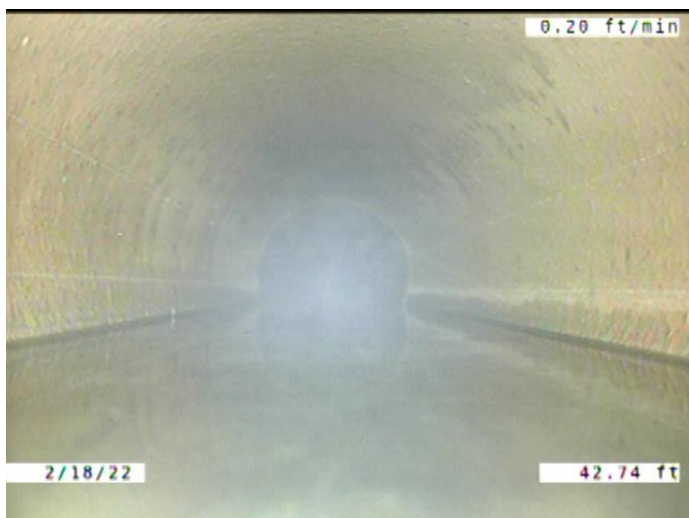
Code: **LL**
 Description: **Line Left**

Distance (ft): **42.7**
 Structural Grade: **0**
 O&M Grade: **2**
 Clock Start/From:
 Clock To:
 1st Value:
 2nd Value:
 Value Percent: **15.000**
 Continuous Index: **F01**
 Within 8" of Joint: **NO**
 Remarks:

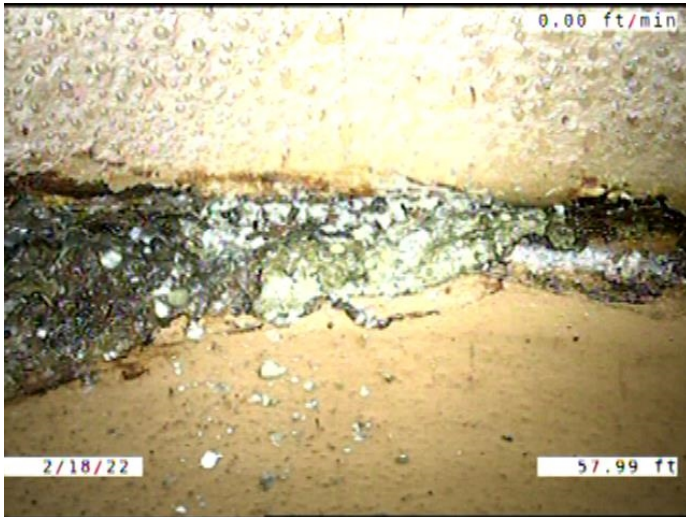
Code: **DAE**
Description: **Deposits Attached Encrustation**

Distance (ft): **58.0**
Structural Grade: **0**
O&M Grade: **2**
Clock Start/From: **9**
Clock To: **3**
1st Value:
2nd Value:
Value Percent: **5.000**
Continuous Index:
Within 8" of Joint: **YES**
Remarks:

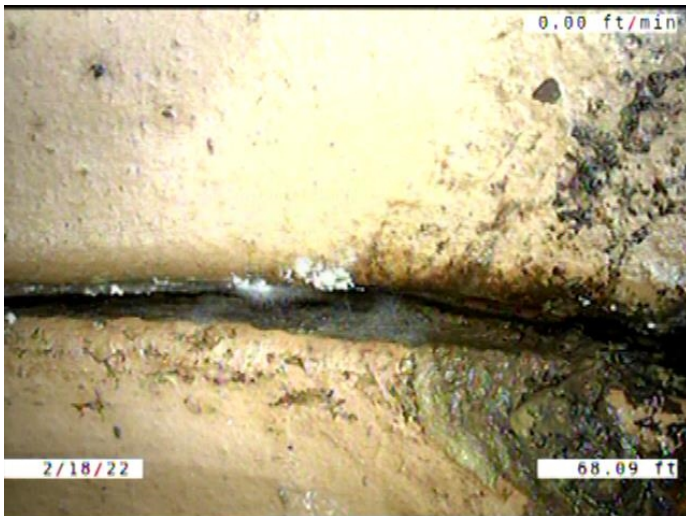
Code: **DAE**
Description: **Deposits Attached Encrustation**

Distance (ft): **68.1**
Structural Grade: **0**
O&M Grade: **2**
Clock Start/From: **2**
Clock To: **4**
1st Value:
2nd Value:
Value Percent: **5.000**
Continuous Index:
Within 8" of Joint: **YES**
Remarks:

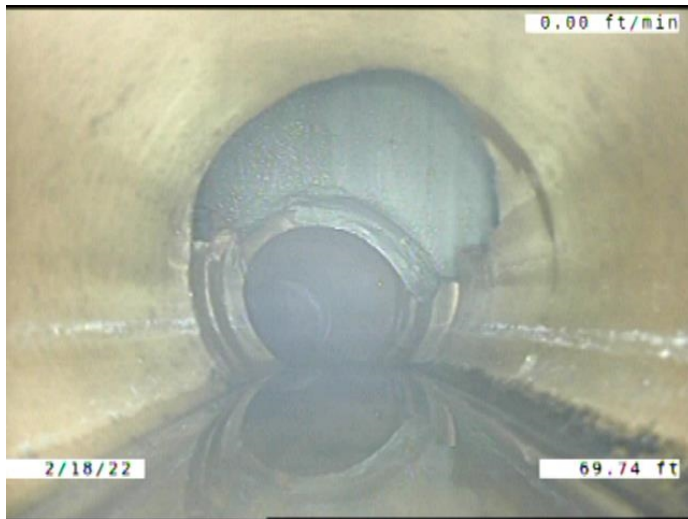
Code: **MWL**
 Description: **Miscellaneous Water Level**

Distance (ft): **69.7**
 Structural Grade: **0**
 O&M Grade: **0**
 Clock Start/From:
 Clock To:
 1st Value:
 2nd Value:
 Value Percent: **10.000**
 Continuous Index:
 Within 8" of Joint: **NO**
 Remarks:
