Profile/Photo Observation Report

Date:	04/10/2018	Weather:		Coding:	PACP 6.0
Pipe Length (ft):	51.0	Owner:	NA	Pre Clean:	No Pre-Cleaning
P.O.#:		Surveyor:	Byrd Fitzgerald	PSR:	P-606-014-013
Customer:		Clean Date:	01/01/1900	Shape:	C

Street:	W 8TH PL	Flow Control:	Not Controlled
City:	Hobart, IN	Year Renewed:	
Location:	Yard	Tape/Media #:	
Purpose:	Routine Assessment	Dia/Height:	10"
Use:	Sanitary	Material:	VCP
Drain Area:	NA	Lining:	
Category:	NA		
Comment:

Location Details:		Direction of Survey:	Upstream
US MH:	M-606-013	DS MH:	M-606-014
		Total Length Surveyed (ft):	41.2

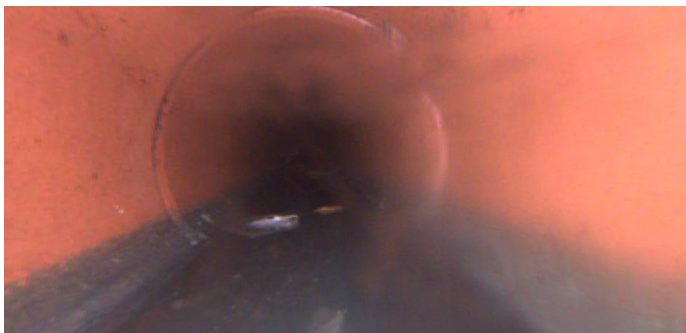
Code: **AMH**
Description: **Manhole**

Distance (ft): **.0**
Structural Grade: **0**
O&M Grade: **0**
Clock Start/From:
Clock To:
1st Value:
2nd Value:
Value Percent:
Continuous Index:
Within 8" of Joint: **NO**
Remarks: **M-606-014**

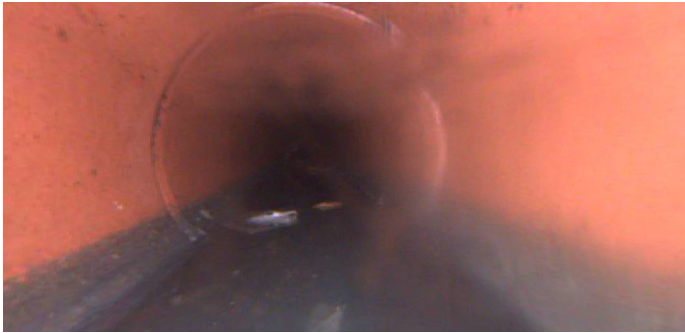
Code:	MWL
Description:	Water Level

Distance (ft):	.0
Structural Grade:	0
O&M Grade:	0
Clock Start/From:	
Clock To:	
1st Value:	
2nd Value:	
Value Percent:	5.000
Continuous Index:	
Within 8" of Joint:	NO
Remarks:

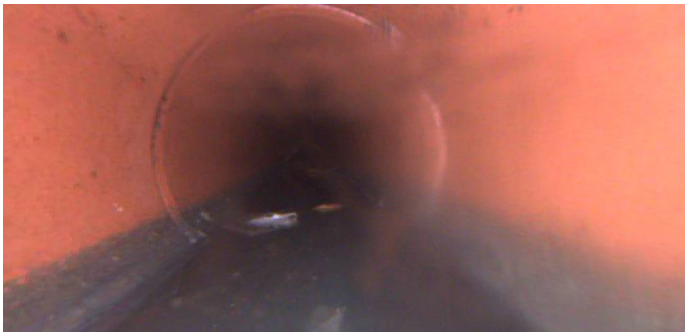
Code:	DSZ
Description:	Deposits Settled Other

Distance (ft):	.0
Structural Grade:	0
O&M Grade:	2
Clock Start/From:	6
Clock To:	
1st Value:	
2nd Value:	
Value Percent:	5.000
Continuous Index:	S01
Within 8" of Joint:	NO
Remarks:	debris

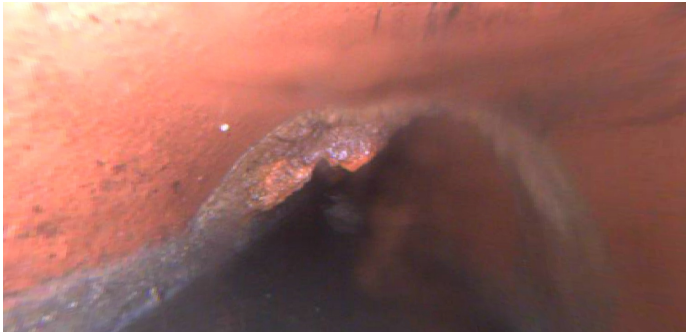
Code: **DAE**
Description: **Deposits Attached Encrustation**

Distance (ft): **6.2**
Structural Grade: **0**
O&M Grade: **2**
Clock Start/From: **8**
Clock To: **4**
1st Value:
2nd Value:
Value Percent: **5.000**
Continuous Index:
Within 8" of Joint: **YES**
Remarks:

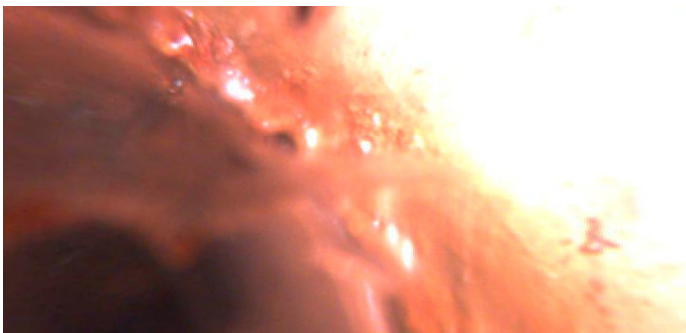
Code: **DAE**
Description: **Deposits Attached Encrustation**

Distance (ft): **16.6**
Structural Grade: **0**
O&M Grade: **2**
Clock Start/From: **8**
Clock To: **4**
1st Value:
2nd Value:
Value Percent: **5.000**
Continuous Index:
Within 8" of Joint: **YES**
Remarks:

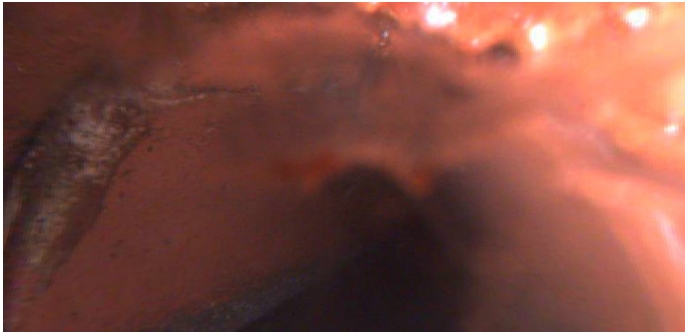
Code: **CS**
Description: **Crack Spiral**

Distance (ft): **16.6**
Structural Grade: **2**
O&M Grade: **0**
Clock Start/From: **11**
Clock To: **12**
1st Value:
2nd Value:
Value Percent:
Continuous Index:
Within 8" of Joint: **YES**
Remarks:

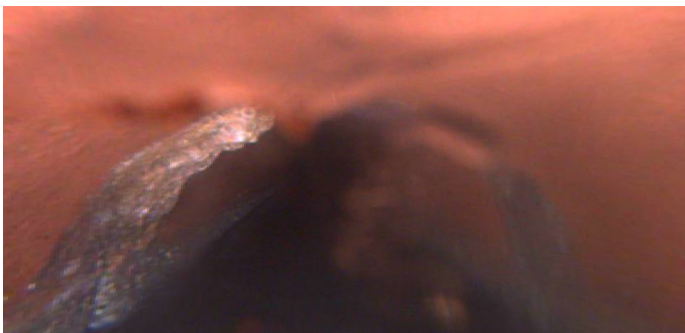
Code: **DAE**
Description: **Deposits Attached Encrustation**

Distance (ft): **26.3**
Structural Grade: **0**
O&M Grade: **2**
Clock Start/From: **7**
Clock To: **10**
1st Value:
2nd Value:
Value Percent: **5.000**
Continuous Index:
Within 8" of Joint: **YES**
Remarks:

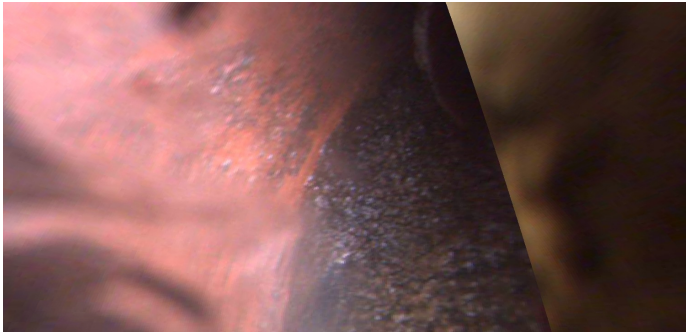
Code: **TF**
Description: **Tap Factory**

Distance (ft): **32.4**
Structural Grade: **0**
O&M Grade: **0**
Clock Start/From: **2**
Clock To:
1st Value: **4.000**
2nd Value:
Value Percent:
Continuous Index:
Within 8" of Joint: **YES**
Remarks:

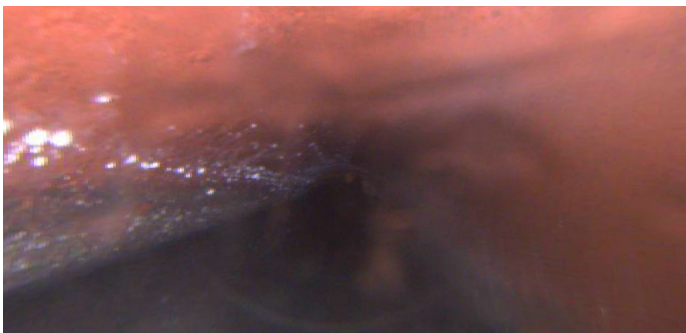
Code: **MSA**
Description: **Abandoned Survey**

Distance (ft): **41.2**
Structural Grade: **0**
O&M Grade: **0**
Clock Start/From:
Clock To:
1st Value:
2nd Value:
Value Percent:
Continuous Index:
Within 8" of Joint: **NO**
Remarks: **no blockage**

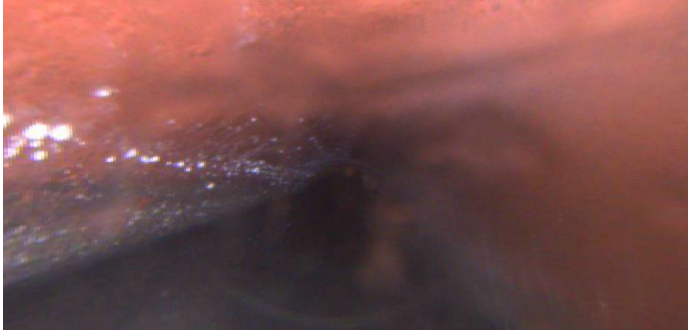
Code:	DSZ
Description:	Deposits Settled Other
Distance (ft):	41.2
Structural Grade:	0
O&M Grade:	2
Clock Start/From:	6
Clock To:	
1st Value:	
2nd Value:	
Value Percent:	5.000
Continuous Index:	F01
Within 8" of Joint:	NO
Remarks:	debris
