Profile/Photo Observation Report

Date:	04/10/2018	Weather:		Coding:	PACP 6.0
Pipe Length (ft):	51.0	Owner:	NA	Pre Clean:	No Pre-Cleaning
P.O.#:		Surveyor:	Byrd Fitzgerald	PSR:	P-606-014-013
Customer:		Clean Date:	01/01/1900	Shape:	C

Street:	FOXCROFT STREET	Flow Control:	Not Controlled
City:	Hobart, IN	Year Renewed:	
Location:	Yard	Tape/Media #:	
Purpose:	Routine Assessment	Dia/Height:	10"
Use:	Sanitary	Material:	VCP
Drain Area:	NA	Lining:	
Category:	NA		
Comment:

Location Details:		Direction of Survey:	Upstream
US MH:	M-606-013	DS MH:	M-606-014
		Total Length Surveyed (ft):	41.2

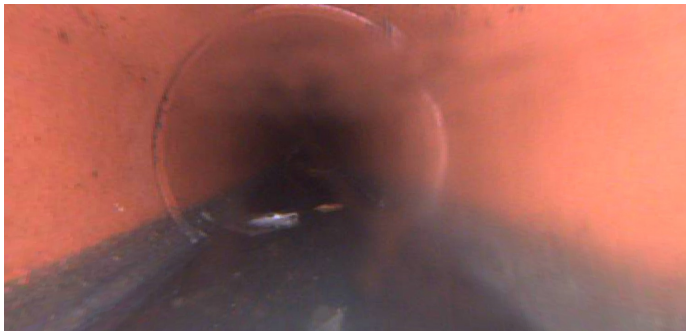
Code: **AMH**
Description: **Manhole**

Distance (ft): **.0**
Structural Grade: **0**
O&M Grade: **0**
Clock Start/From:
Clock To:
1st Value:
2nd Value:
Value Percent:
Continuous Index:
Within 8" of Joint: **NO**
Remarks: **M-606-014**

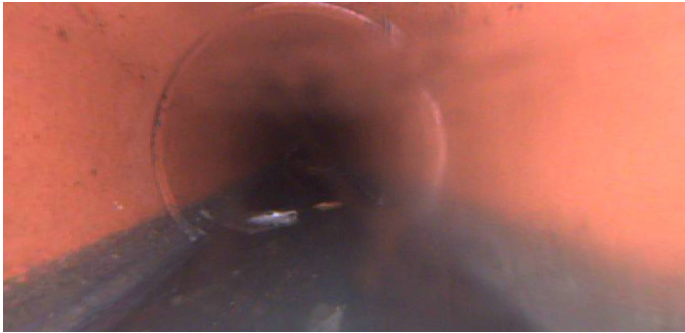
Code:	MWL
Description:	Water Level

Distance (ft):	.0
Structural Grade:	0
O&M Grade:	0
Clock Start/From:	
Clock To:	
1st Value:	
2nd Value:	
Value Percent:	5.000
Continuous Index:	
Within 8" of Joint:	NO
Remarks:

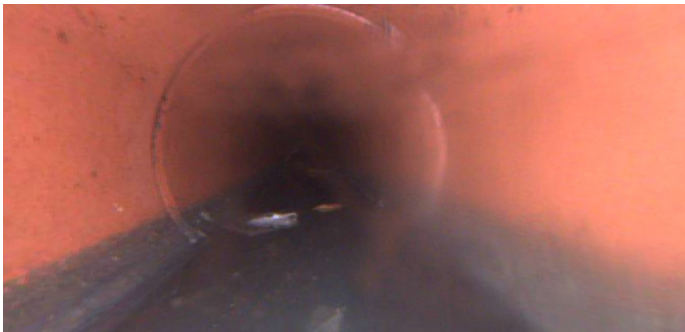
Code:	DSZ
Description:	Deposits Settled Other

Distance (ft):	.0
Structural Grade:	0
O&M Grade:	2
Clock Start/From:	6
Clock To:	
1st Value:	
2nd Value:	
Value Percent:	5.000
Continuous Index:	S01
Within 8" of Joint:	NO
Remarks:	debris

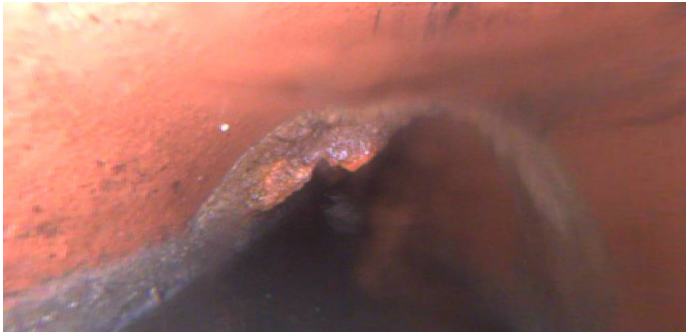
Code: **DAE**
Description: **Deposits Attached Encrustation**

Distance (ft): **6.2**
Structural Grade: **0**
O&M Grade: **2**
Clock Start/From: **8**
Clock To: **4**
1st Value:
2nd Value:
Value Percent: **5.000**
Continuous Index:
Within 8" of Joint: **YES**
Remarks:

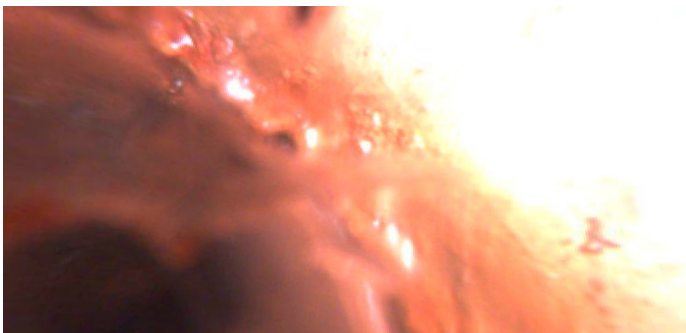
Code: **DAE**
Description: **Deposits Attached Encrustation**

Distance (ft): **16.6**
Structural Grade: **0**
O&M Grade: **2**
Clock Start/From: **8**
Clock To: **4**
1st Value:
2nd Value:
Value Percent: **5.000**
Continuous Index:
Within 8" of Joint: **YES**
Remarks:

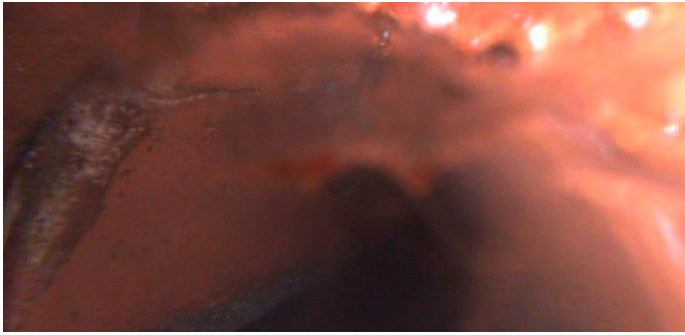
Code: **CS**
Description: **Crack Spiral**

Distance (ft): **16.6**
Structural Grade: **2**
O&M Grade: **0**
Clock Start/From: **11**
Clock To: **12**
1st Value:
2nd Value:
Value Percent:
Continuous Index:
Within 8" of Joint: **YES**
Remarks:

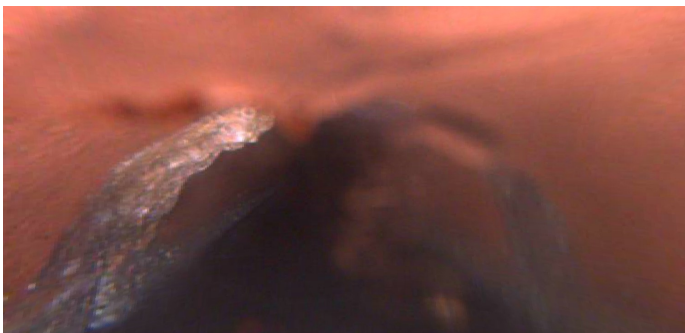
Code: **DAE**
Description: **Deposits Attached Encrustation**

Distance (ft): **26.3**
Structural Grade: **0**
O&M Grade: **2**
Clock Start/From: **7**
Clock To: **10**
1st Value:
2nd Value:
Value Percent: **5.000**
Continuous Index:
Within 8" of Joint: **YES**
Remarks:

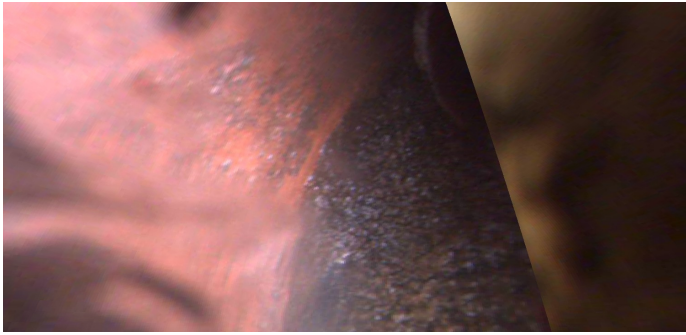
Code: **TF**
Description: **Tap Factory**

Distance (ft): **32.4**
Structural Grade: **0**
O&M Grade: **0**
Clock Start/From: **2**
Clock To:
1st Value: **4.000**
2nd Value:
Value Percent:
Continuous Index:
Within 8" of Joint: **YES**
Remarks:

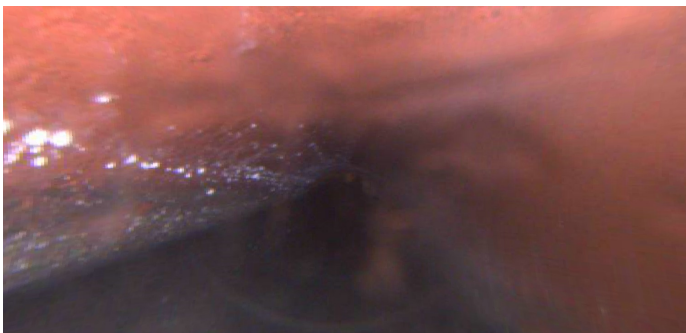
Code: **MSA**
Description: **Abandoned Survey**

Distance (ft): **41.2**
Structural Grade: **0**
O&M Grade: **0**
Clock Start/From:
Clock To:
1st Value:
2nd Value:
Value Percent:
Continuous Index:
Within 8" of Joint: **NO**
Remarks: **no blockage**

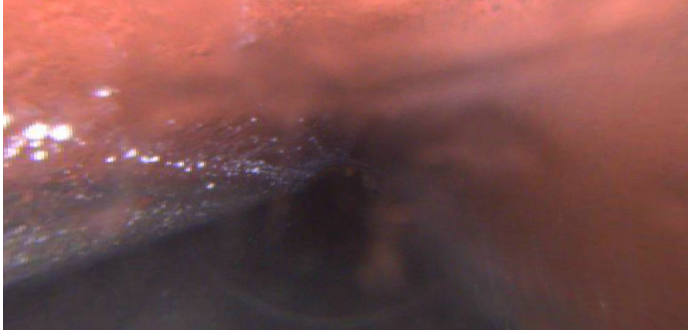
Code:	DSZ
Description:	Deposits Settled Other
Distance (ft):	41.2
Structural Grade:	0
O&M Grade:	2
Clock Start/From:	6
Clock To:	
1st Value:	
2nd Value:	
Value Percent:	5.000
Continuous Index:	F01
Within 8" of Joint:	NO
Remarks:	debris
