Profile/Photo Observation Report

Date:	02/18/2022	Weather:		Coding:	PACP 7.0
Pipe Length (ft):	51.0	Owner:	City of Hobart	Pre Clean:	Heavy Cleaning
P.O.#:	YES502259	Surveyor:	S. Bucklin	PSR:	P-606-014-013
Customer:	City of Hobart	Clean Date:	01/27/2022	Shape:	C

Street:	West 8th Place	Flow Control:	Not Controlled
City:	Hobart, IN	Year Renewed:	
Location:	Other	Tape/Media #:	
Purpose:	Routine Assessment	Dia/Height:	10"
Use:	Sanitary Sewage Pipe	Material:	VCP
Drain Area:		Lining:	None
Category:	NA		
Comment:			
Location Details:	DRIVEWAY	Direction of Survey:	Upstream
US MH:	M-606-013	DS MH:	M-606-014
		Total Length Surveyed (ft):	51.0

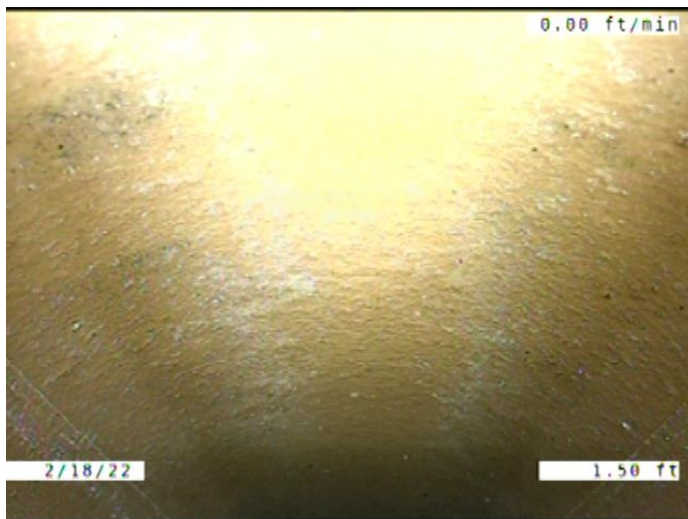
Code: **MGO**
Description: **Miscellaneous General Observation**

Distance (ft): **1.5**
Structural Grade: **0**
O&M Grade: **0**
Clock Start/From:
Clock To:
1st Value:
2nd Value:
Value Percent:
Continuous Index:
Within 8" of Joint: **NO**
Remarks: **CHANNEL IN THE DOWNSTREAM
MANHOLE SITS 4"-5" BELOW THE PI**

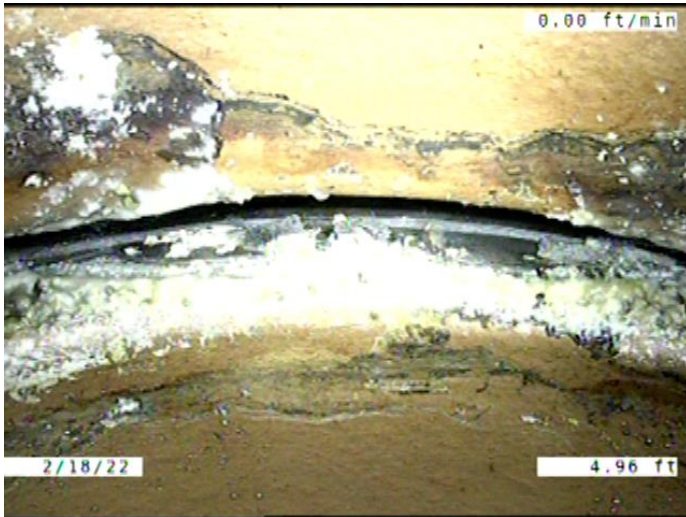
Code: **DAE**
Description: **Deposits Attached Encrustation**

Distance (ft): **5.0**
Structural Grade: **0**
O&M Grade: **2**
Clock Start/From: **11**
Clock To: **1**
1st Value:
2nd Value:
Value Percent: **5.000**
Continuous Index:
Within 8" of Joint: **YES**
Remarks:

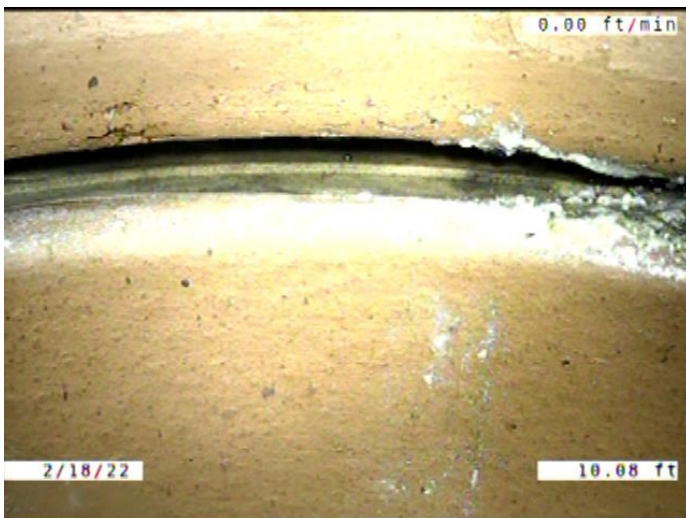
Code: **DAE**
Description: **Deposits Attached Encrustation**

Distance (ft): **10.1**
Structural Grade: **0**
O&M Grade: **2**
Clock Start/From: **11**
Clock To: **1**
1st Value:
2nd Value:
Value Percent: **5.000**
Continuous Index:
Within 8" of Joint: **YES**
Remarks:

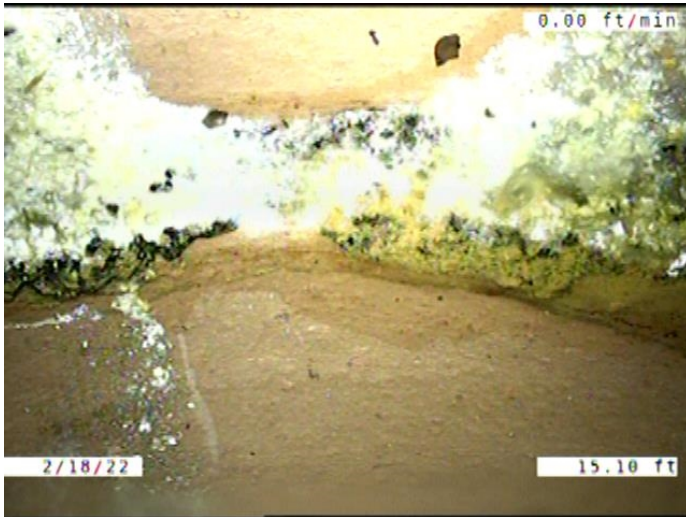
Code: **DAE**
Description: **Deposits Attached Encrustation**

Distance (ft): **15.1**
Structural Grade: **0**
O&M Grade: **2**
Clock Start/From: **11**
Clock To: **1**
1st Value:
2nd Value:
Value Percent: **5.000**
Continuous Index:
Within 8" of Joint: **YES**
Remarks:

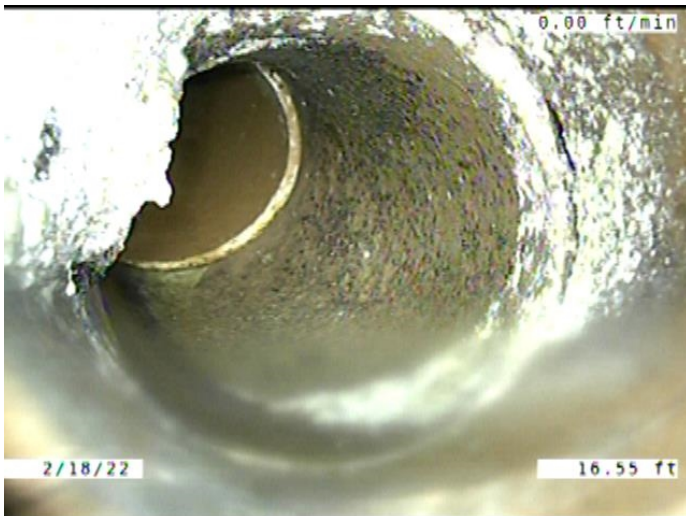
Code: **TF**
Description: **Tap Factory**

Distance (ft): **16.5**
Structural Grade: **0**
O&M Grade: **0**
Clock Start/From: **11**
Clock To:
1st Value: **4.000**
2nd Value:
Value Percent:
Continuous Index:
Within 8" of Joint: **YES**
Remarks: **CONSTANTLY RUNNING WATER FROM THE MAIN TO SERVICE JOINT.**

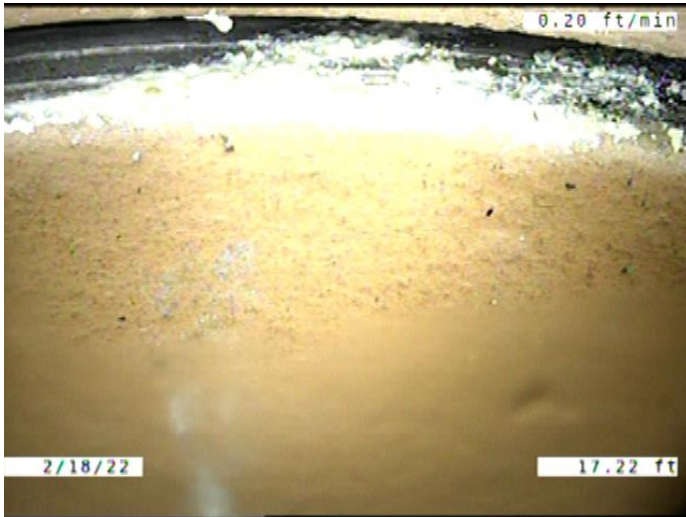
Code: **DAE**
Description: **Deposits Attached Encrustation**

Distance (ft): **17.2**
Structural Grade: **0**
O&M Grade: **2**
Clock Start/From: **11**
Clock To: **1**
1st Value:
2nd Value:
Value Percent: **5.000**
Continuous Index:
Within 8" of Joint: **YES**
Remarks:

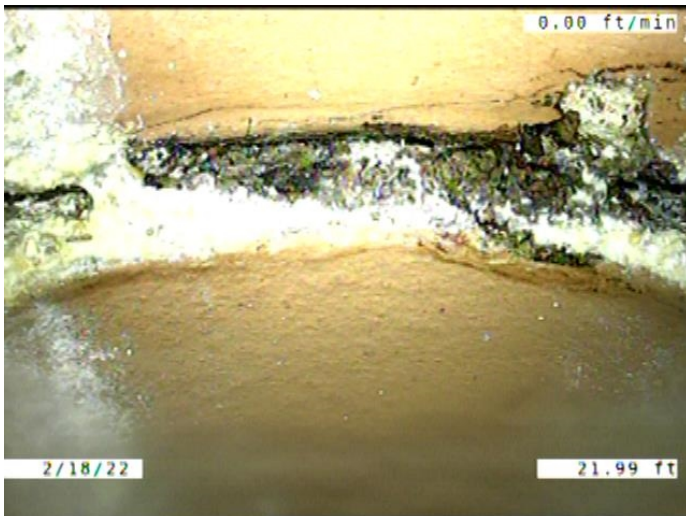
Code: **DAE**
Description: **Deposits Attached Encrustation**

Distance (ft): **22.0**
Structural Grade: **0**
O&M Grade: **2**
Clock Start/From: **11**
Clock To: **1**
1st Value:
2nd Value:
Value Percent: **5.000**
Continuous Index:
Within 8" of Joint: **YES**
Remarks:

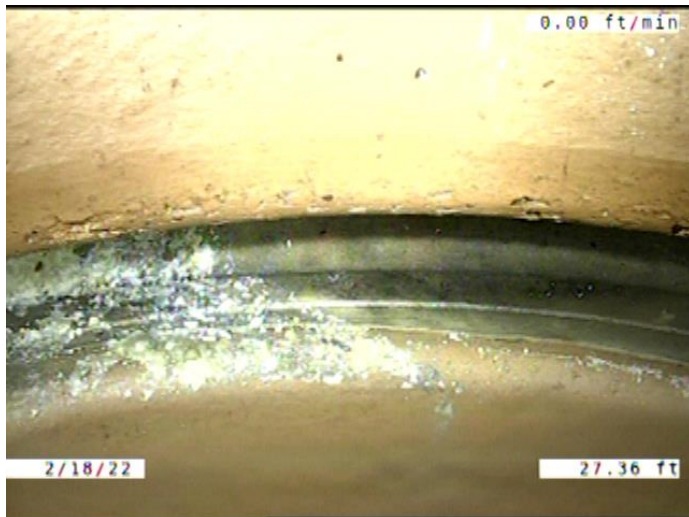
Code:	DAE
Description:	Deposits Attached Encrustation
Distance (ft):	27.4
Structural Grade:	0
O&M Grade:	2
Clock Start/From:	10
Clock To:	11
1st Value:	
2nd Value:	
Value Percent:	5.000
Continuous Index:	
Within 8" of Joint:	YES
Remarks:

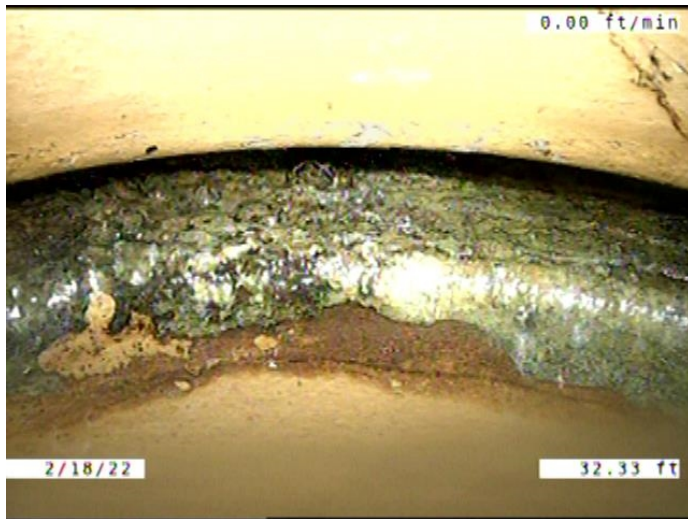
Code: **DAE**
Description: **Deposits Attached Encrustation**

Distance (ft): **32.3**
Structural Grade: **0**
O&M Grade: **2**
Clock Start/From: **8**
Clock To: **4**
1st Value:
2nd Value:
Value Percent: **5.000**
Continuous Index:
Within 8" of Joint: **YES**
Remarks:

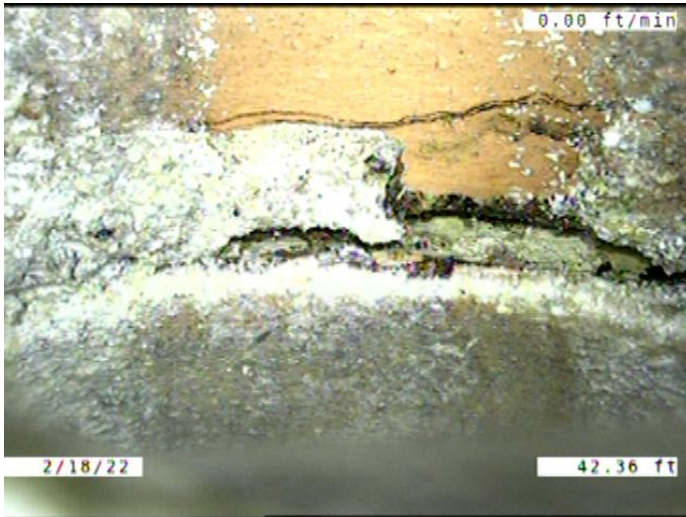
Code: **DAE**
 Description: **Deposits Attached Encrustation**

Distance (ft): **42.4**
 Structural Grade: **0**
 O&M Grade: **2**
 Clock Start/From: **10**
 Clock To: **2**
 1st Value:
 2nd Value:
 Value Percent: **5.000**
 Continuous Index:
 Within 8" of Joint: **YES**
 Remarks:
